# Hicks Flat Final Project Report

Prepared by Matt Baldzikowski, CPESC #828, Midpeninsula Regional Open Space District

December 2013

# Hicks Flat Remediation Project Field Implementation Report

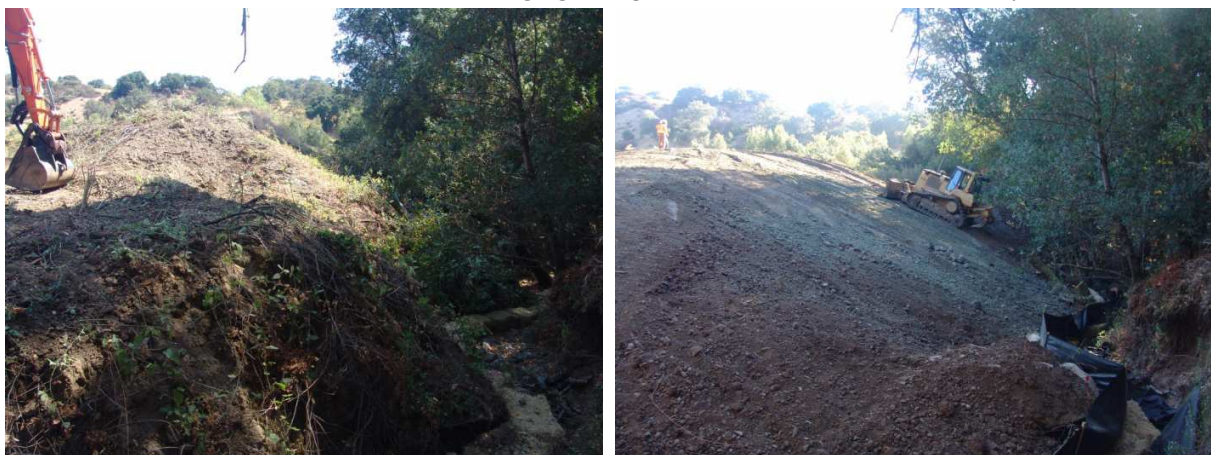
**Figure 3.** Slope flattening to achieve stable slope configuration.

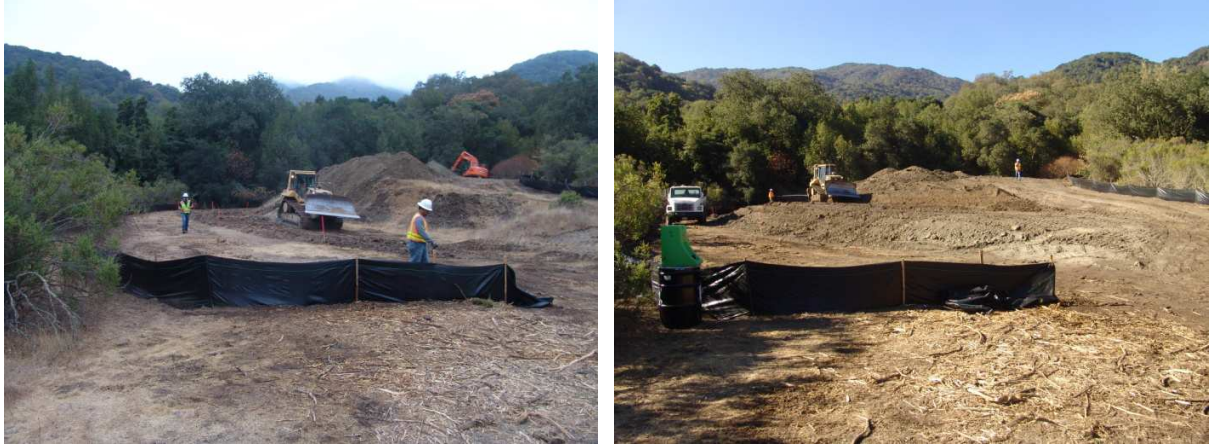
**Figure 4.** Stable waste (fill) disposal location.

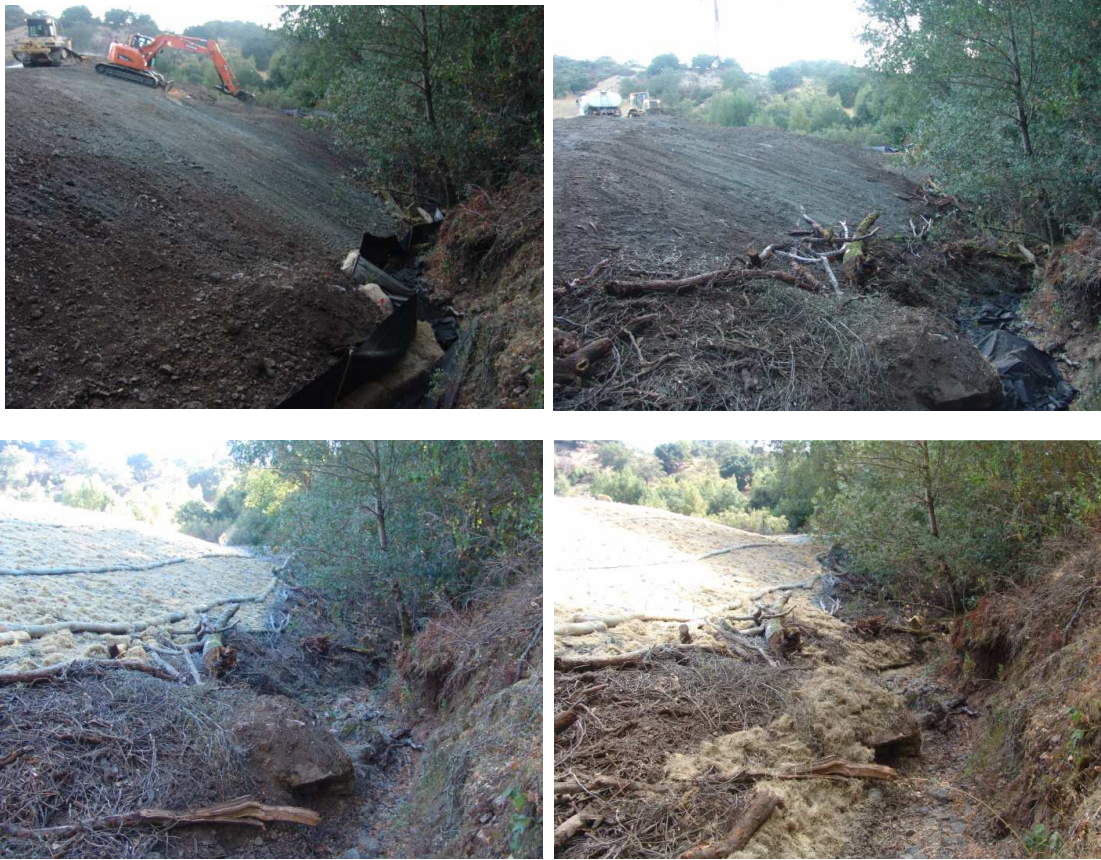
Erosion and sediment control measures were installed during project implementation and at the completion of the grading for final project surface stabilization, as recommended on the Erosion Control Plan sheet, and Revegetation Plan developed for the project. These included the installation of silt fencing, straw bales, straw wattles, extensive creek protection measures (described in Field Implementation Report), straw mulch, hydroseeding, and site plantings of native blackberry, and willow cuttings. Additionally, the near creek environment was treated with native woody material for additional erosion control and creek restoration/ wildlife habitat benefits (photo's next page).

**Figure 6.** Creek protection, restoration.

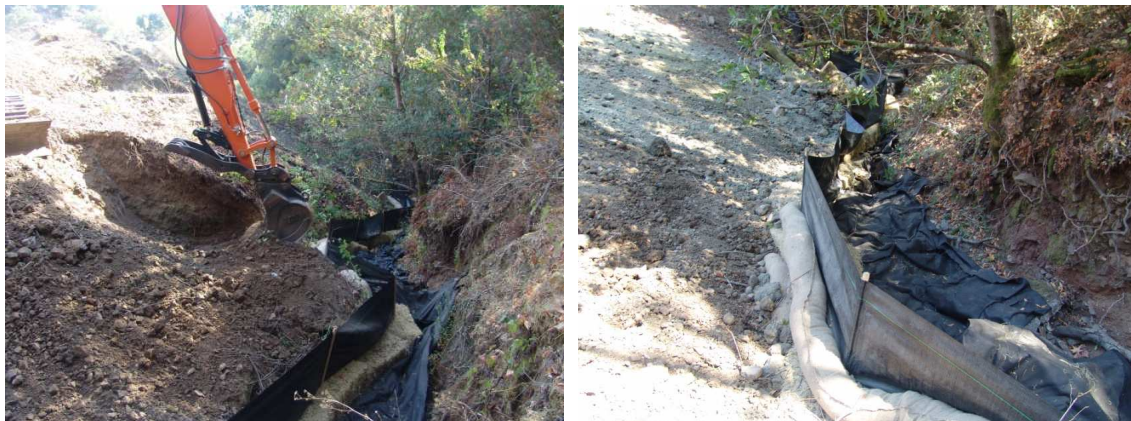
The project involved grading steep banks adjacent to an intermittent stream channel, with very rocky substrate. A little extra emphasis on stream protection maintained the active channel in excellent condition, requiring very little clean-up. This required additional encouragement and participation by MROSD staff to convey and execute properly. Silt fence was staked to the top of a row of straw bales placed tightly against the stream bank. The fence was offset to approximately the middle of the bales. This allowed the excavator bucket room to pull the slope edge, and contain loose soil ravel that would have over-topped the straw bales alone, spilling into the stream bed. Gaps or voids were plugged with straw wattles which were easily cleared of soil, and removed at the end of grading. Additionally, lining the channel with fabric allowed for easy location and removal of the minimal volume of soil clods and rock that happened to make it over the silt fence.

**Figure 7.** Creek protection practices.

Straw bale placement was utilized to elevate the toe of the excavated slope above the ordinary high water mark of Hicks Creek. This was beneficial regarding permit streamlining, but also had the additional benefit of maintaining native vegetation roots and stems intact. The majority of this vegetation is native blackberry and poison oak, and it is anticipated that the toe of the re-graded slope will re-establish vegetation more quickly due to the preservation of this root zone.

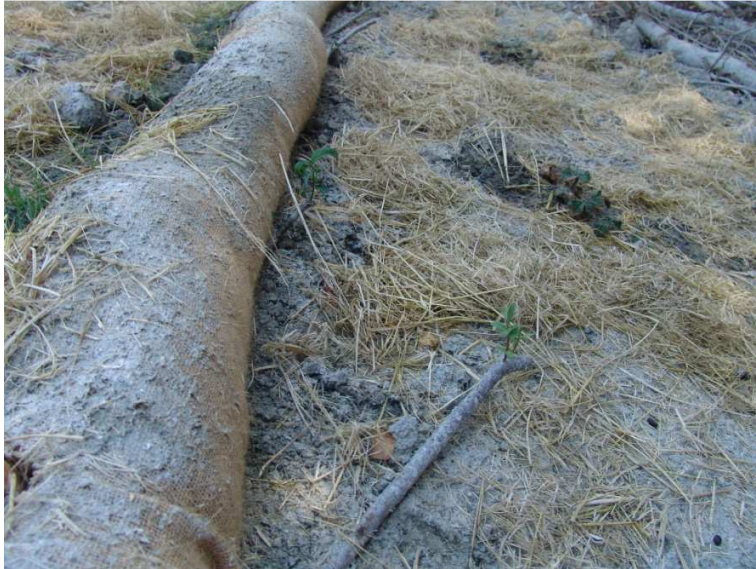
Blackberry plantings were installed prior to hydroseeding. These plantings should have been covered with the planting pots prior to hydroseeding. The hydroseed mix had to be manually removed from the

blackberry leaves, lesson learned. Blackberries have been watered manually by MROSD since installation, awaiting rain, and are alive and producing new growth. Willow poles planted on site are also exhibiting new growth (photo below).

**Figure 8.** Blackberry and willow growth.

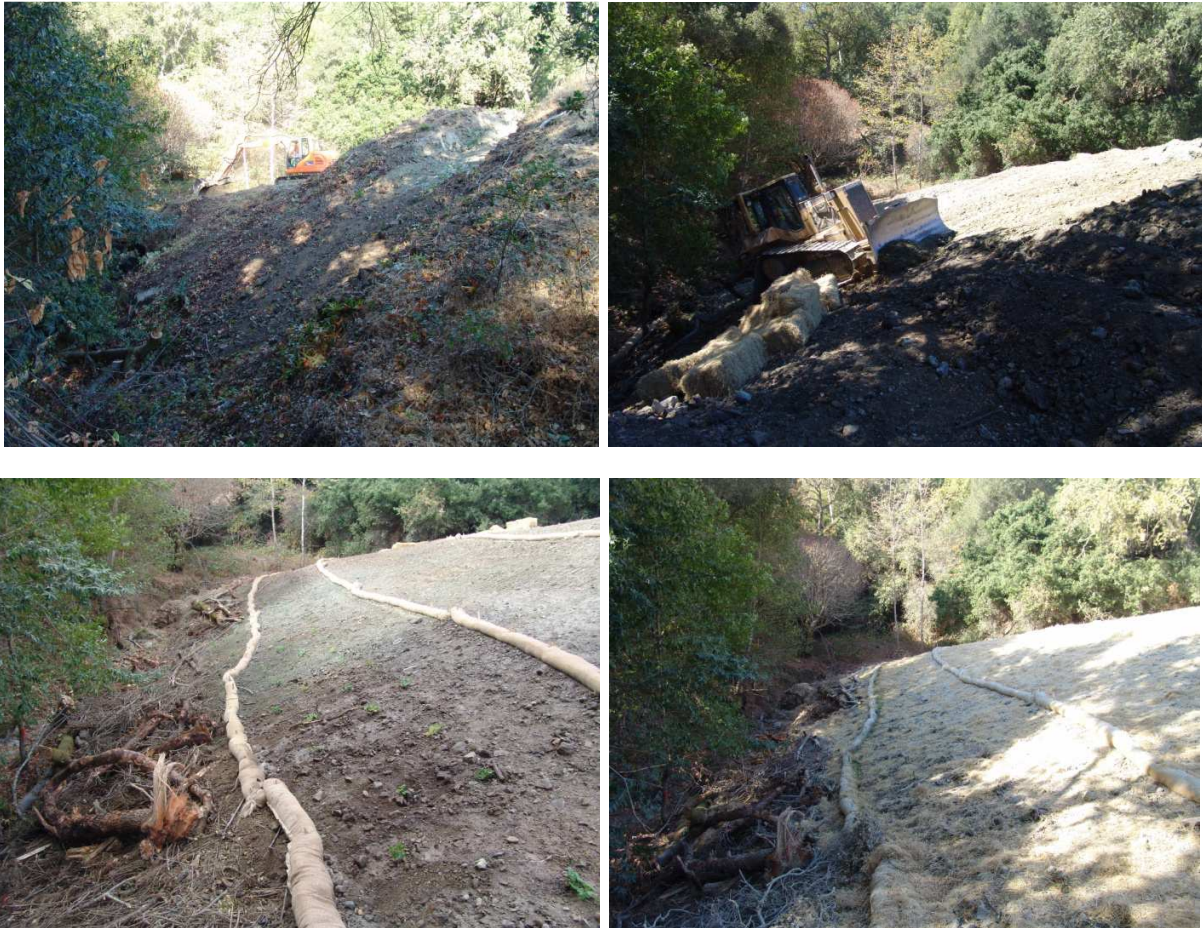
**Figure 9.** Photo point 5 sequence. Slope flattening, creek-side restoration, final erosion control implementation.

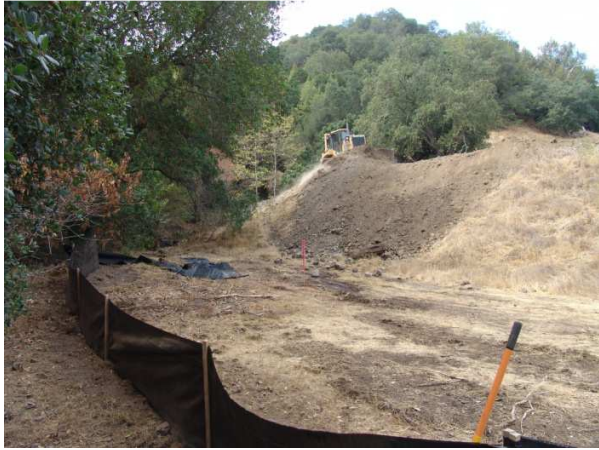
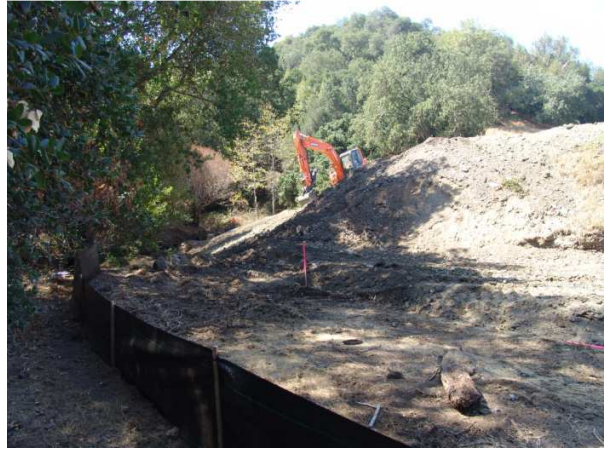
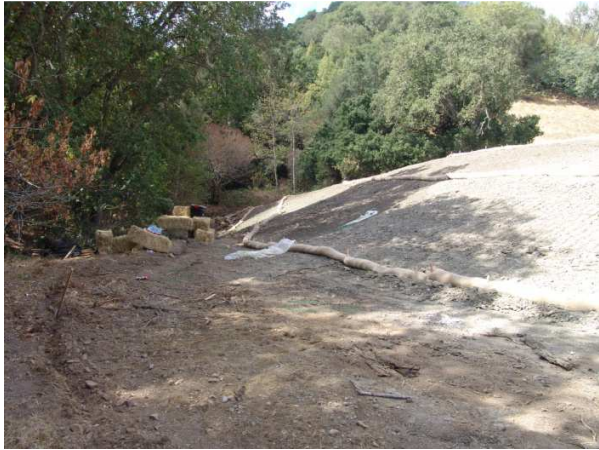
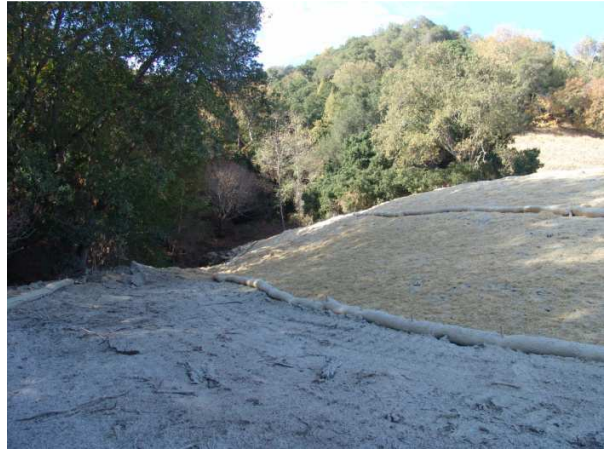
**Figure 10.** Photo point 4 sequence. Slope flattening through erosion control completion.

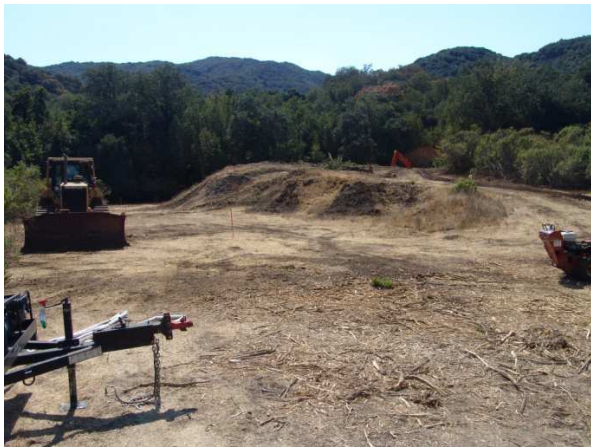
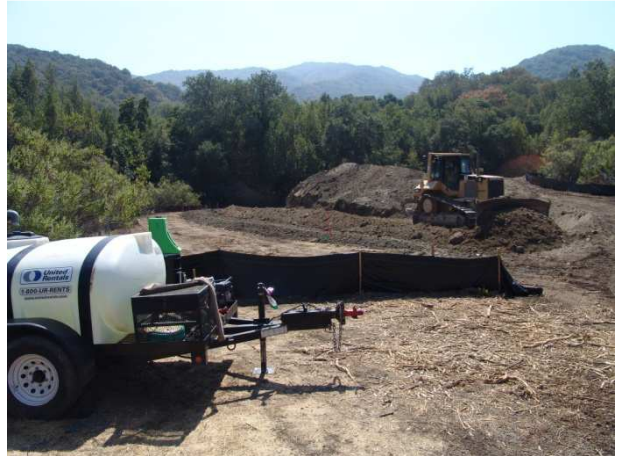
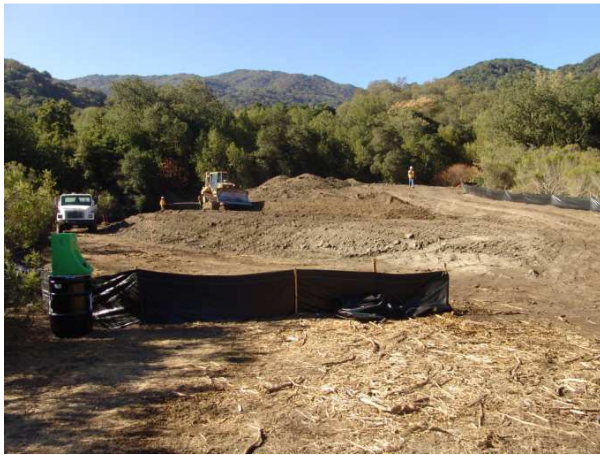
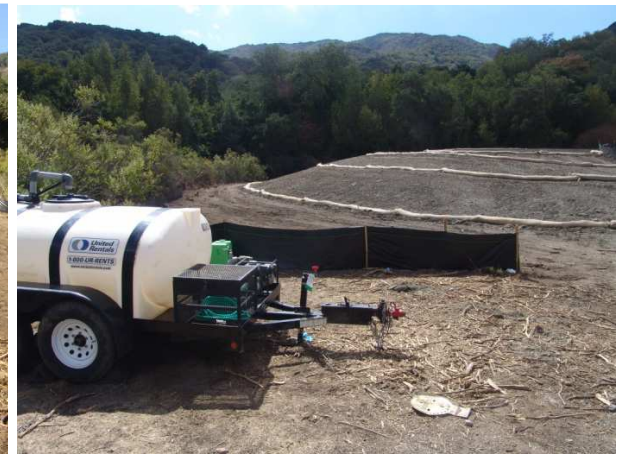
**Figure 11.** Photo point 3 sequence. Waste disposal (fill) placement through grading completion.

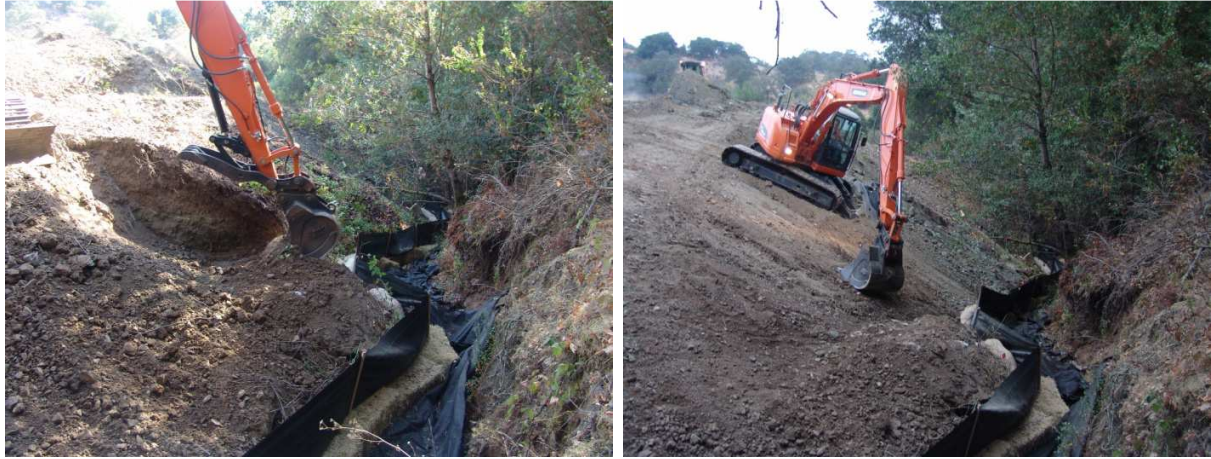
Stream protection measures during construction were extensive, and very effective. These included straw bales placed tightly against the channel bank, augmented with straw wattles to fill gaps as needed. Silt fence was also tightly staked on top of the straw bales to contain soil

and rock which could roll down during slope grading. Additionally, the entire channel was lined, bank to bank, with geotextile fabric to contain any soil/ rock that made it over the silt fence. Loose soil and rock dislodged during construction was carefully removed by heavy equipment and then finished off by hand as the temporary construction BMP's were removed.

Creek protection BMP's.

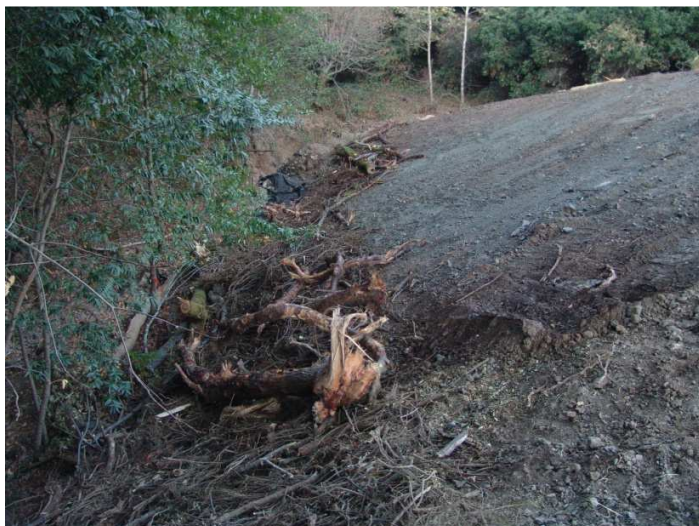
Final erosion control BPM's were installed per the specifications of the engineered grading plans and the revegetation plan. These include: slope flattening, track walking, straw wattle and silt fence placement, hydroseeding, and surface straw mulch application. Additionally, woody slash (including two bay trees which had been undermined and had fallen last winter on the slope to be re-graded) was spread immediately adjacent to the intermittent stream channel at the graded toe of the project. This maintained the bay trees where they had fallen, and provided beneficial woody material adjacent to the stream, consistent with biotechnical stream restoration techniques detailed in stream restoration manuals (DFW, DPR).

Wood slash placement.

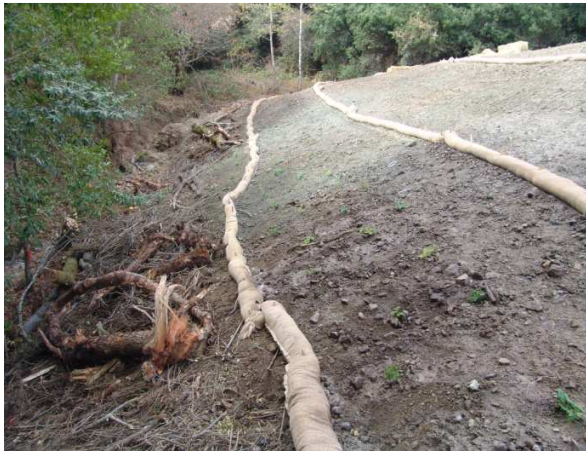
Difficulty was encountered with pounding willow stakes into the very rocky substrate at the toe of the project area. Instead, willow poles were left long 4-6', instead of cut into smaller stakes, and were planted within the trench beneath the lowest row of straw wattle on the slope. The willow poles had been soaked prior to planting, and were hand packed with moist soil beneath the wattle. Native Blackberry plants were planted on the slope above the wood slash and lower row of wattles with willow, and should aggressively re-colonize down the toe of the slope. Willows and blackberries have been watered every 7-14 days following planting, and both species exhibit new growth.

Willow and blackberry planting.

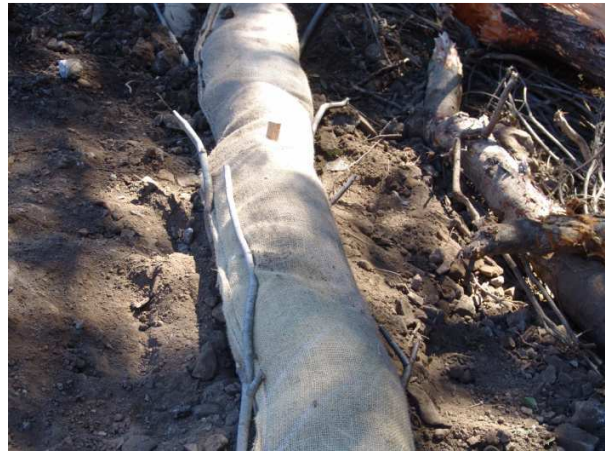
Willow poles planted in straw wattle trench.

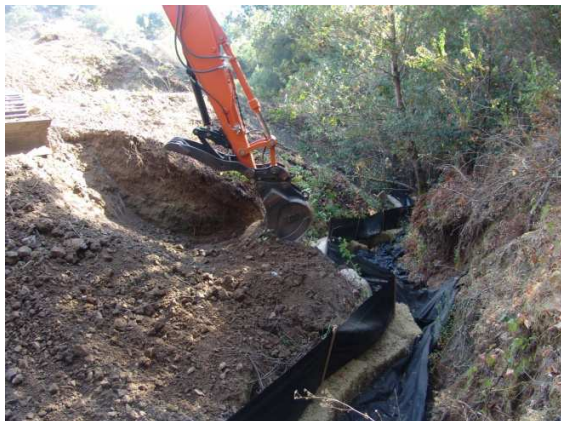
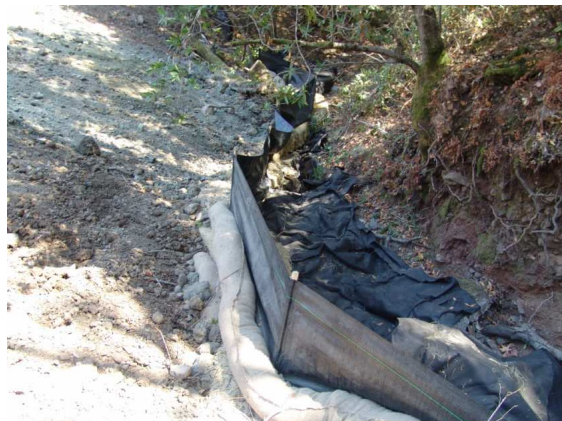
The project involved grading steep banks adjacent to an intermittent stream channel, with very rocky substrate. A little extra emphasis on stream protection maintained the active channel in excellent condition, requiring very little clean-up. This required additional encouragement and participation by MROSD staff to convey and execute properly. Silt fence was staked to the top of a row of straw bales placed tightly against the stream bank. The fence was offset to approximately the middle of the bales. This allowed the excavator bucket room to pull the slope edge, and contain loose soil ravel that would have over-topped the straw bales alone, spilling into the stream bed. Gaps or voids were plugged with straw wattles which were easily cleared of soil, and removed at the end of grading. Additionally, lining the channel with fabric allowed for easy location and removal of the minimal volume of soil clods and rock that happened to make it over the silt fence.

Straw bale placement was utilized to elevate the toe of the excavated slope above the ordinary high water mark of Hicks Creek. This was beneficial regarding permit streamlining, but also had the additional benefit of maintaining native vegetation roots and stems intact. The majority of this vegetation is native blackberry and poison oak, and it is anticipated that the toe of the re-graded slope will re-establish vegetation more quickly due to the preservation of this root zone.

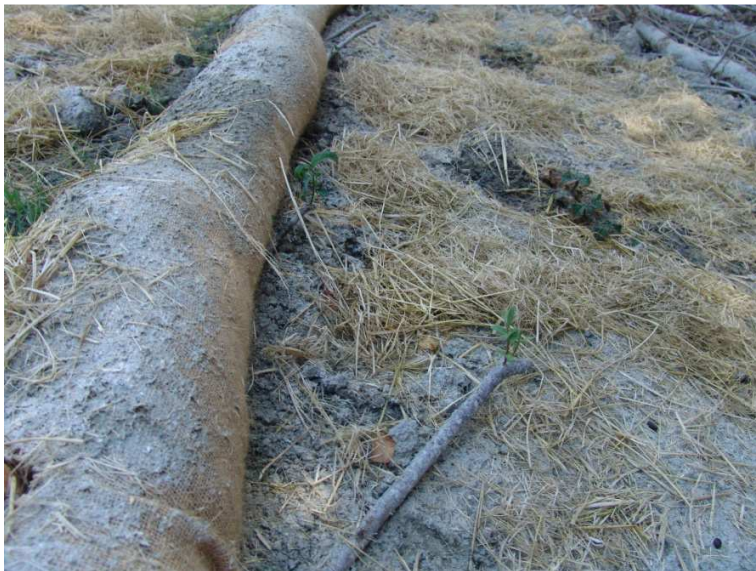
Blackberry plantings were installed prior to hydroseeding. These plantings should have been covered with the planting pots prior to hydroseeding. The hydroseed mix had to be manually removed from the blackberry leaves, ouch, lesson learned. Blackberries have been watered manually by MROSD since installation, awaiting rain, and are alive and producing new growth. Willow poles planted on site are also exhibiting new growth (photo below).

Blackberry and willow cutting growth.
