PHASE II: SENADOR MINE RESTORATION PROJECT ALMADEN QUICKSILVER COUNTY PARK SANTA CLARA COUNTY, CALIFORNIA

FINAL REPORT

October 2016

Prepared by:
Santa Clara County Parks Department

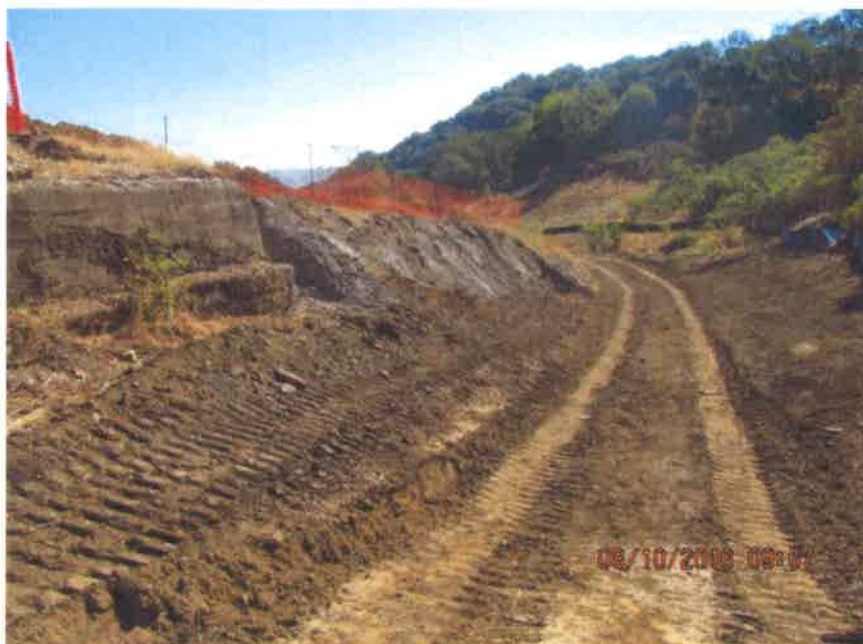
McAbee Creek – Looking downstream from above TF 45. Gray area on the left (north bank) has been excavated to remove calcines. The concrete wall is shown on the left side of the photo.

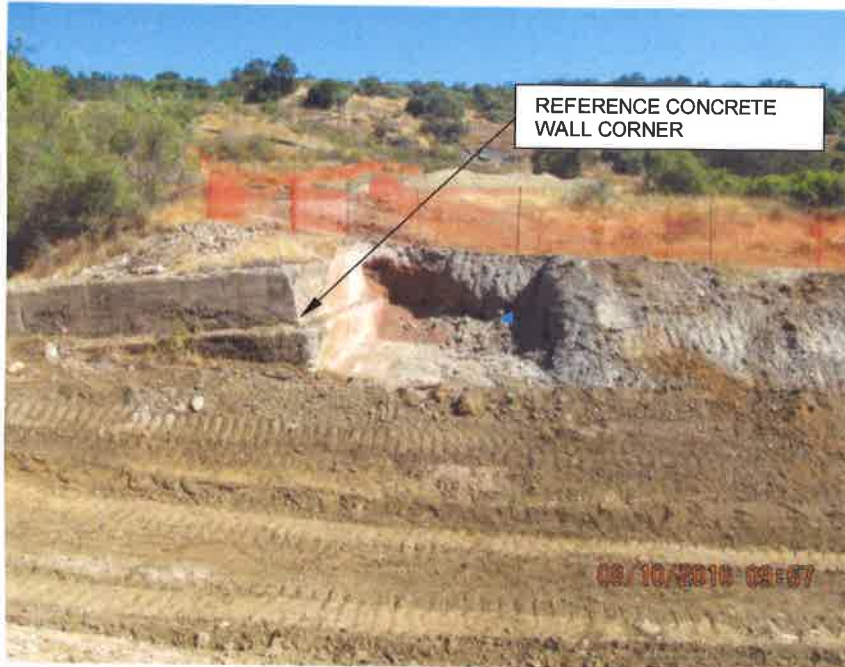
McAbee Creek – Looking north from south bank of creek at the additional calcine excavation adjacent to the concrete wall. This excavation is at Senador Mine Trail.

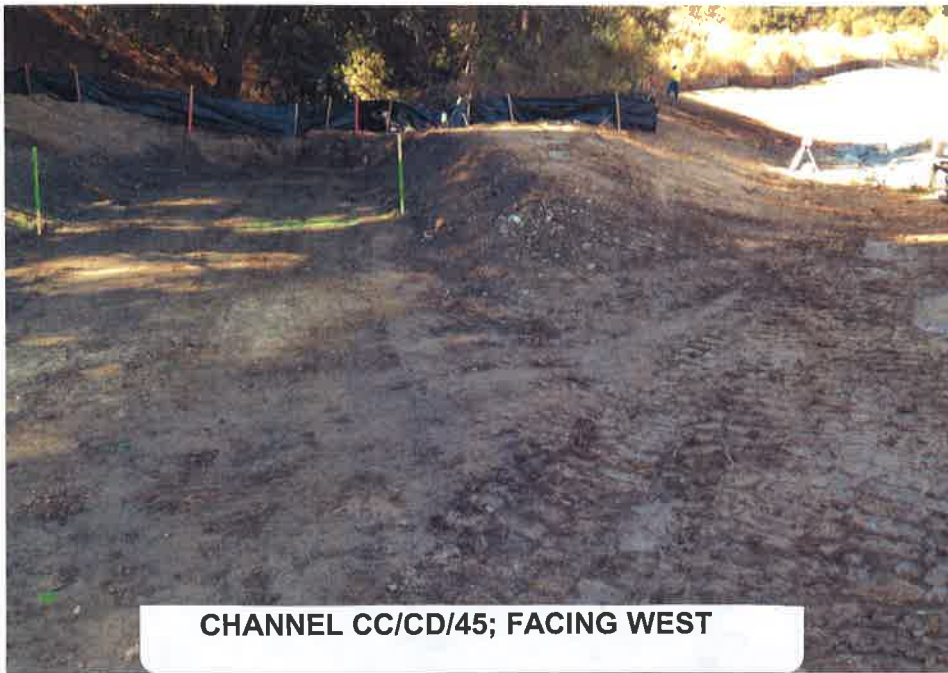
CHANNEL CC/CD/45; FACING WEST

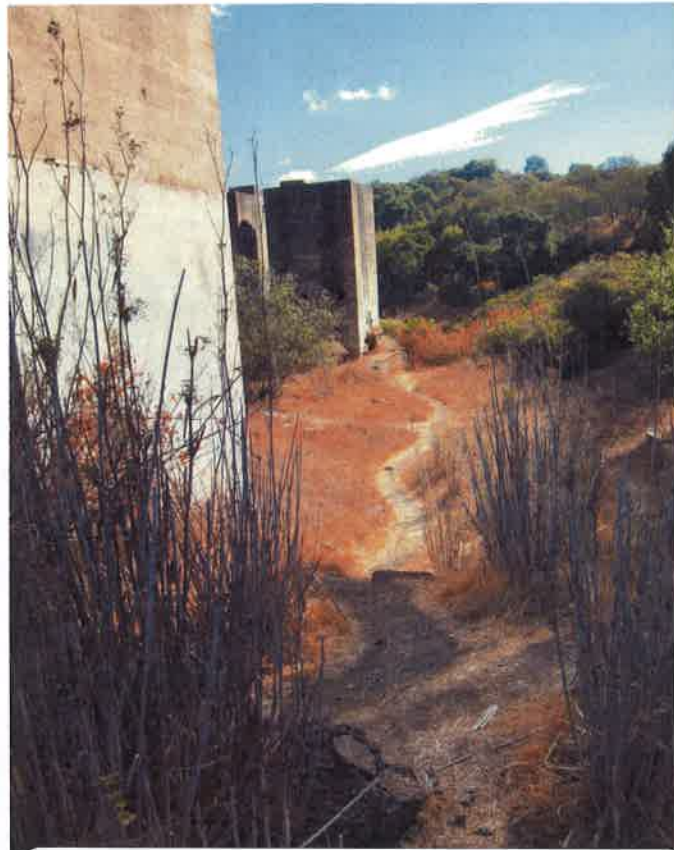
EXISTING CONDITIONS: STREAM CHANNEL CC/CD/45; FACING EAST

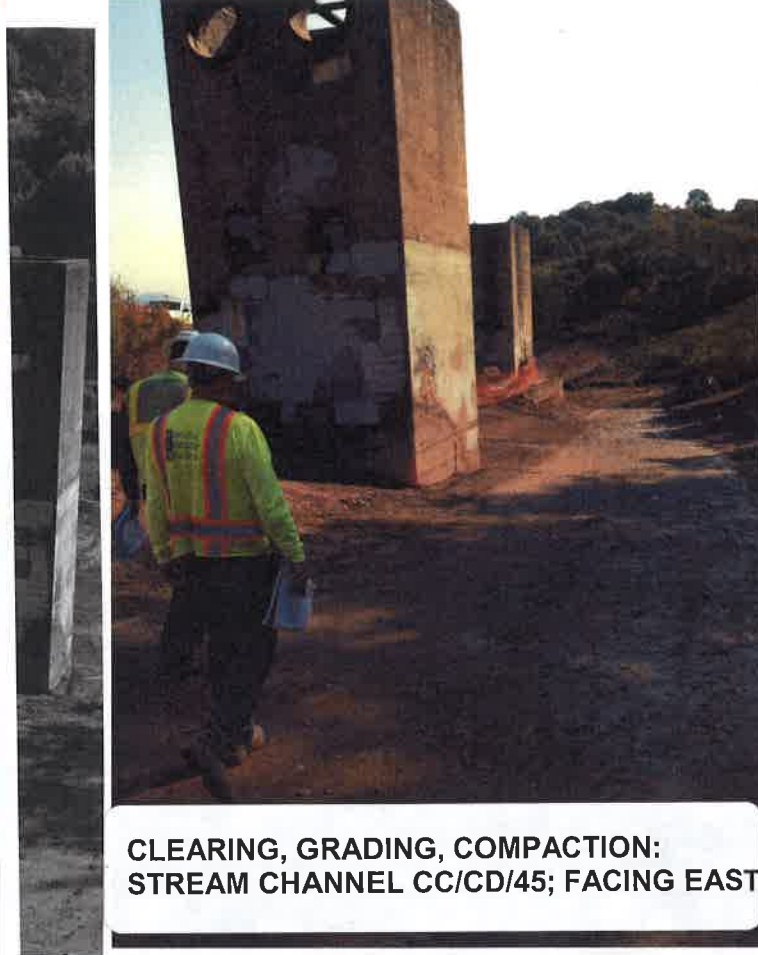
CLEARING, GRADING, COMPACTION: STREAM CHANNEL CC/CD/45; FACING EAST

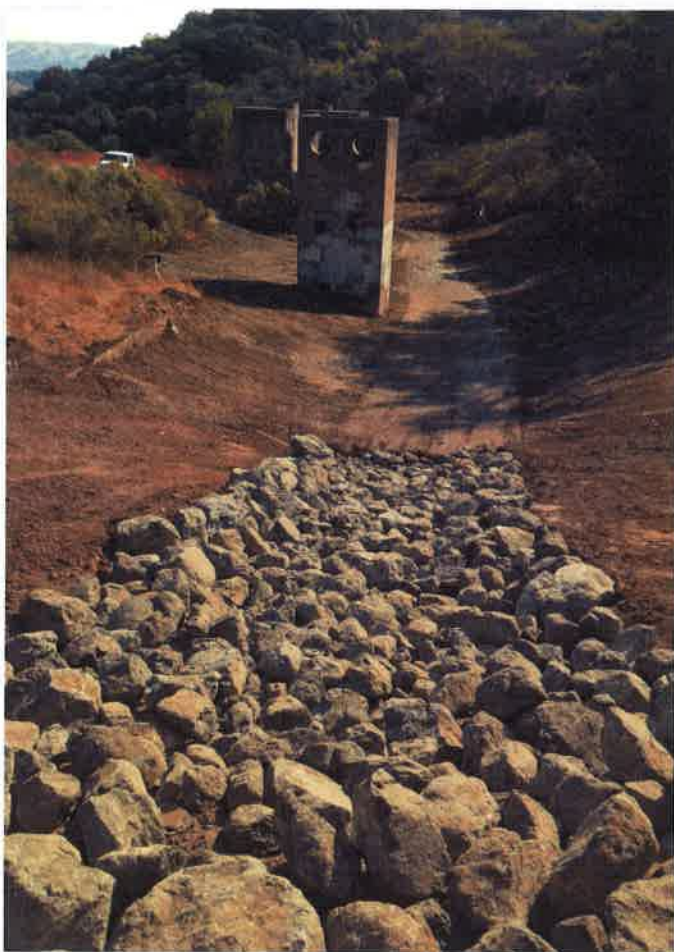
RIP RAP INSTALLATION: STREAM CHANNEL CC/CD/45; FACING EAST

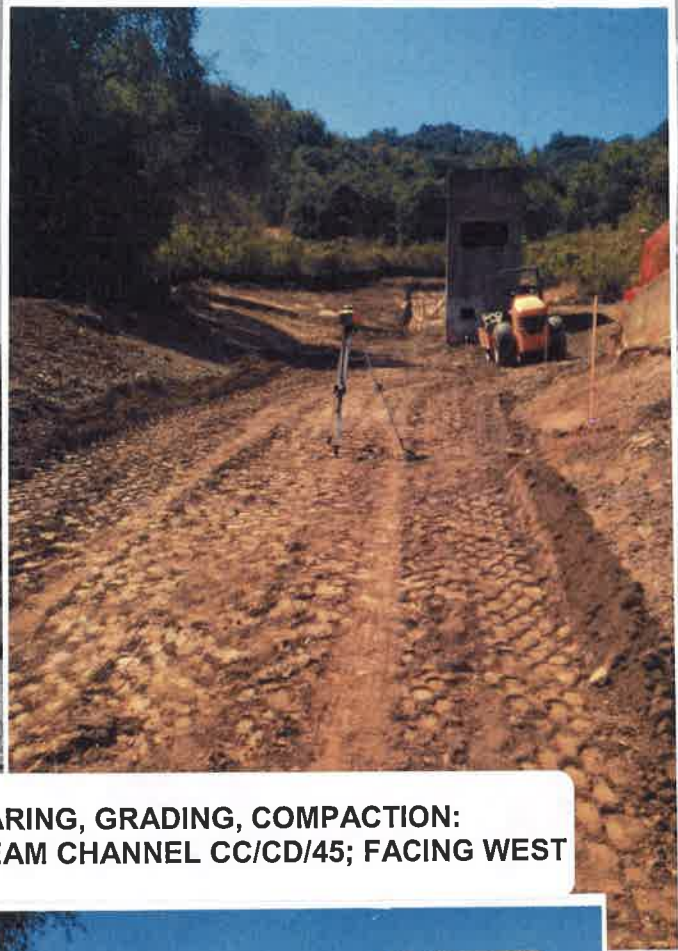
**CLEARING, GRADING, COMPACTION:
STREAM CHANNEL CC/CD/45; FACING WEST**

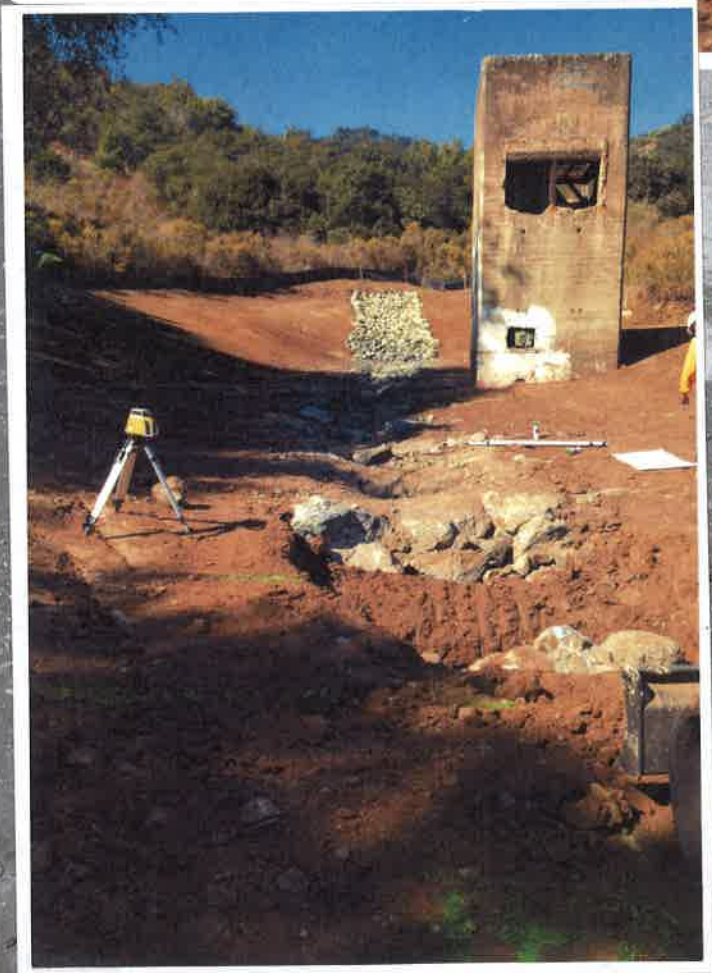
**STEP POOL PREPARATION: STREAM
CHANNEL CC/CD/45; FACING WEST**

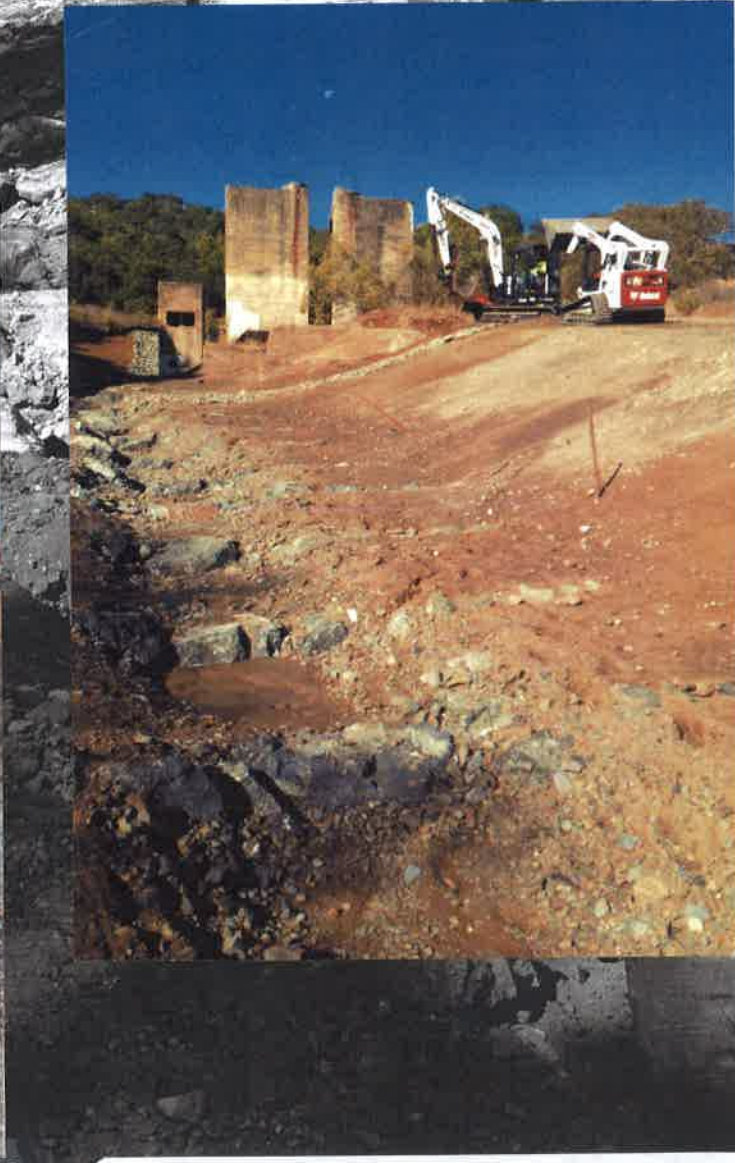
STEP POOL PREPARATION: STREAM CHANNEL CC/CD/45; FACING WEST

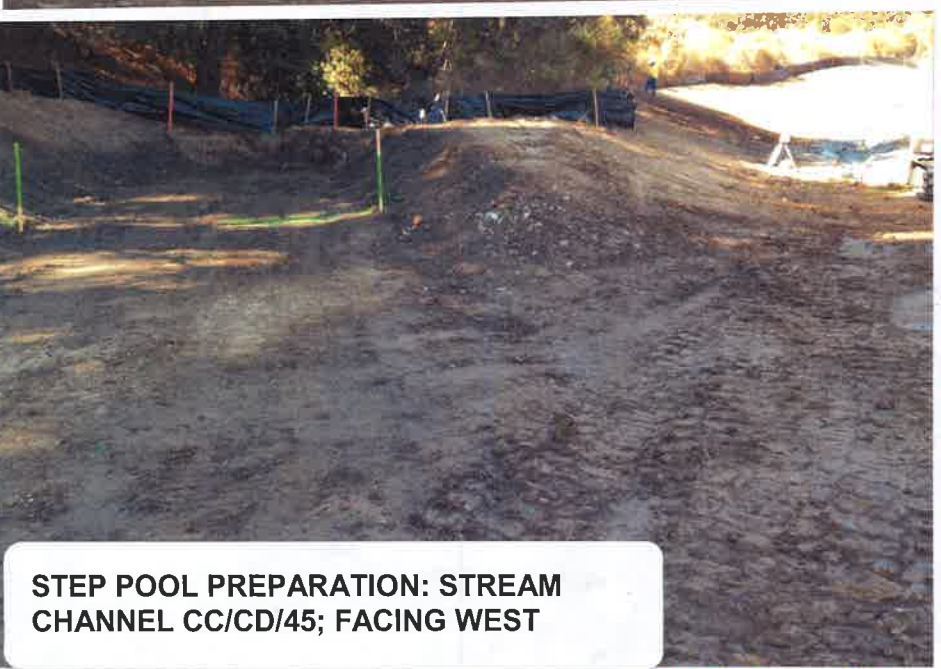
STEP POOL PREPARATION: STREAM CHANNEL CC/CD/45; FACING WEST

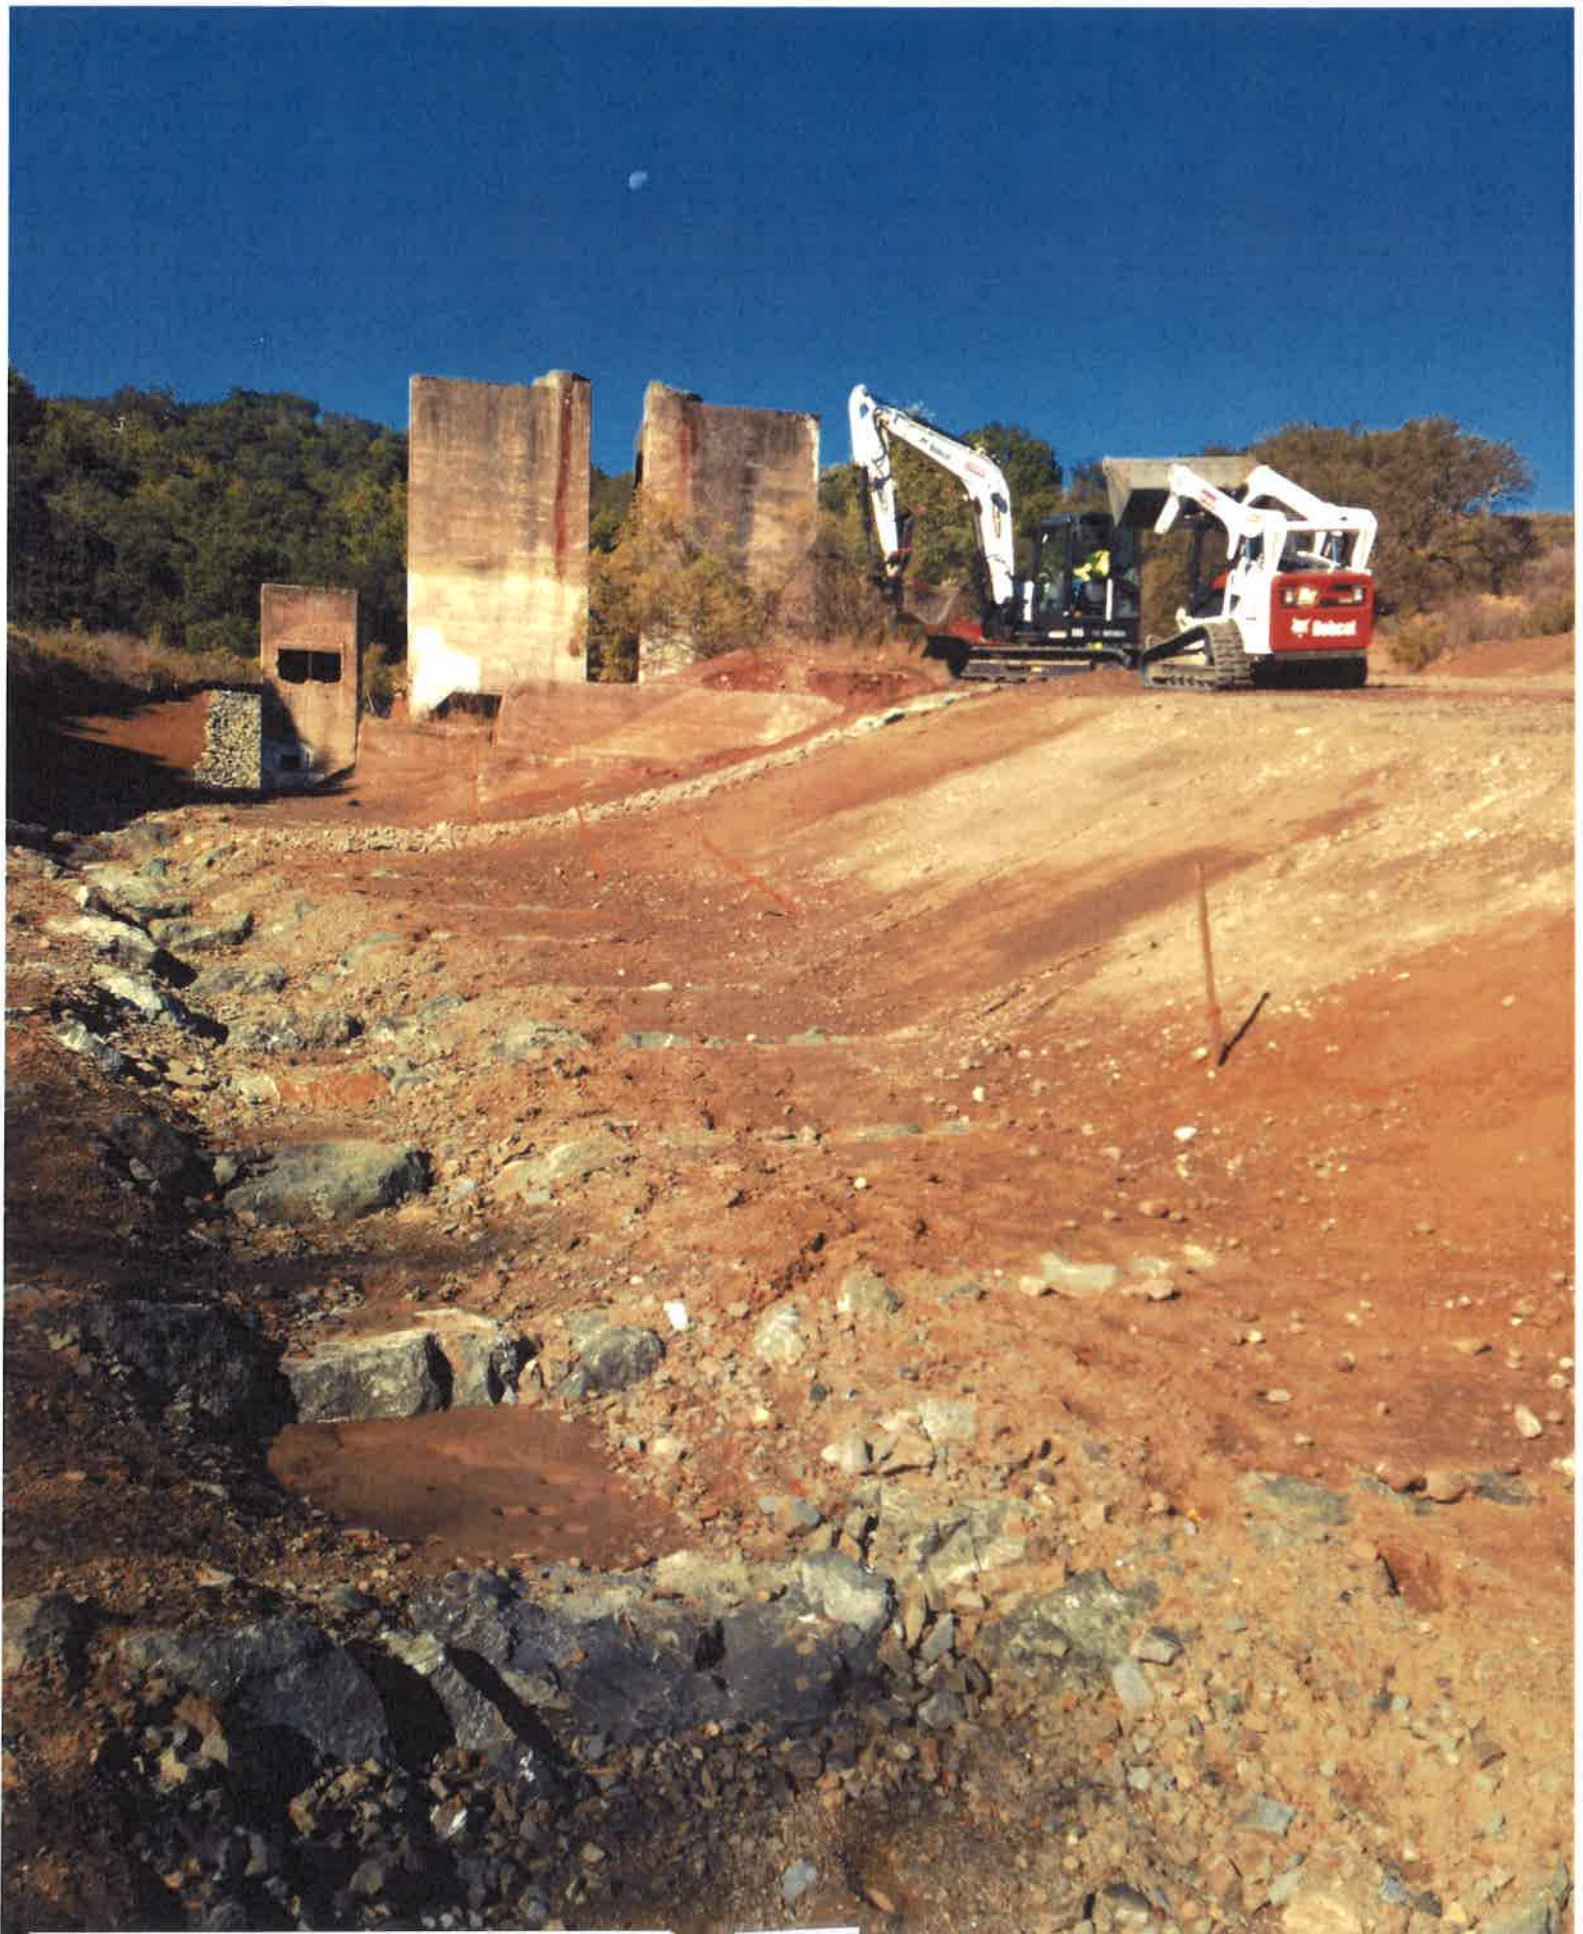
STEP POOL PREPARATION: STREAM CHANNEL CC/CD/45; FACING WEST

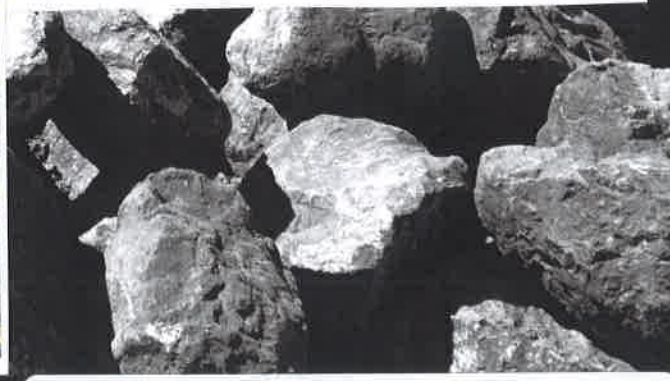
RIP RAP INSTALLATION: STREAM CHANNEL 22; FACING WEST

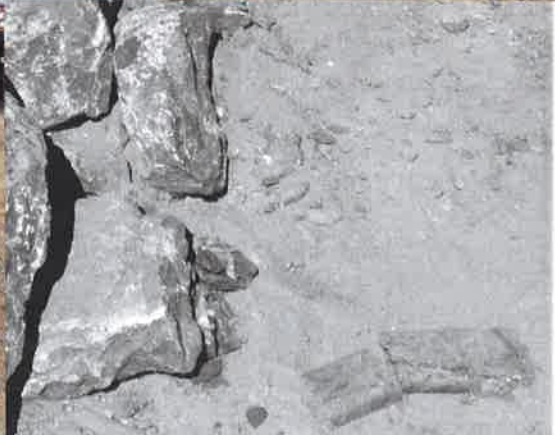
RIP RAP INSTALLATION: STREAM CHANNEL 31: FACING NORTH

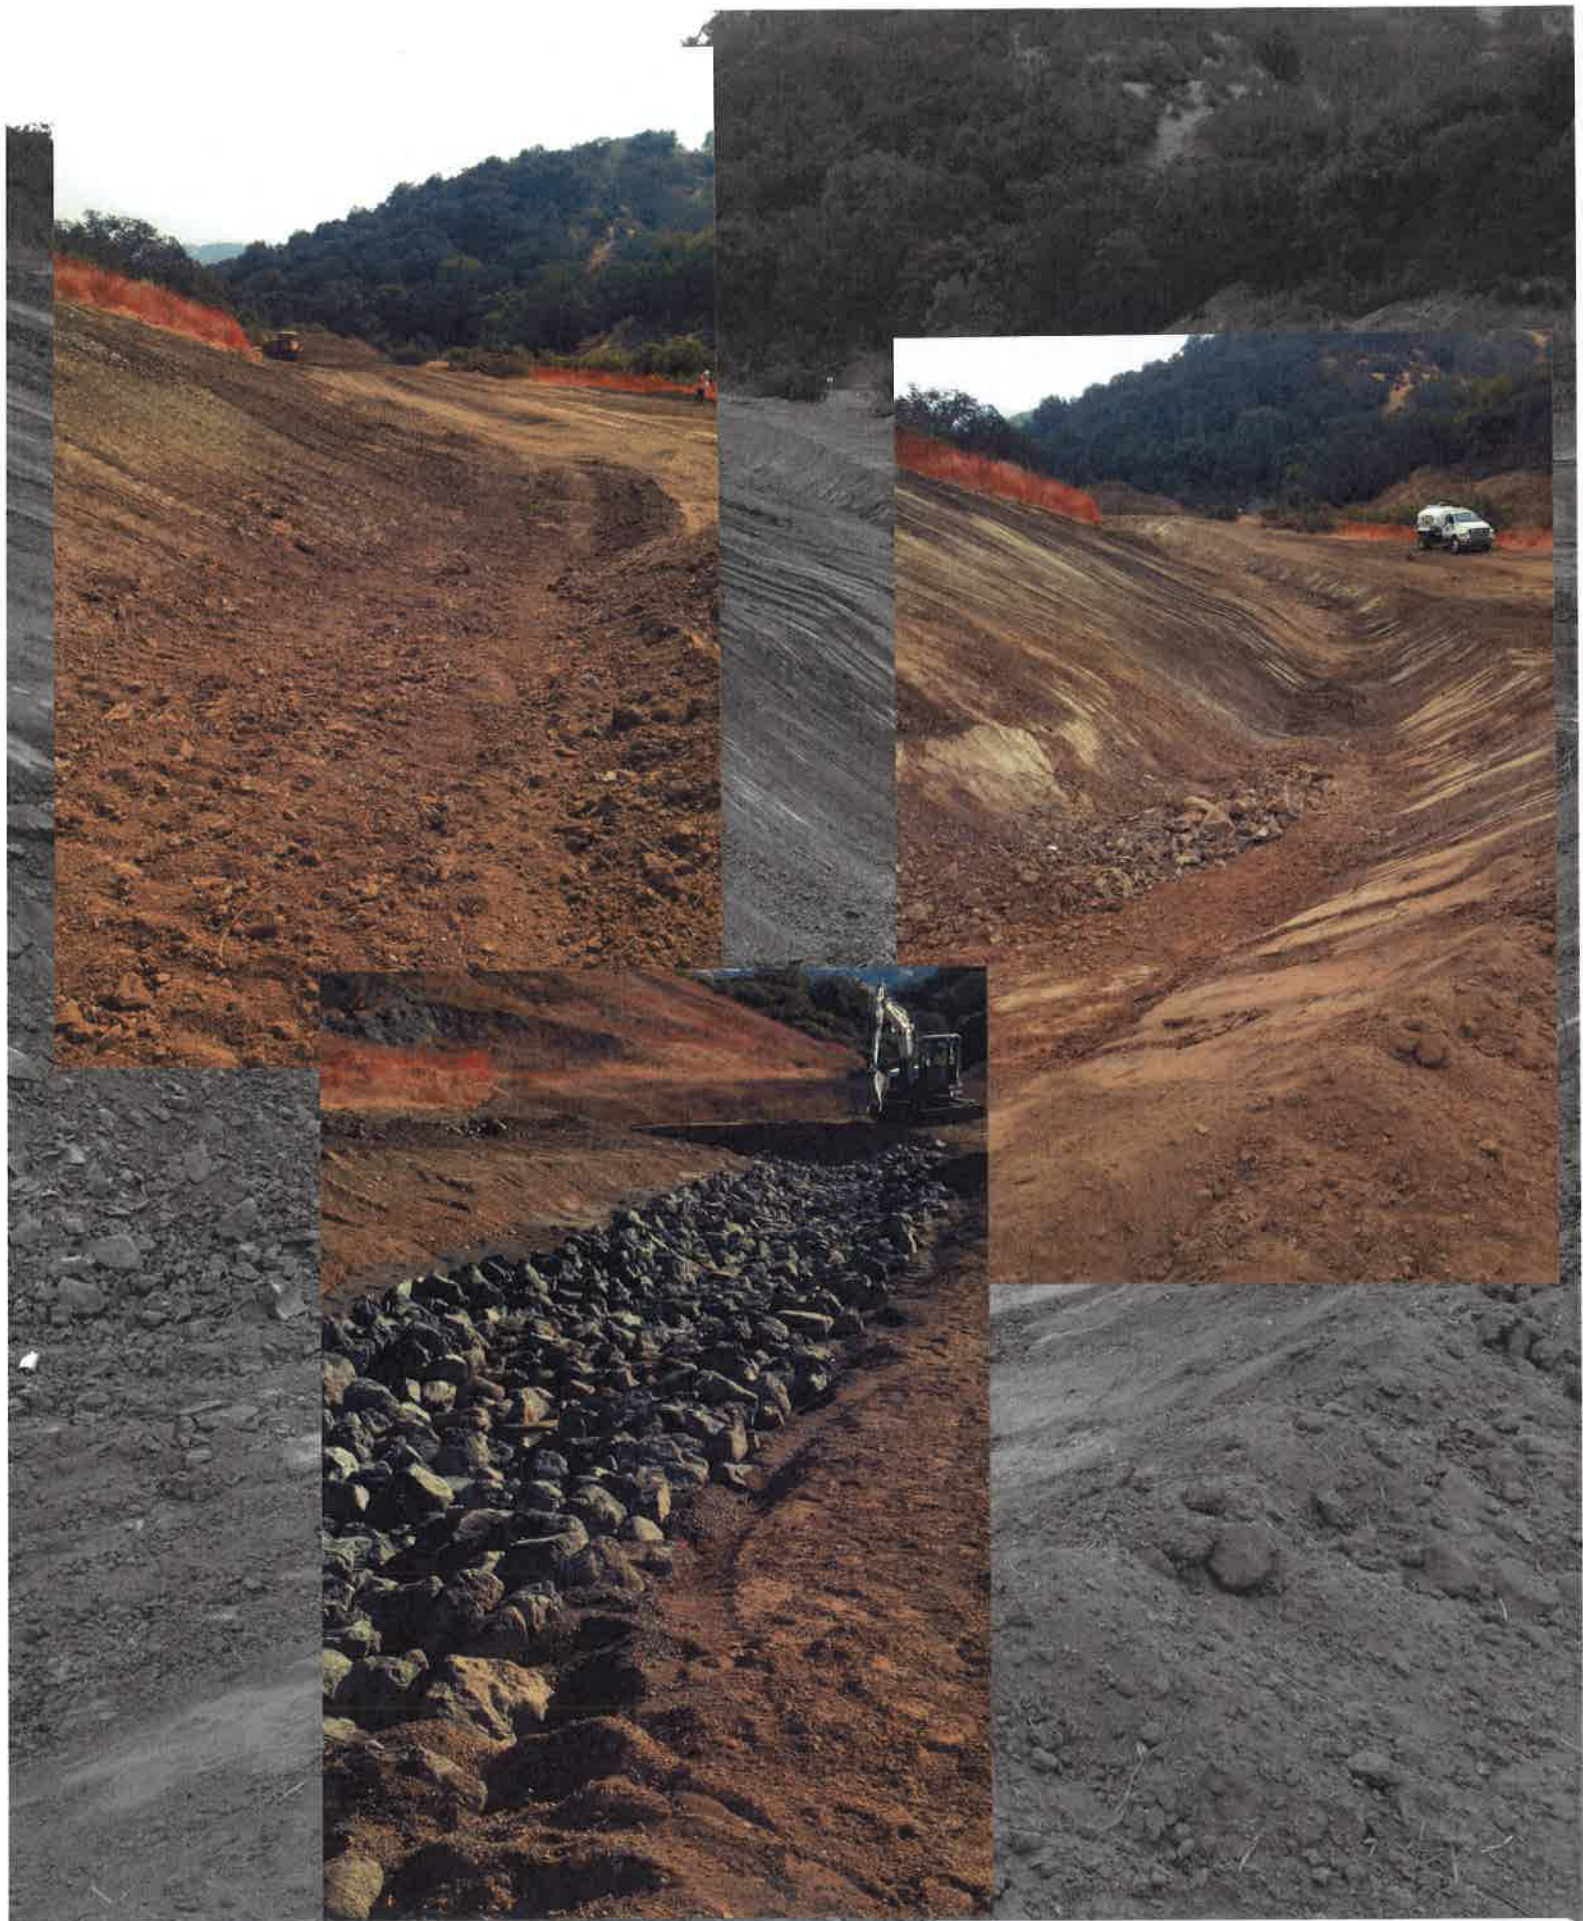
CHANNEL FORMATION: STREAM CHANNEL 22/31; FACING EAST

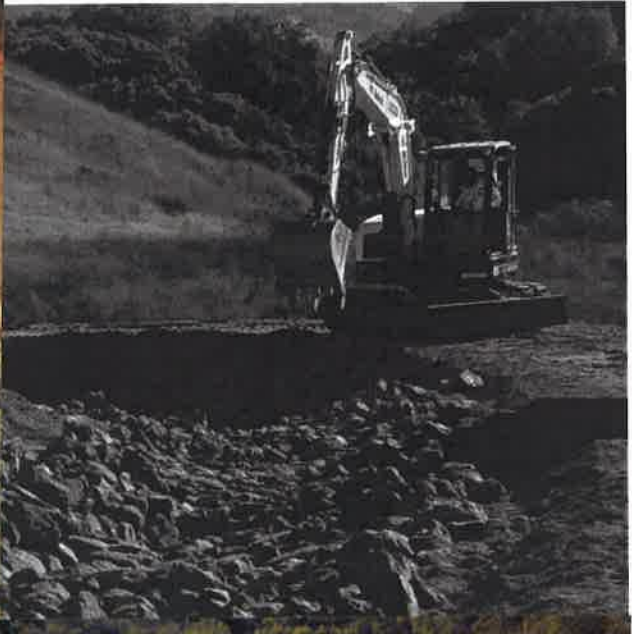
CHANNEL FORMATION: STREAM CHANNEL 22; FACING WEST

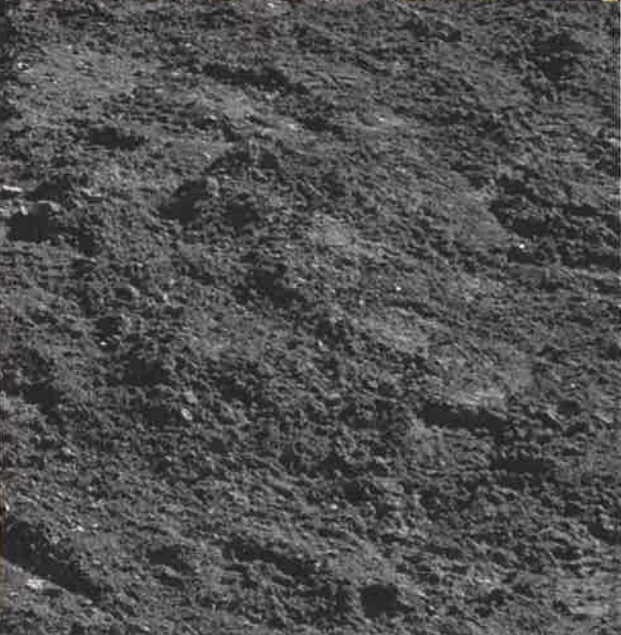
RIP RAP INSTALLATION: STREAM CHANNEL 31: FACING NORTH

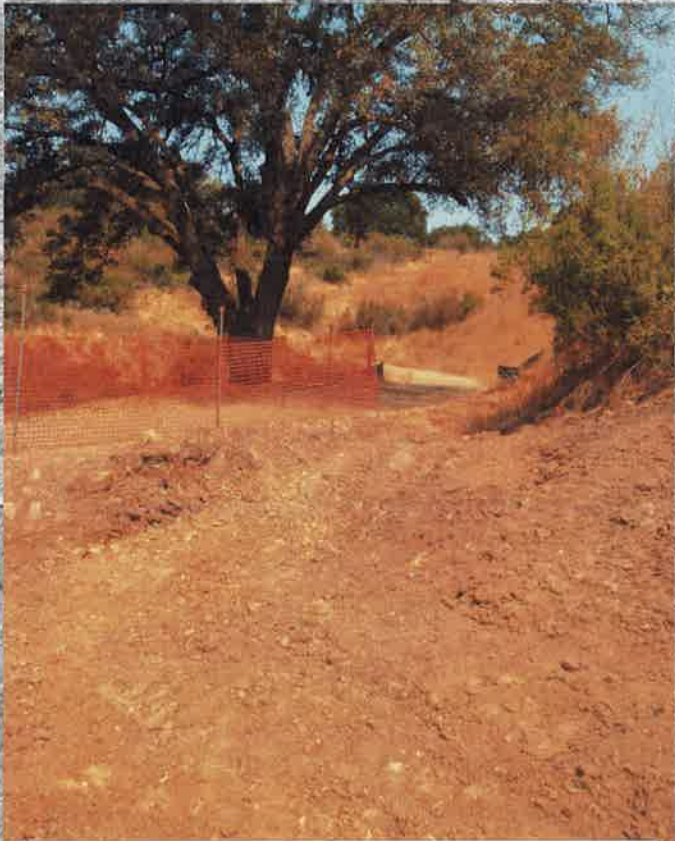
**CLEARING, GRUBBING, ROUGH GRADING:
STREAM CHANNEL 22; FACING WEST**

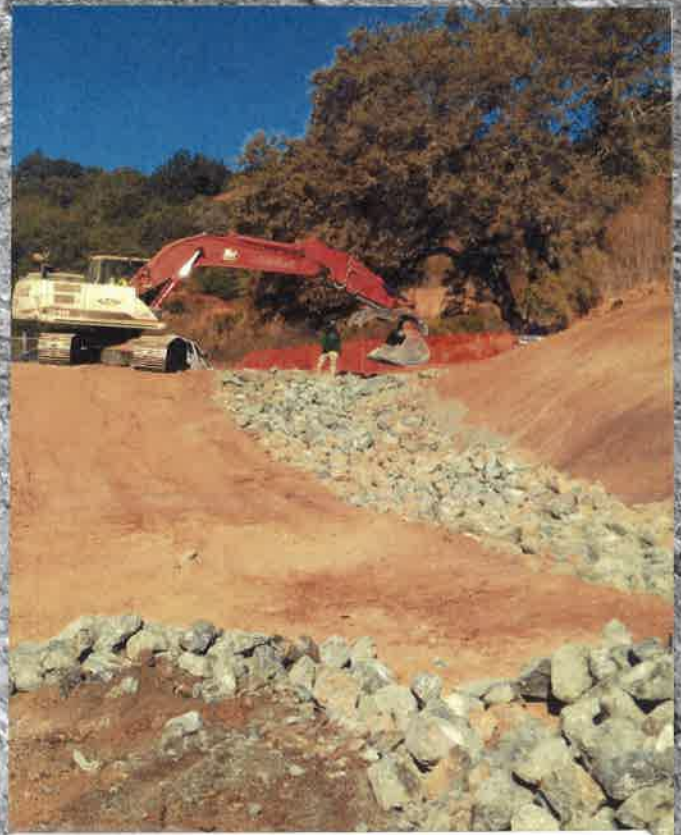
**RIP RAP INSTALLATION: STREAM
CHANNEL 22; FACING WEST**

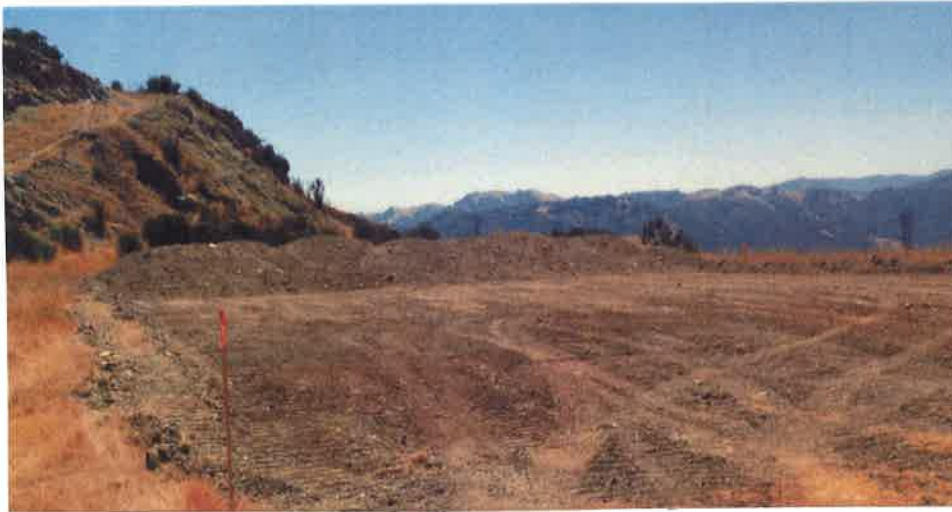
The San Francisco Open Cut repository (SFOC) is located on Mine Hill, near the juncture of Castillero Trail and Wood Road Trail. Approximately 20,000 square feet of clay topsoil were excavated to prepare for the deposit of over 500 cubic yards of calcine waste. Photo below illustrates the excavation and stockpiling of the existing soil to expose the calcine deposits.

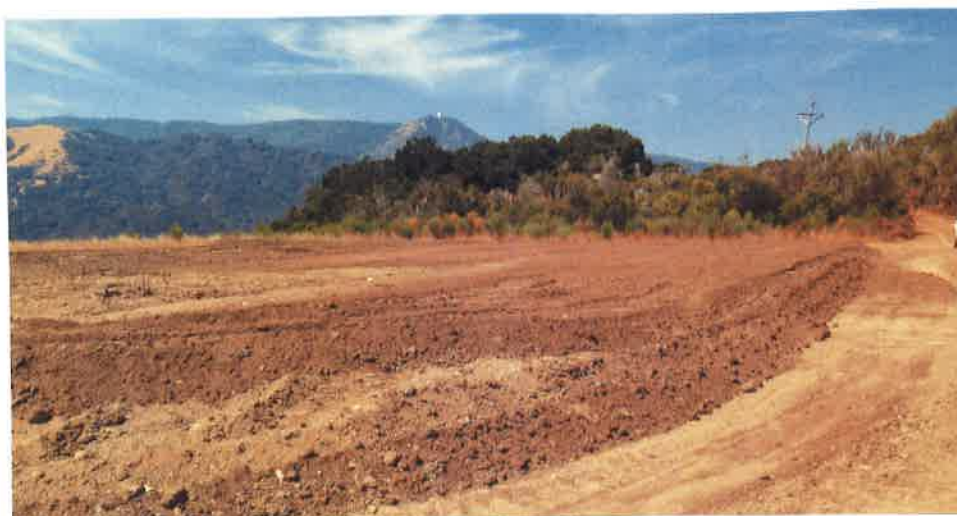
Photo below illustrates the import and spreading of additional clay soil to cover the calcine waste material prior to leveling and compaction.
