SUBJECT: Transmittal of Settlement Agreement and Stipulated Order No. R2-2012-0055, Sanitary District No. 1 of Marin County (District)

For VIOLATIONS of Waste Discharge Requirements
Required by SECTION 13385 of the California Water Code

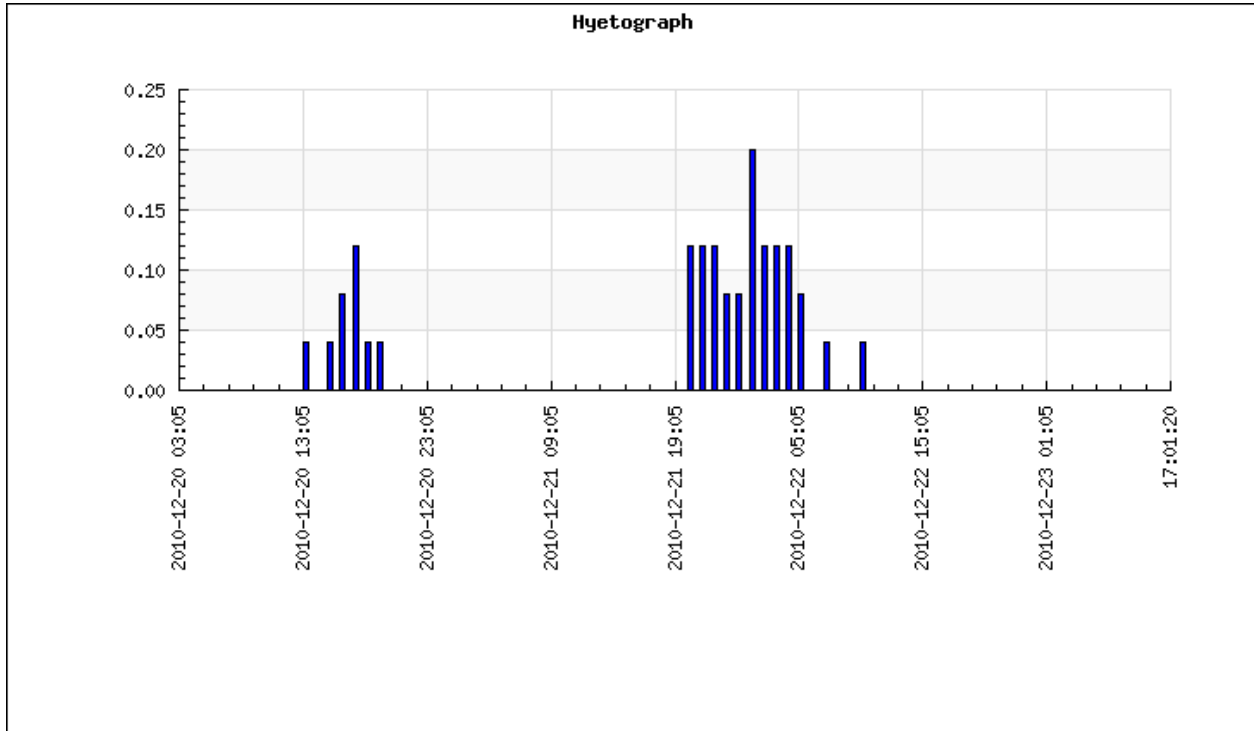
Appendix A.2: December 21-22, 2010, Storm Hourly Hyetograph

Source: <http://marin.onerain.com>; Single Graph, Kentfield - Precipitation increment (2010-12-20 11:05:00 - 2010-12-23 11:05:00 US/Pacific)

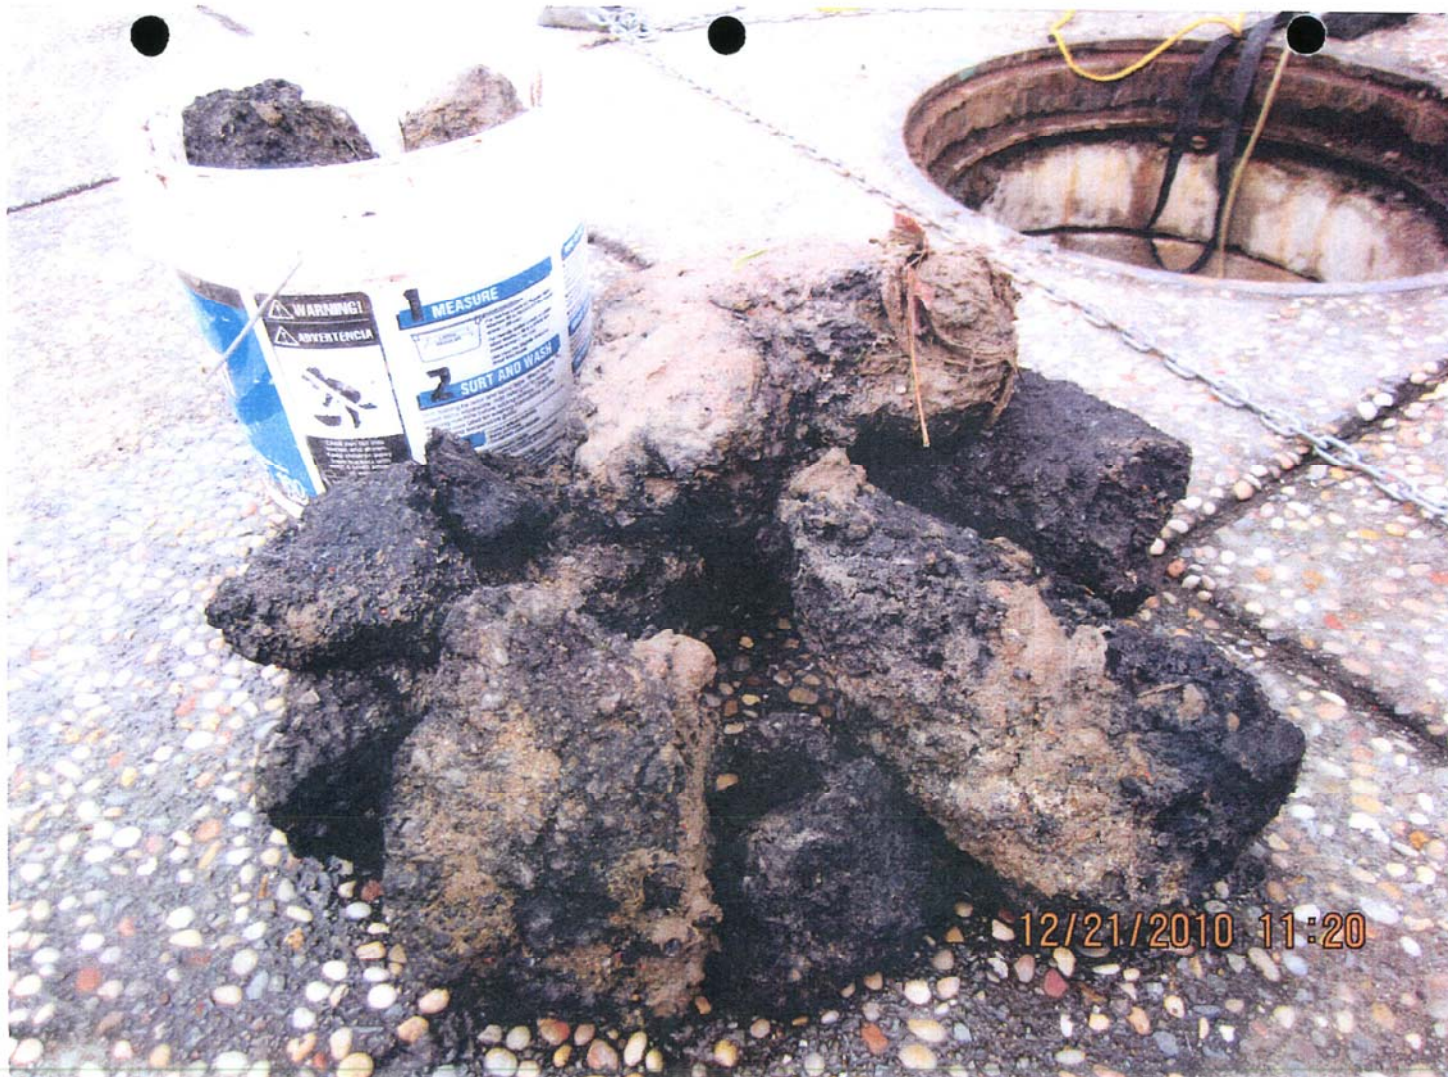
Photo 1: District photo of construction debris removed from the 27-inch Kent Middle School pipeline at manhole #2513 on December 21, 2010 at 11:20 am.

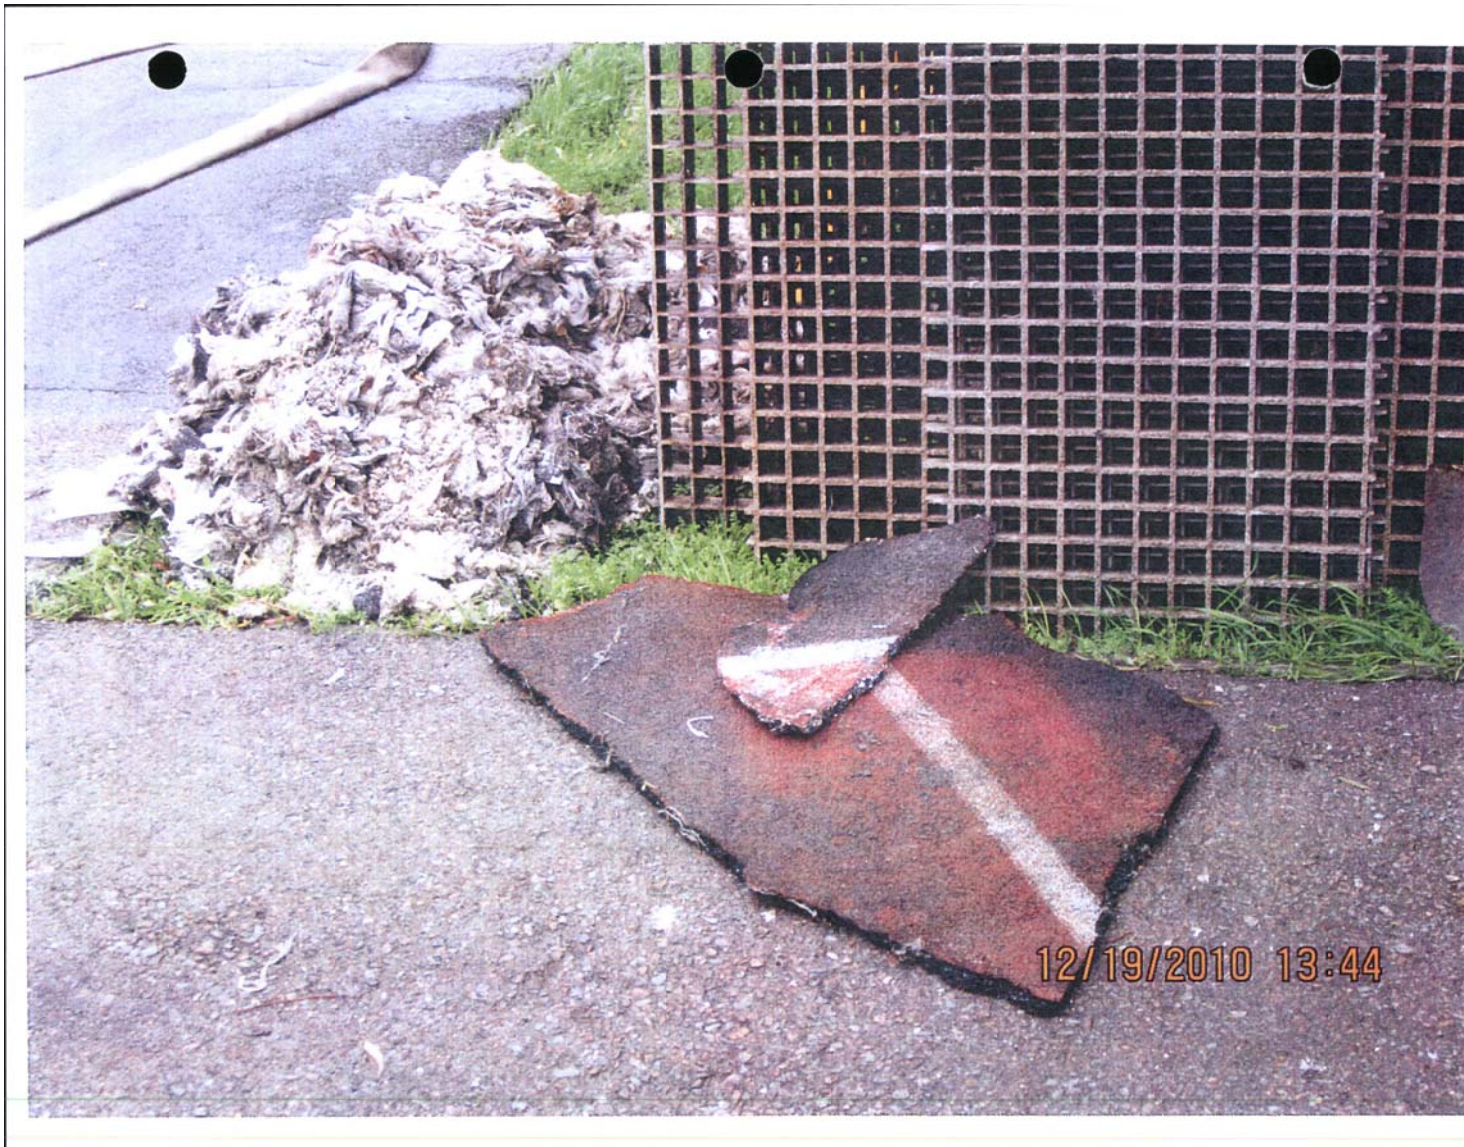
Photo 3: Nute Engineering, Inc. photo of December 22, 2010, SSO, from manhole #2647 at the intersection of Behrens Drive and Sherwood Ct.

Furthermore, during the December 22, 2010, SSOs, the Discharger failed to report an unknown volume SSO that occurred on the same date, from manhole #2647 at the intersection of Behrens Drive and Sherwood Ct (see Appendix D, Photo 3). Photo 3 was taken by Nute Engineering, Inc. staff who stated that shortly after this photo was taken, a Discharger vactor truck arrived²¹. The total SSO volume discharged was likely small based on the photographic evidence and the fact that Discharger staff arrived to recover sewage shortly after the picture was taken. Nonetheless, this SSO should have been reported via CIWQS.
