Calcine Paved Roads and Jacques Gulch Site Visit Photos

Almaden Quicksilver County Park & Santa Teresa County Park Mine Material Evaluation

Calcine Paved Roads Site Visit Photos

Jacques Gulch Site Visit Photos

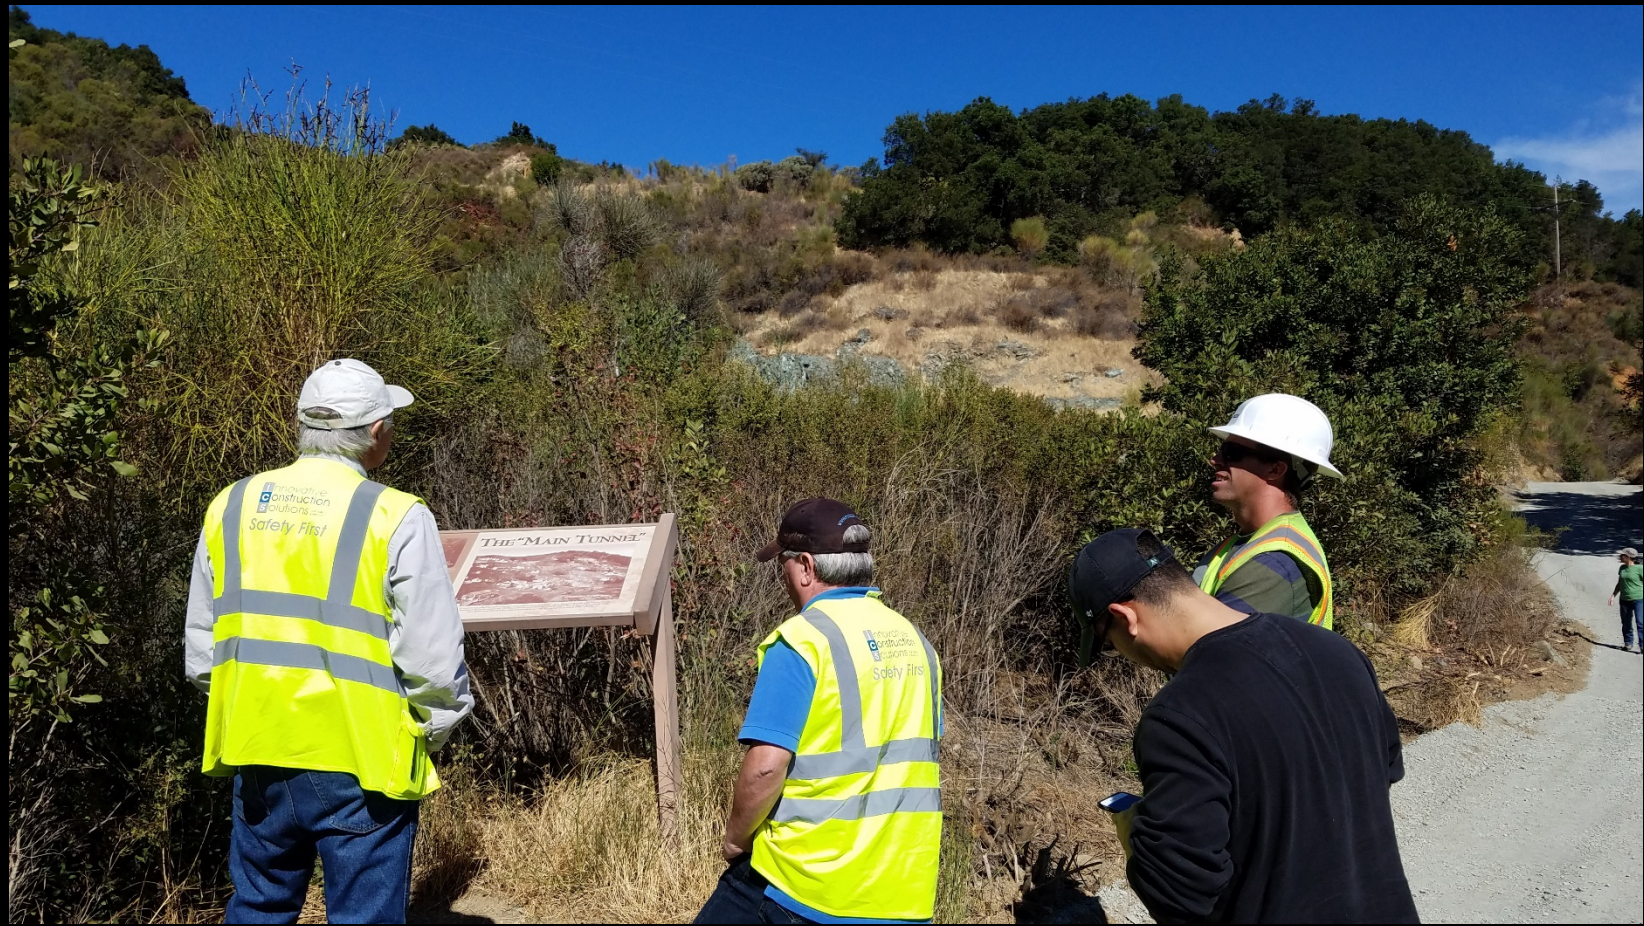
Site visit including Waterboard permit & TMDL staff, SFEP, Parks staff, and Roux consultant team.

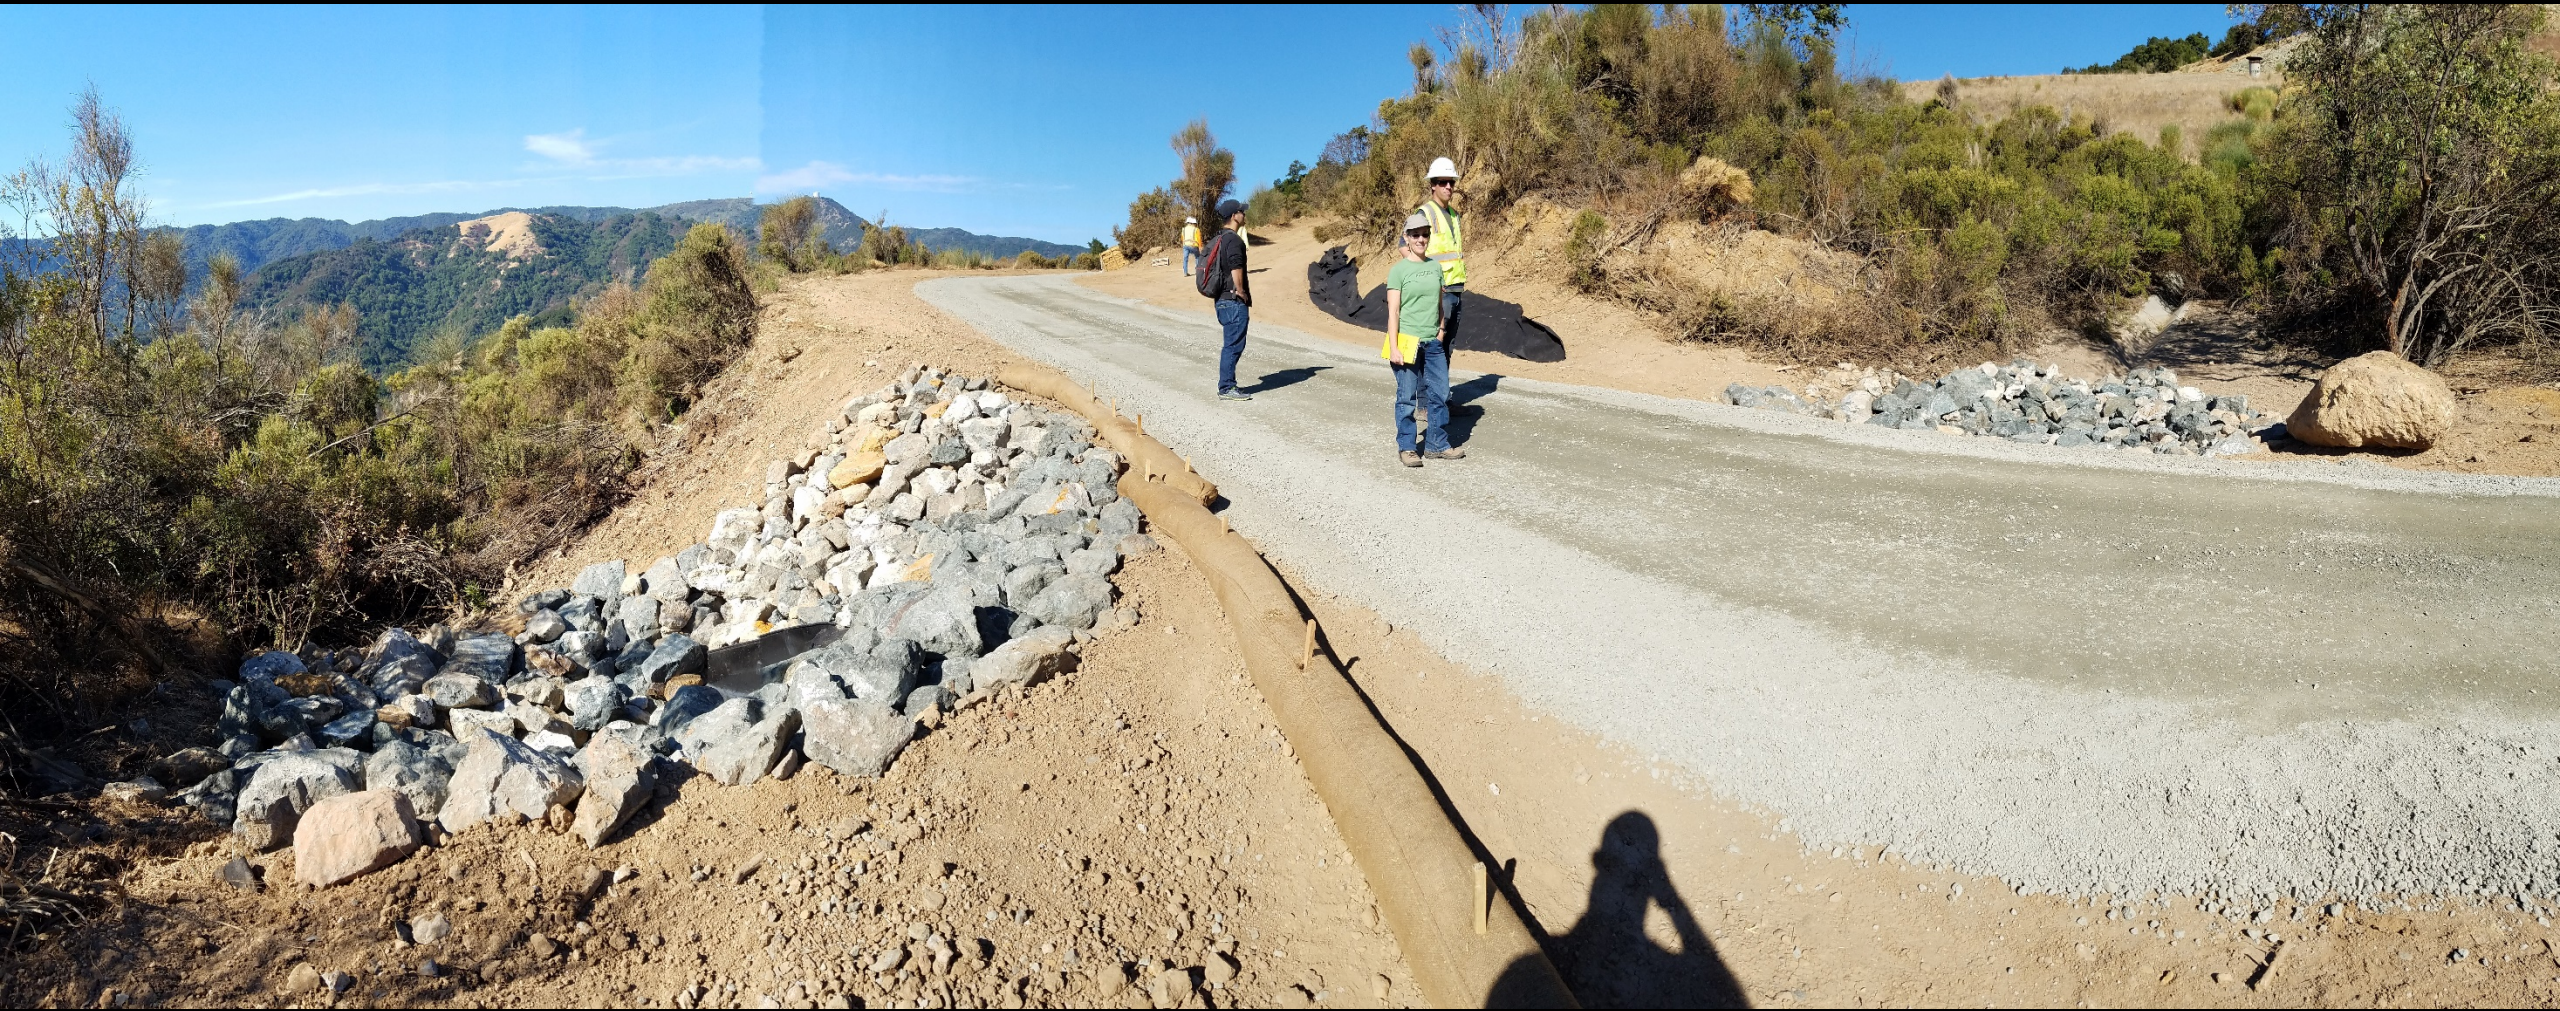
Waterboard and Roux consultants examine a culvert drainage upgrade on Castillero Trail. All calcines have been removed at the time of this photo.

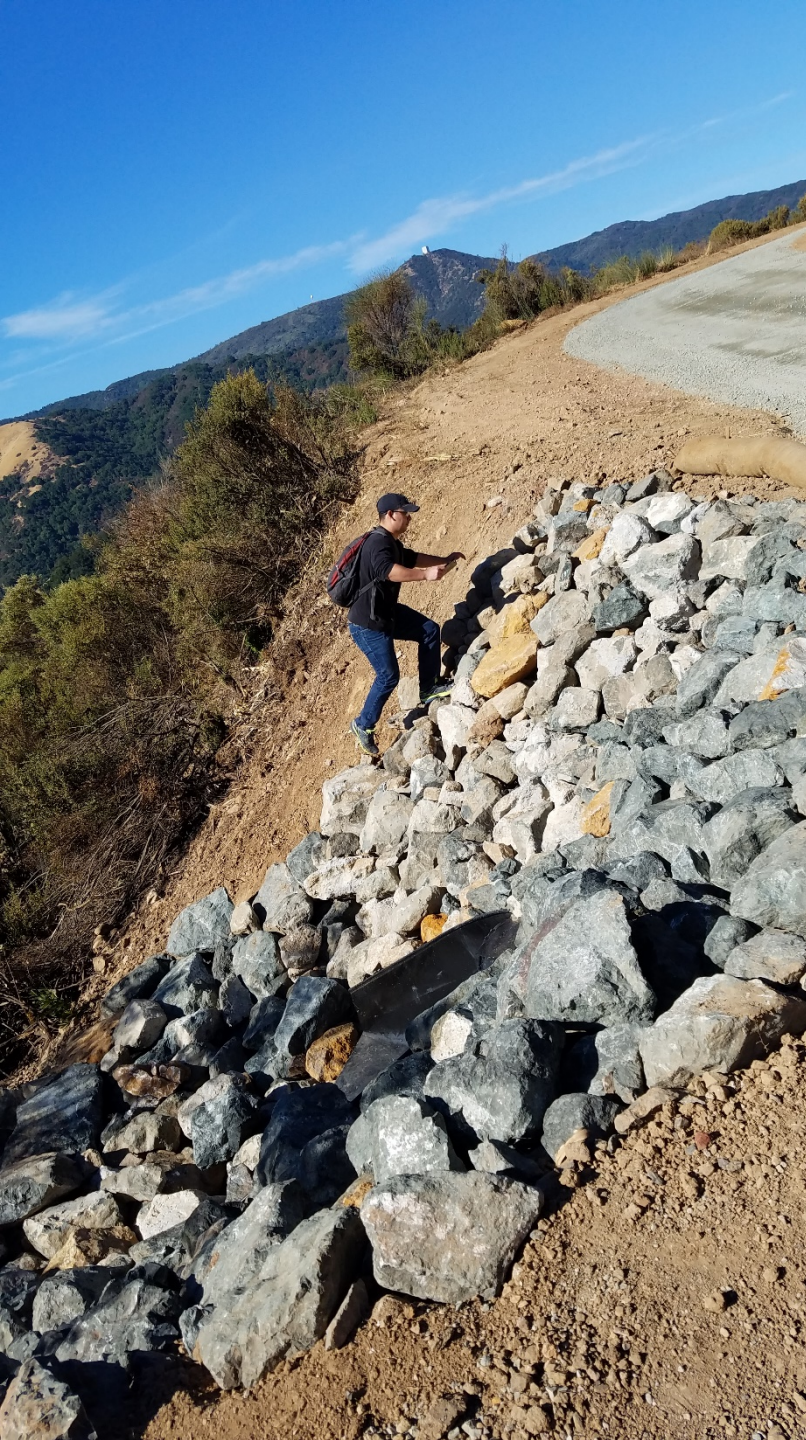
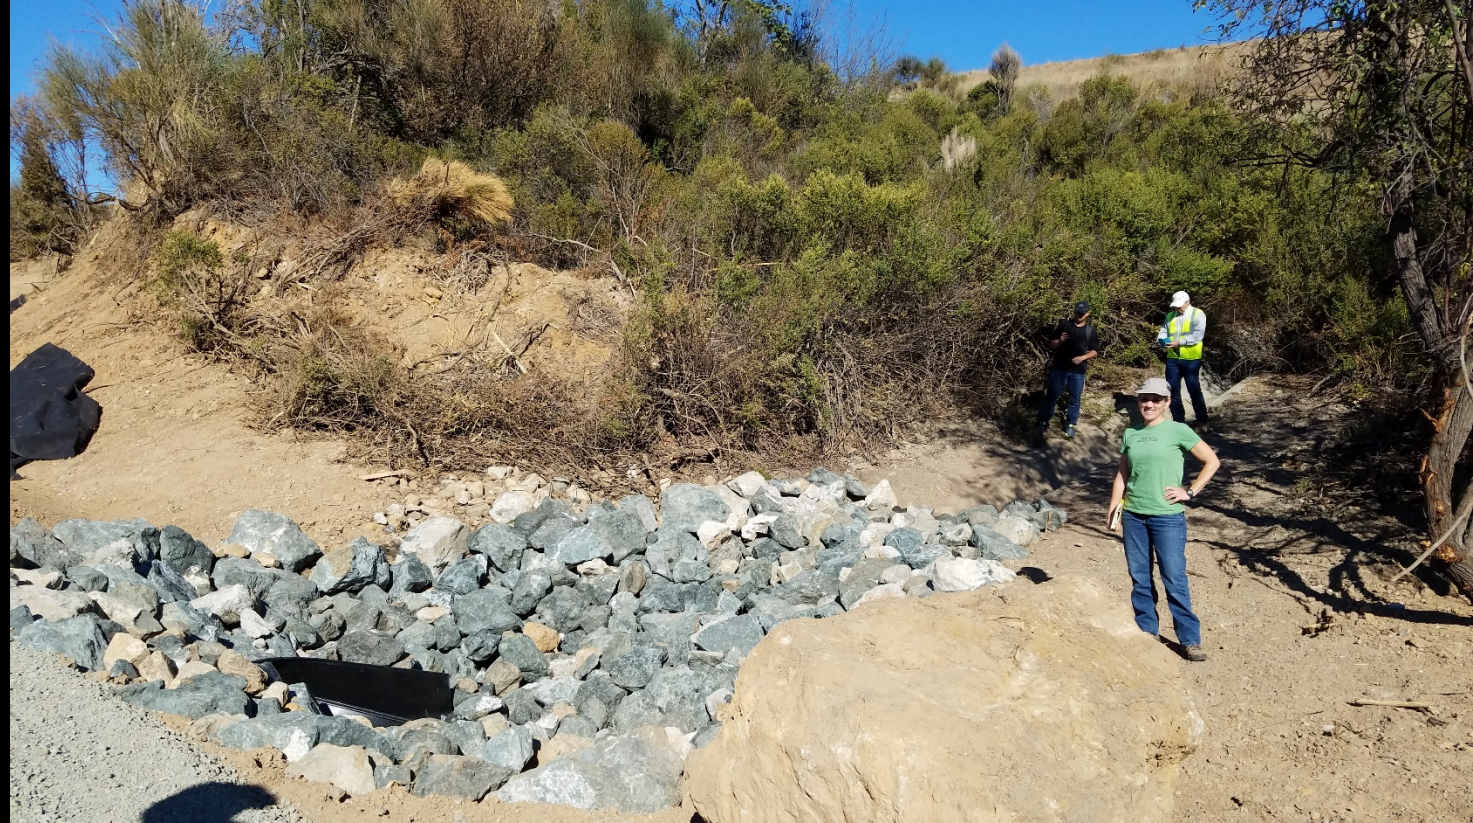
Closer photos of the same culvert drainage upgrade on Castillero Trail. All calcines have been removed at the time of this photo.

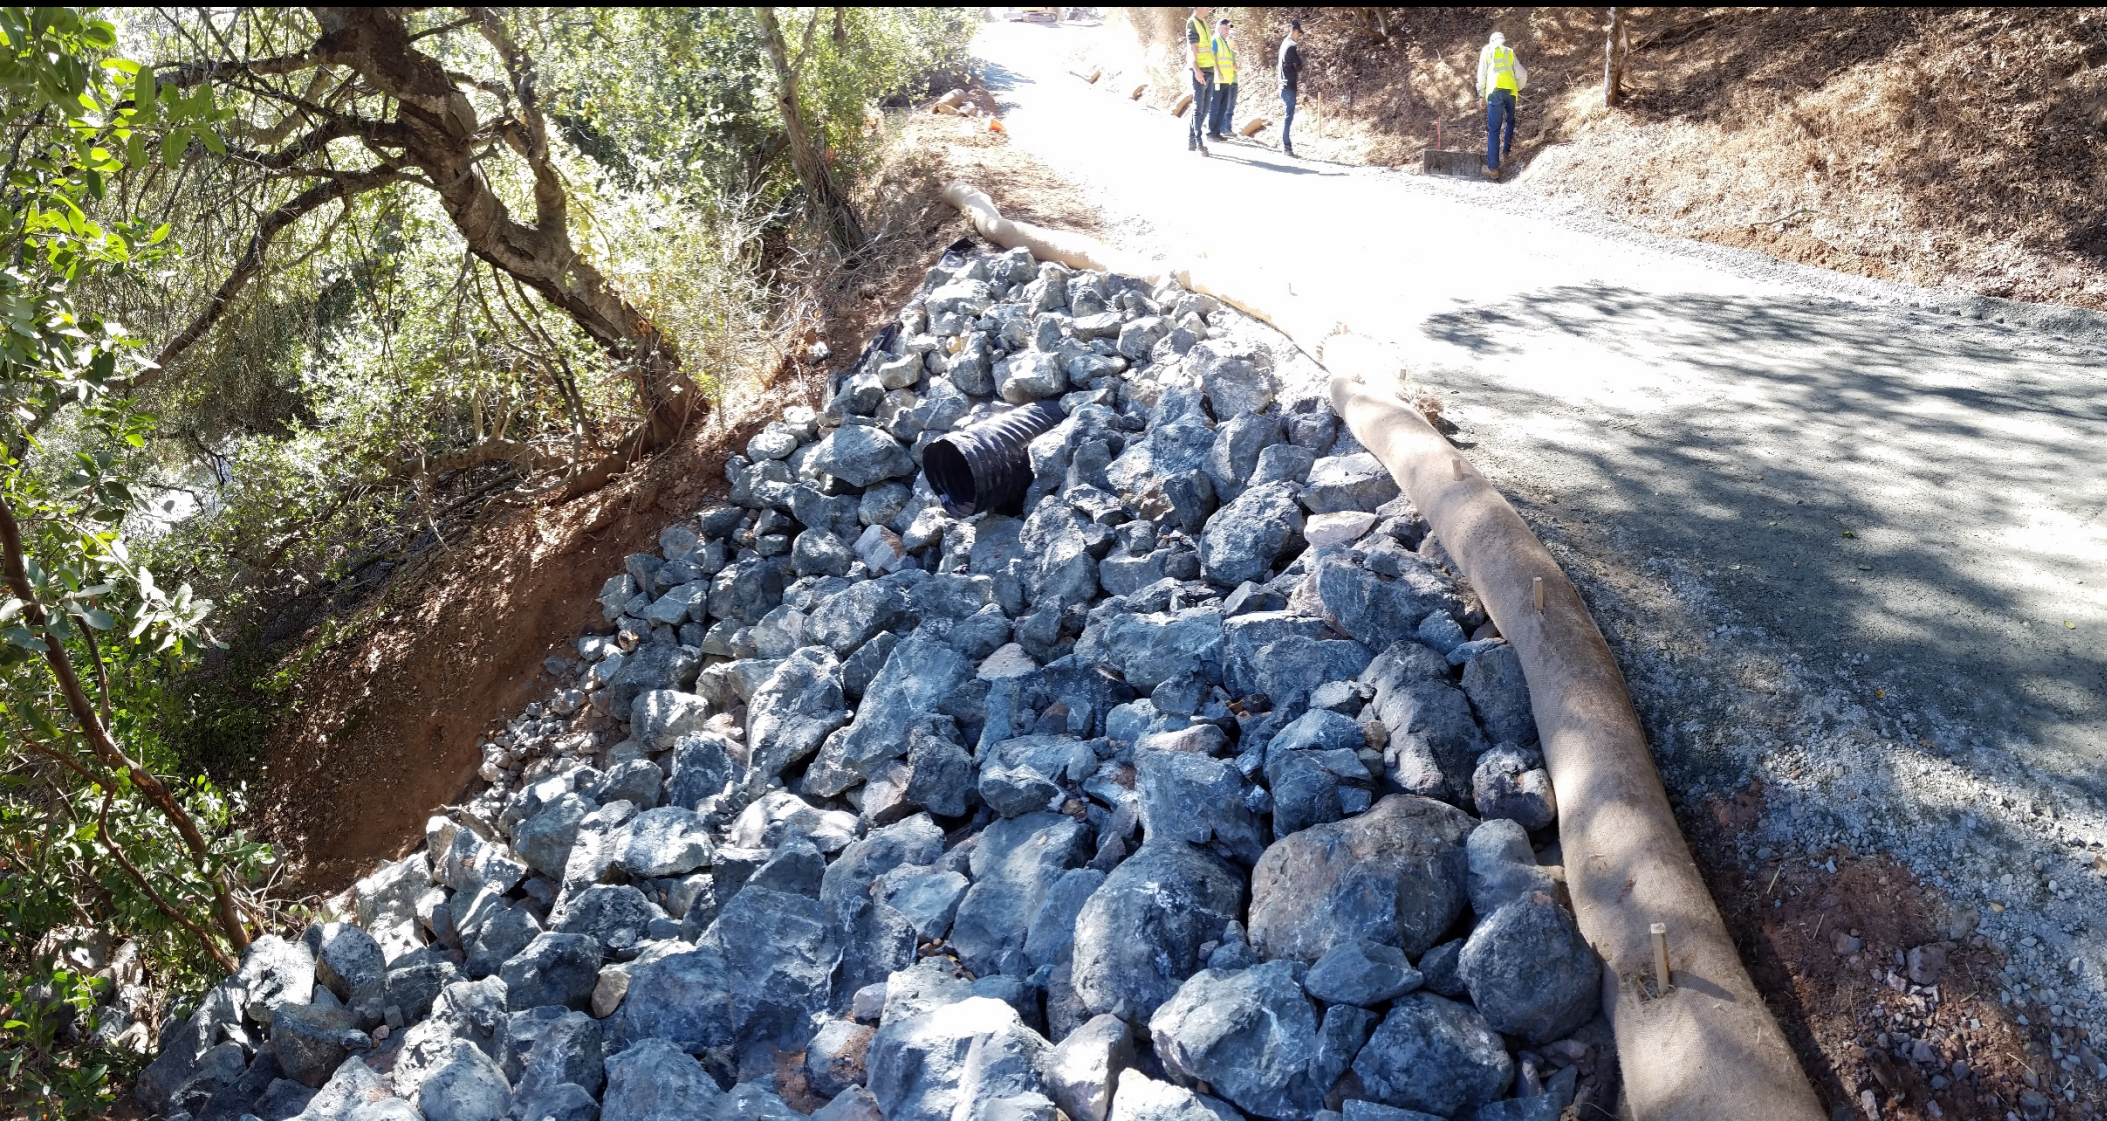
New corrugated culvert pipe installed on Yellow kid Trail with outfall erosion protection.

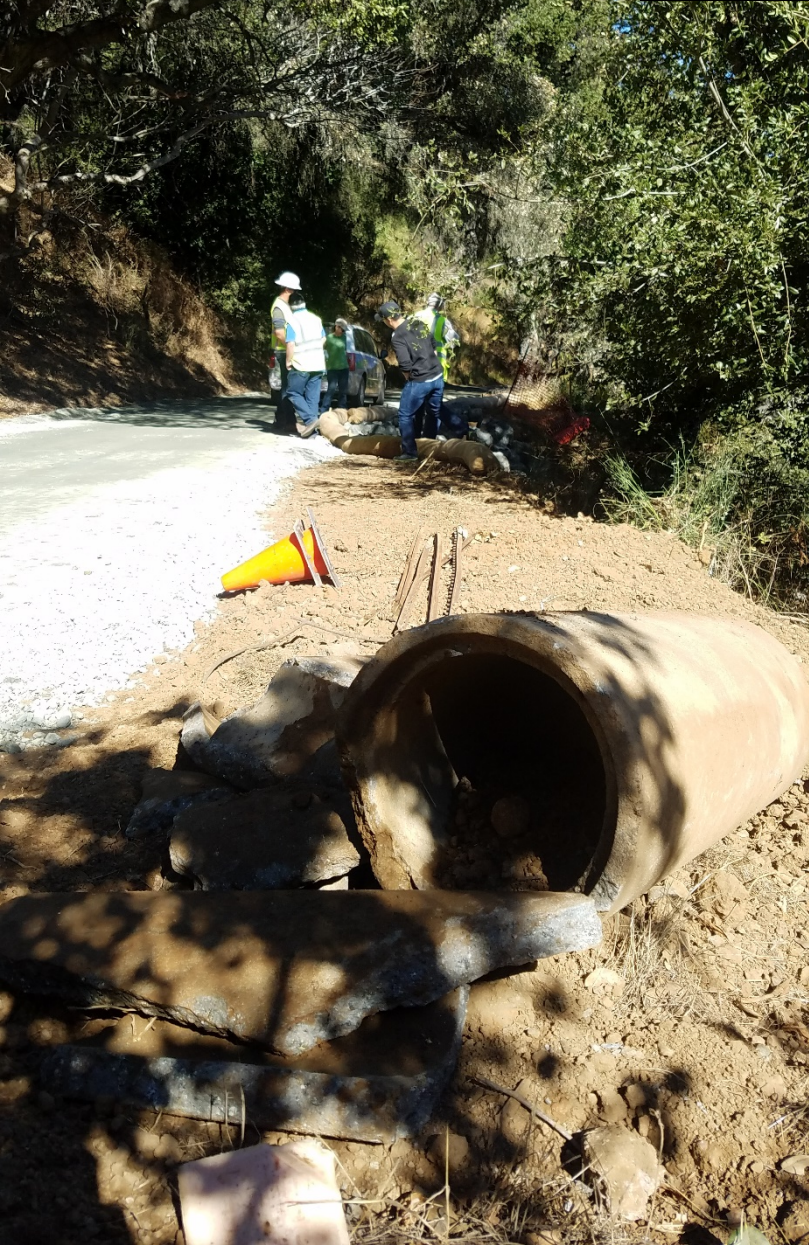
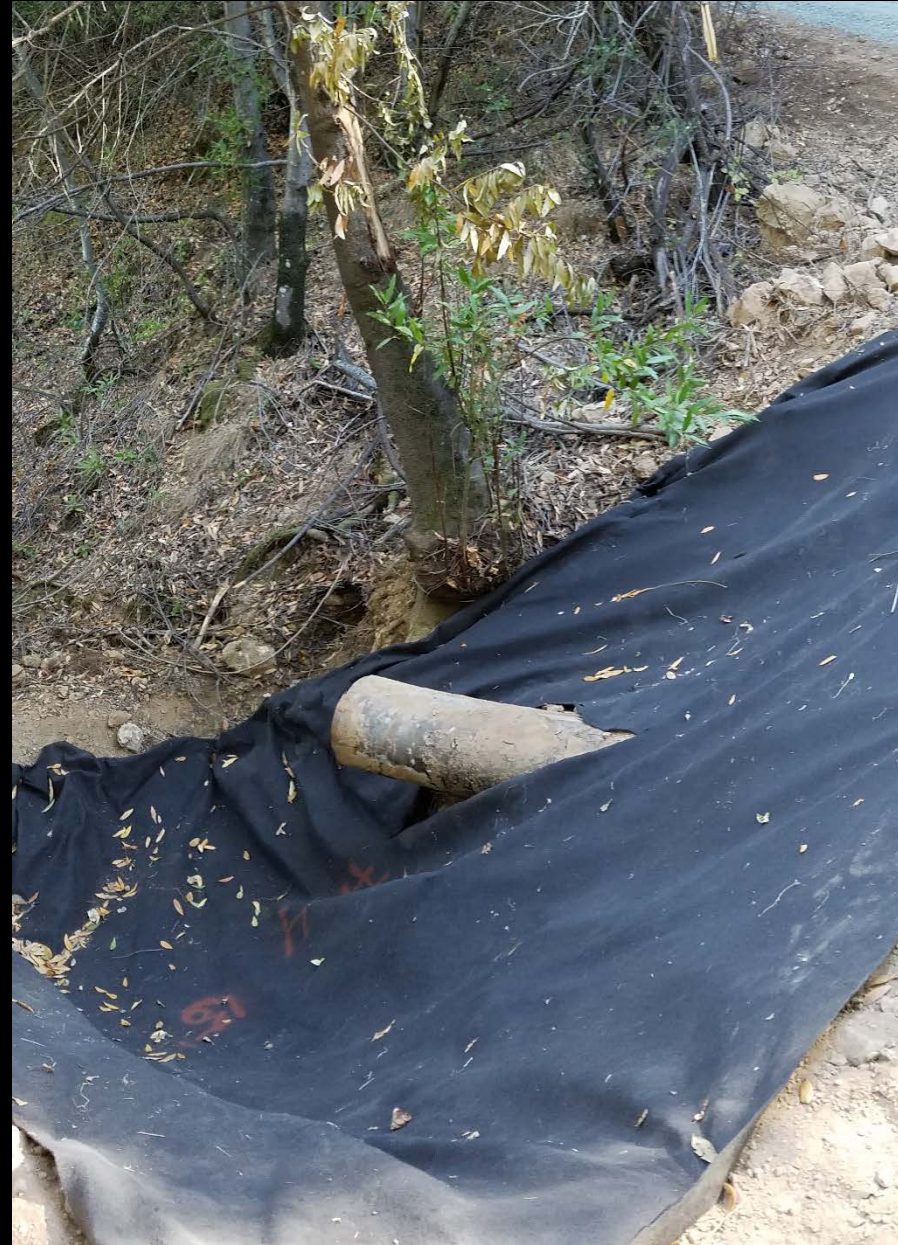
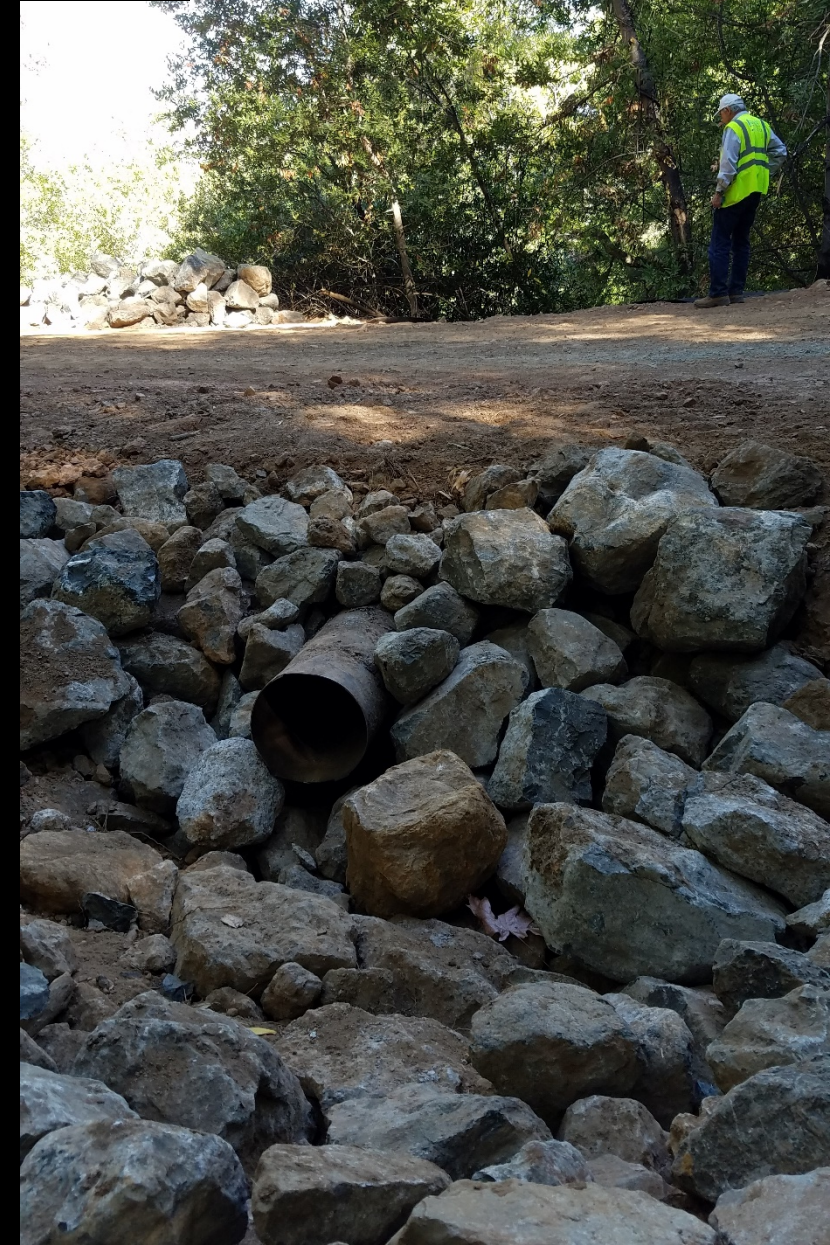
These photos show several culvert upgrades and armoring to prevent erosion of trails and banks.

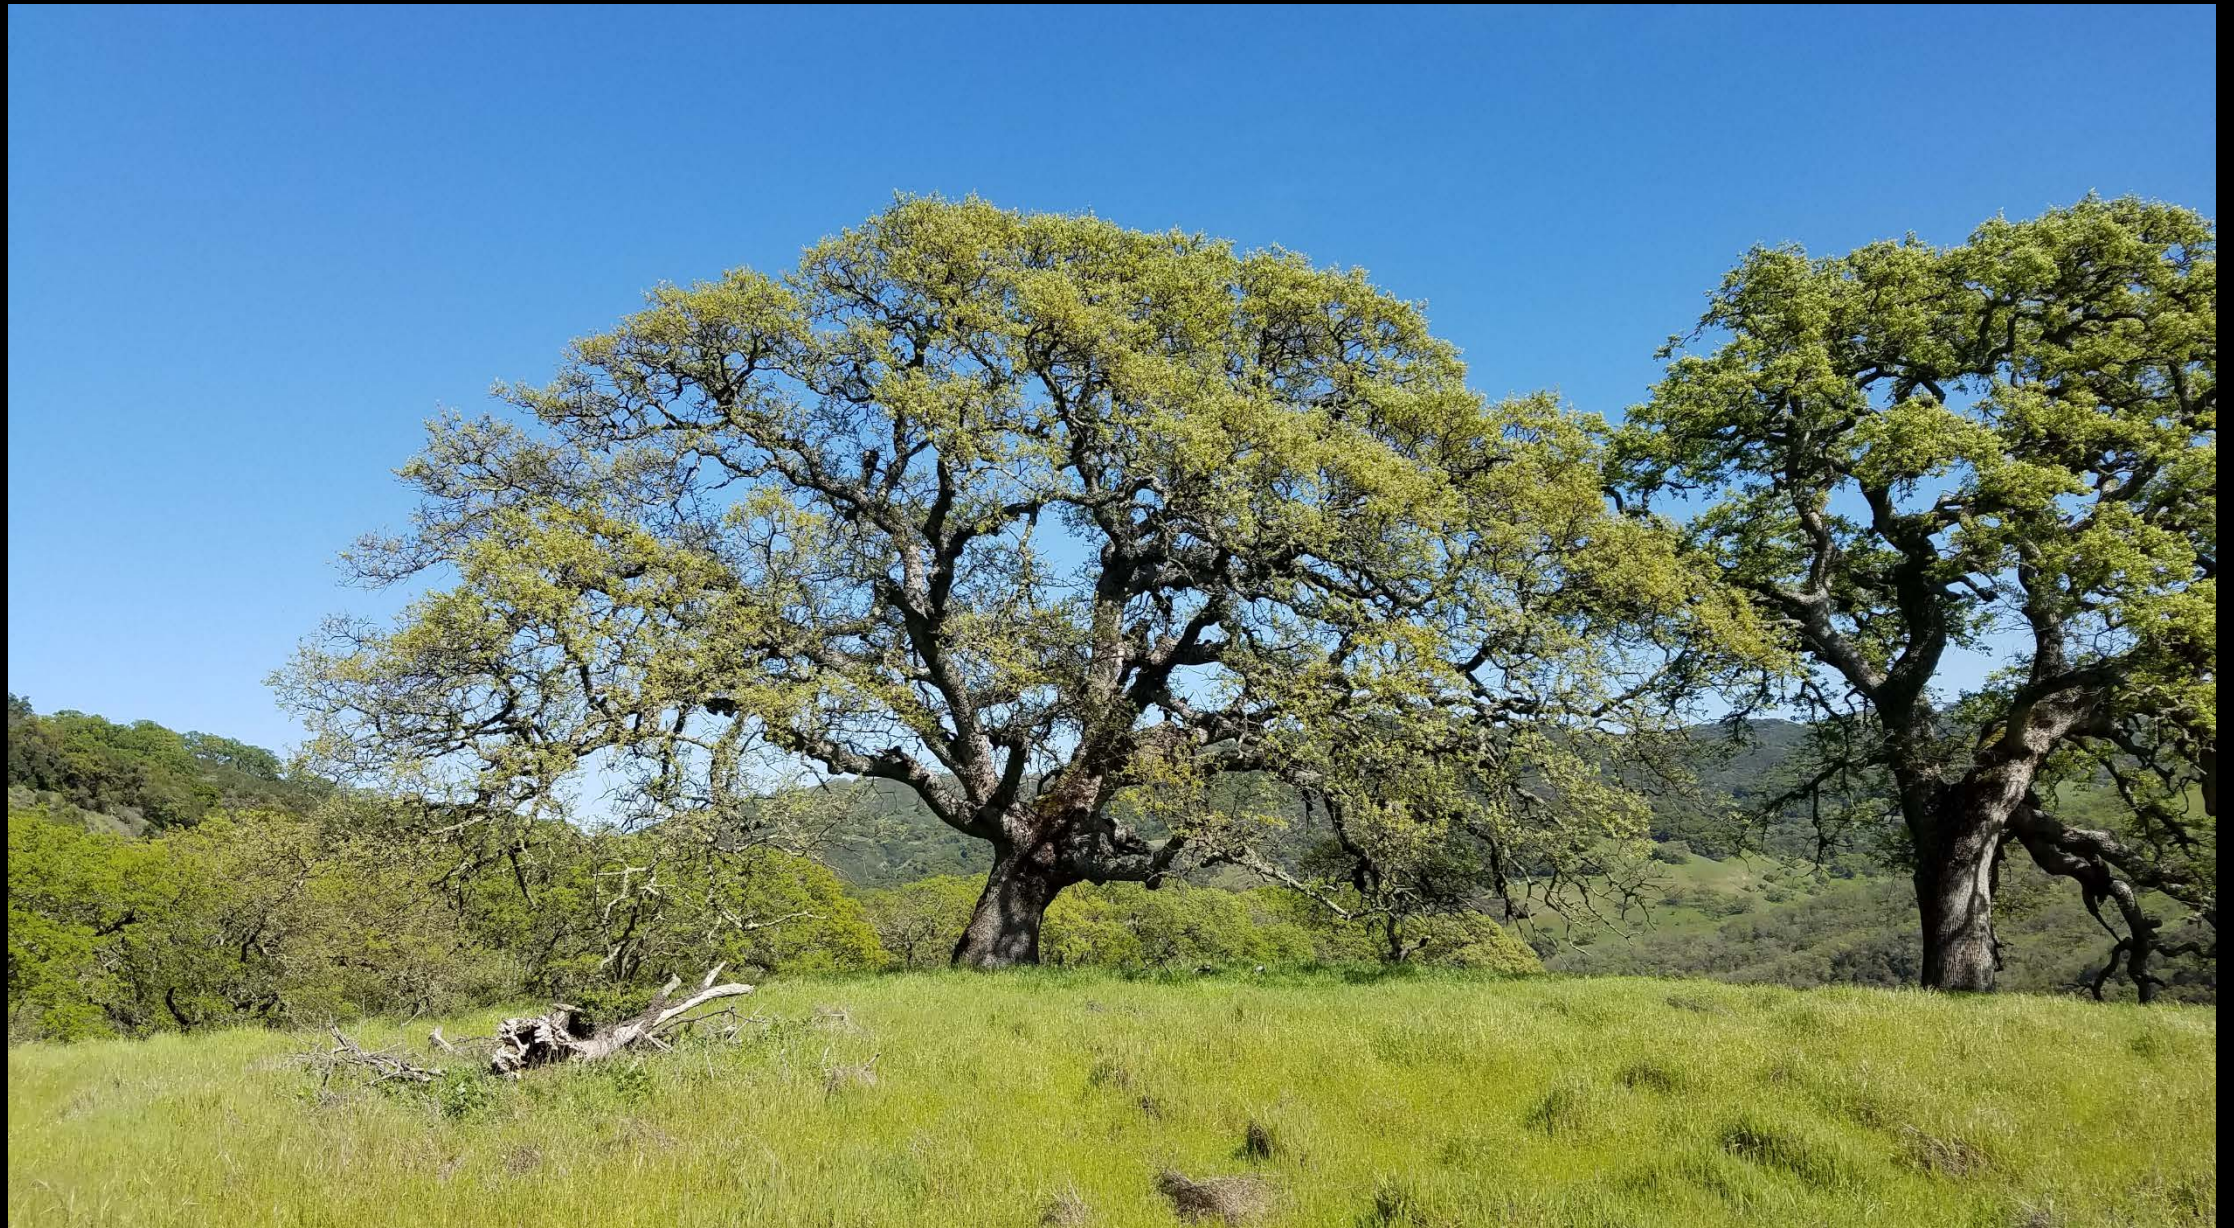
These photos are taken as the team progressed up the reach. This site visit was attended by SFEP, TMDL Waterboard staff, and Parks staff. These two photos show the fully remediated lower Jacques Gulch as the group proceeds to the project site.

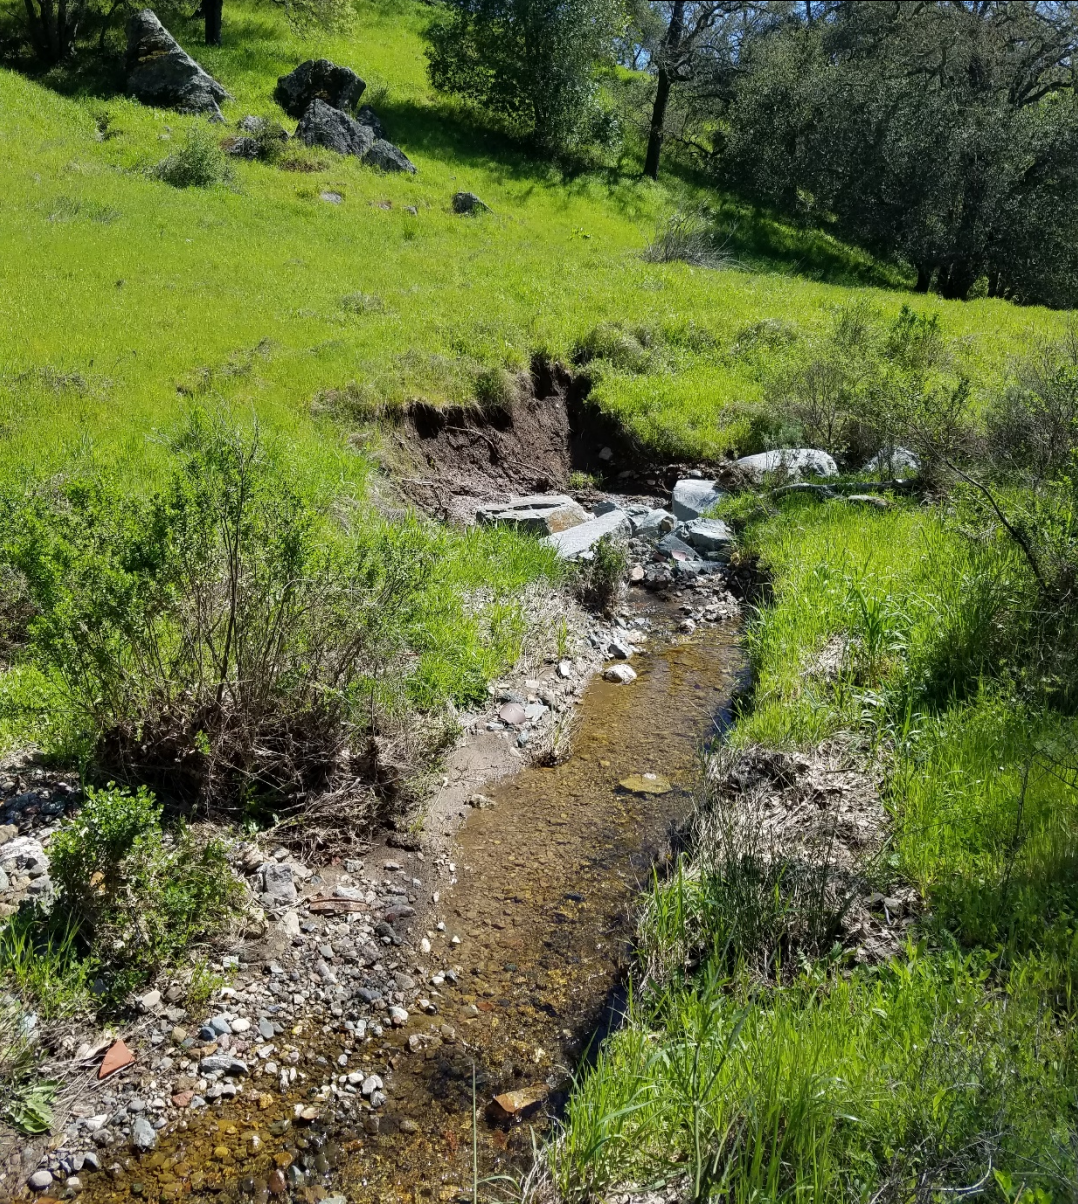
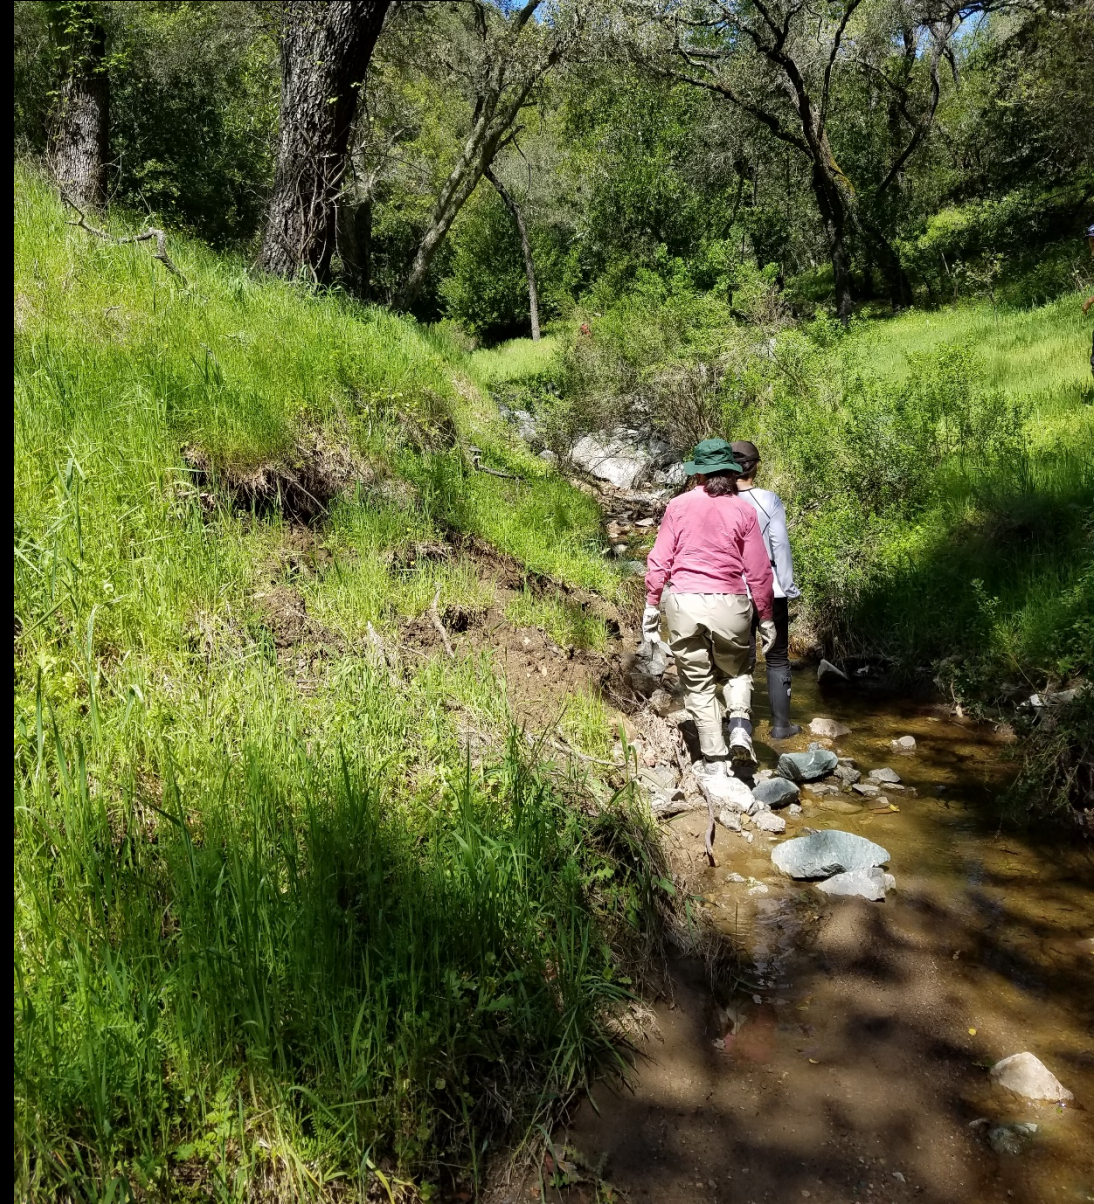
Erosional features and increased tree coverage as we progressed into the reach. The photo to the left is facing downstream.

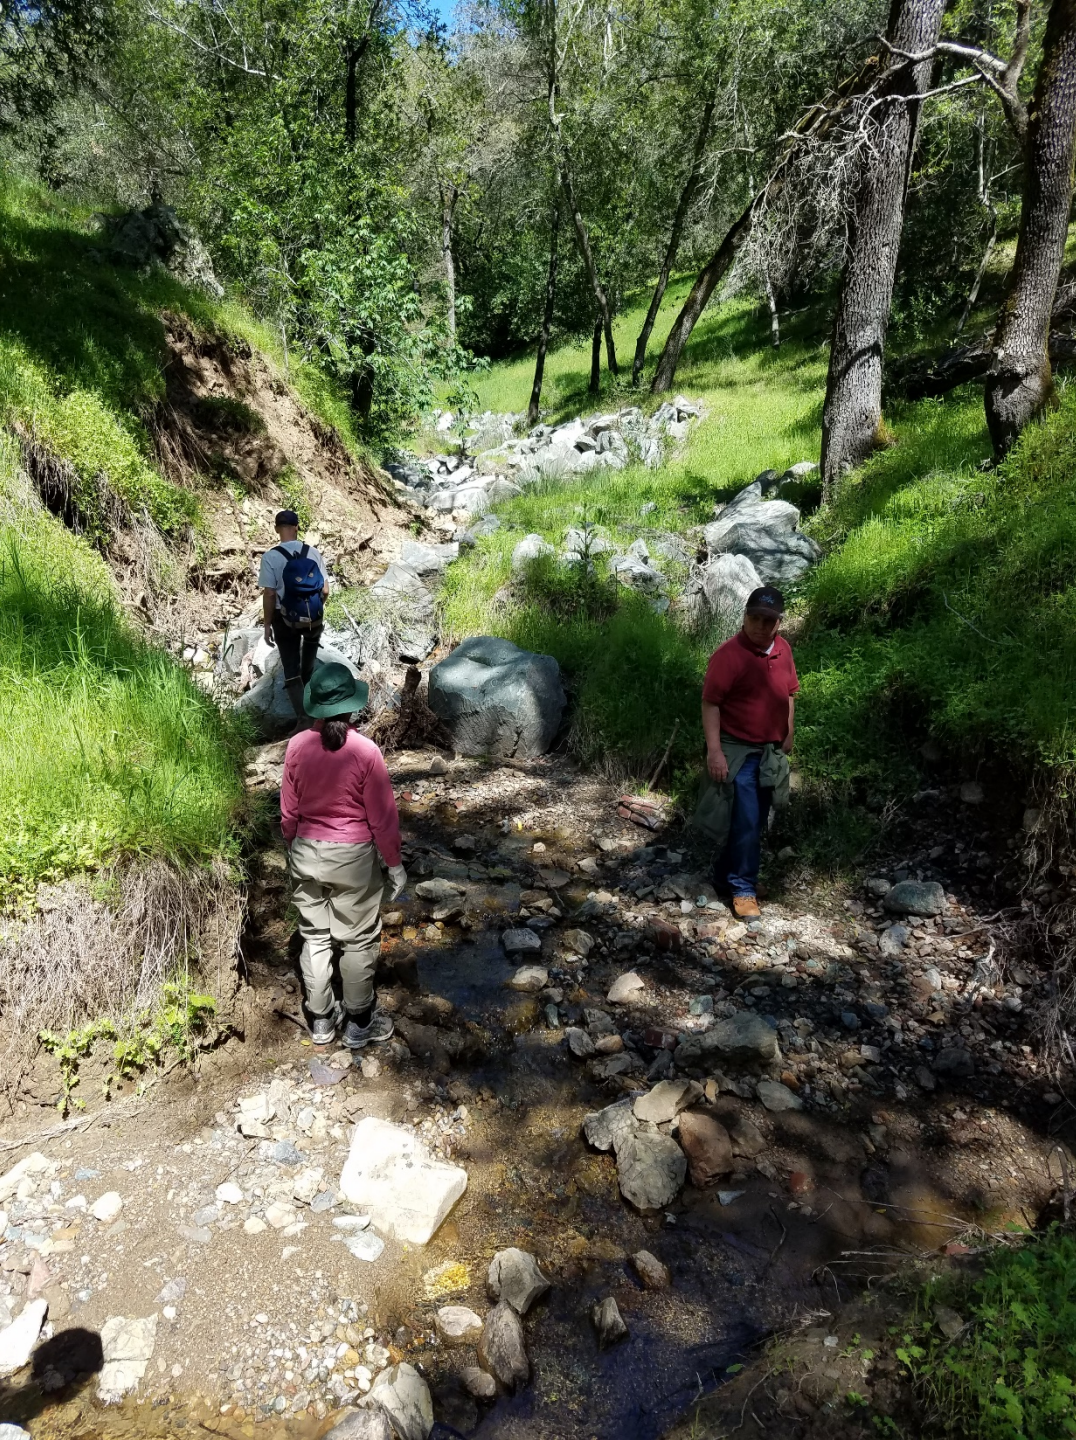
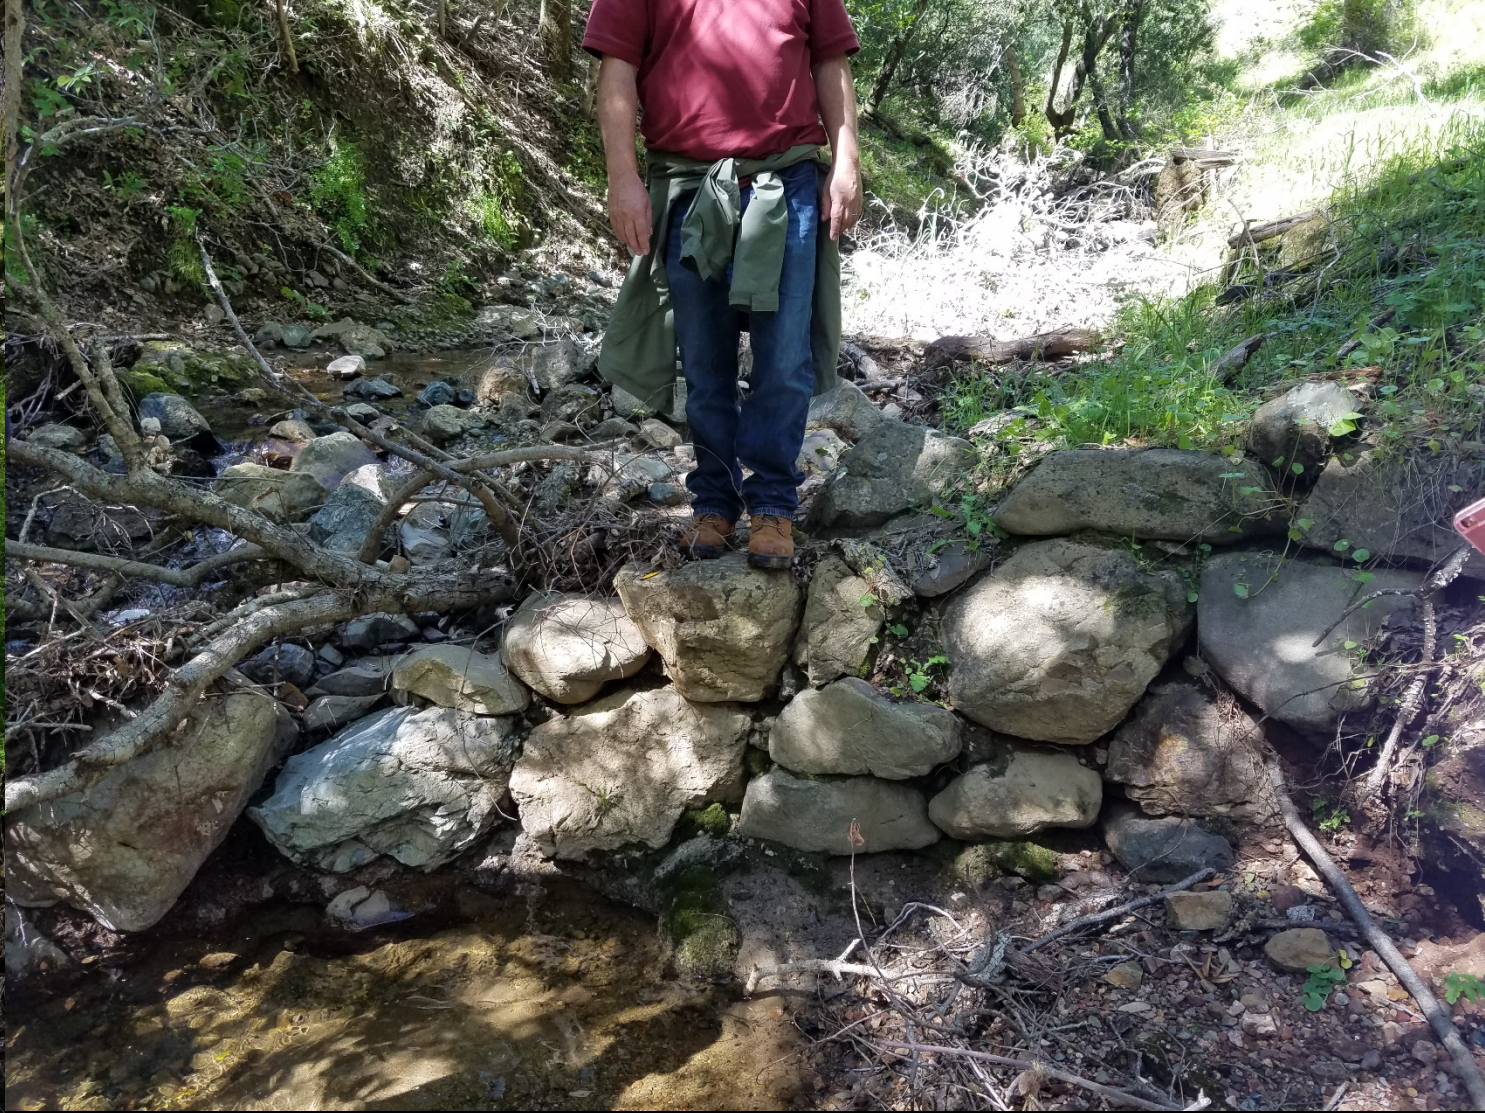
The photo to the left shows the team progressing towards the project site. You will notice that the slopes are quickly getting steeper and are dotted with mature trees, stabilizing the slope toes. The Photo above is a historical damn that would need to be removed to gain access to the project site.
