Calcine Paved Roads and Jacques Gulch Site Visit Photos

Almaden Quicksilver County Park & Santa Teresa County Park Mine Material Evaluation

Calcine Paved Roads Site Visit Photos

Jacques Gulch Site Visit Photos

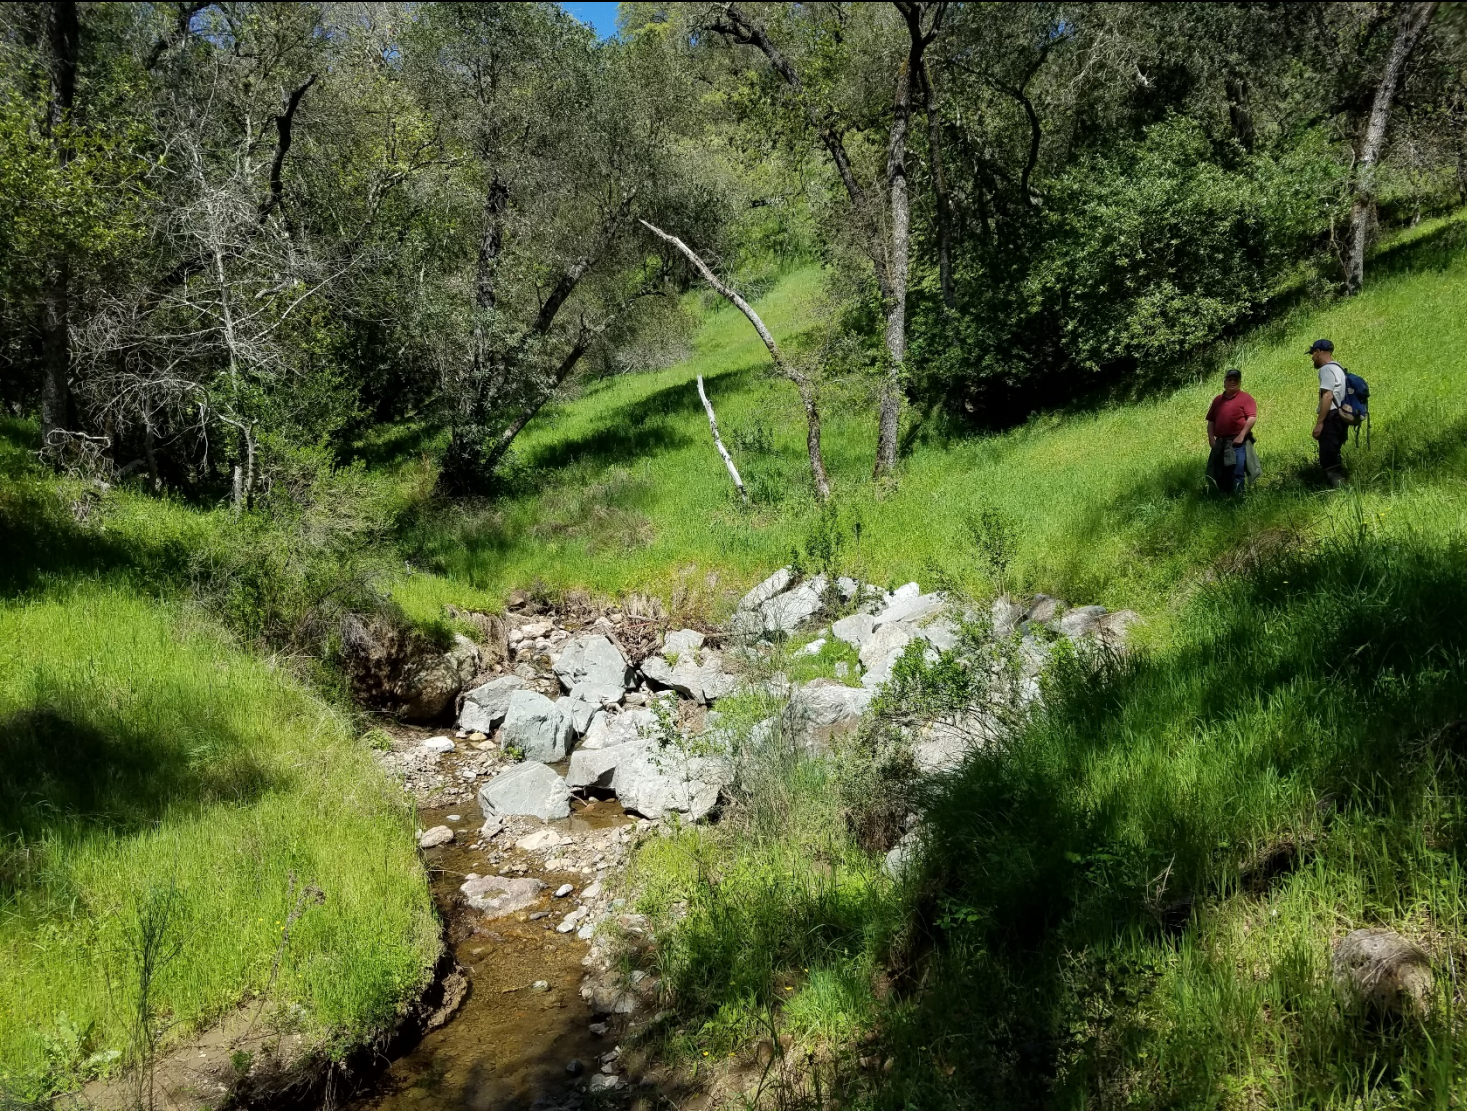
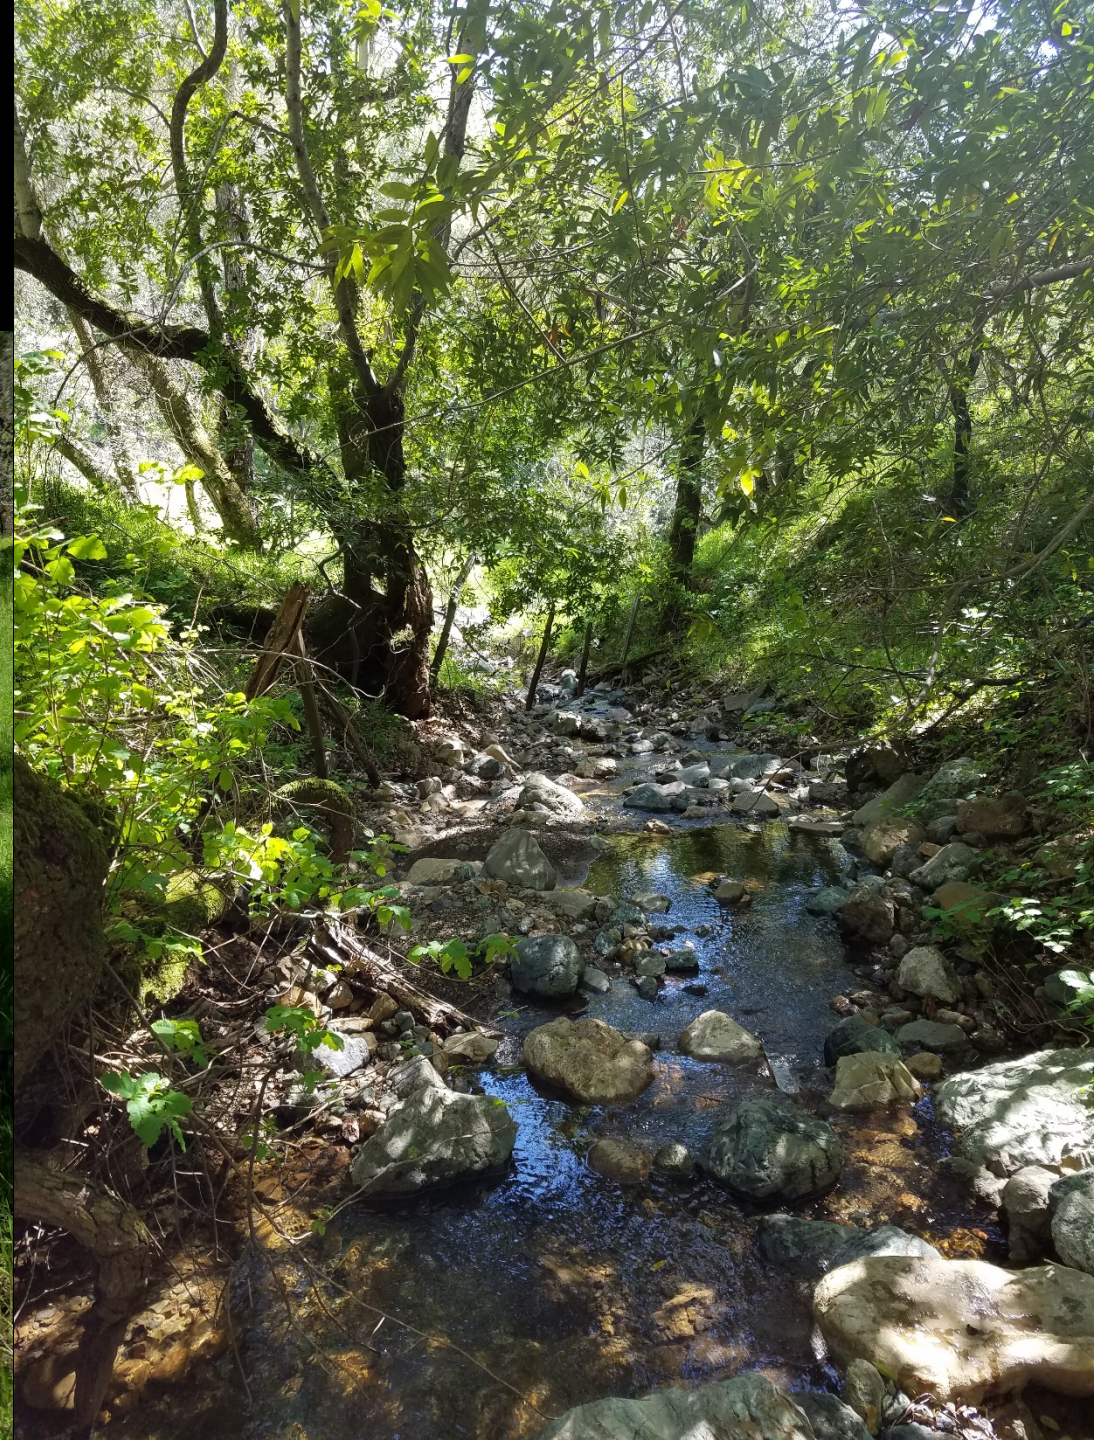
The photo below shows the slopes on either side of the reach, directly before the project site. The photo to the right shows the beginning of the project site, the most downstream portion. This portion of the reach did not show significant numbers of calcines.

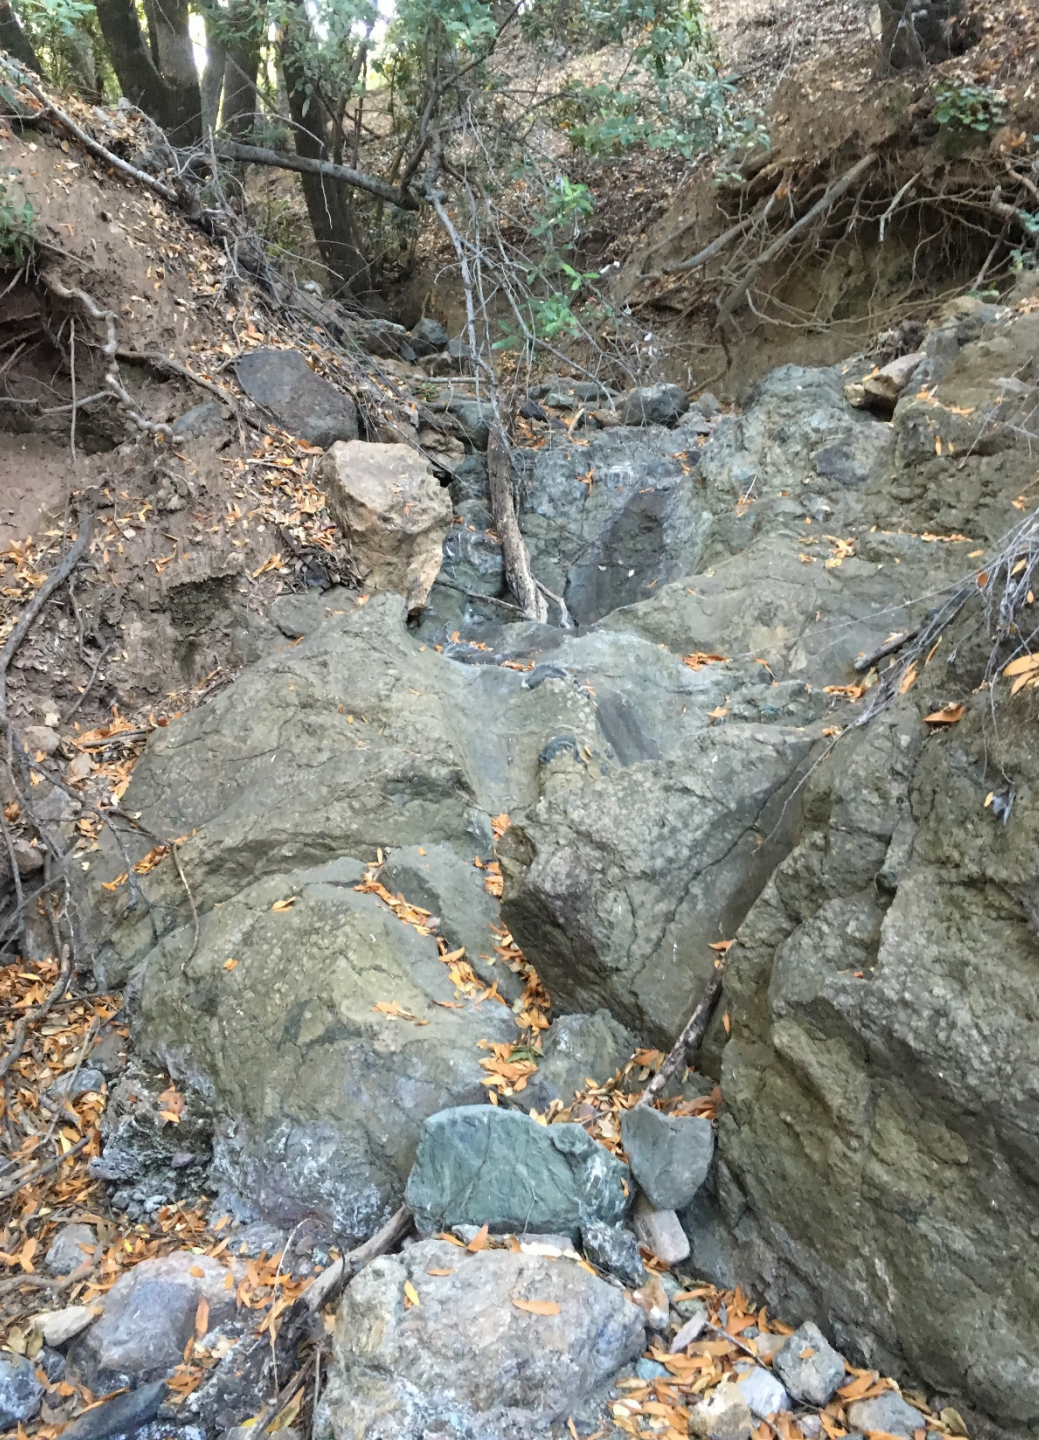
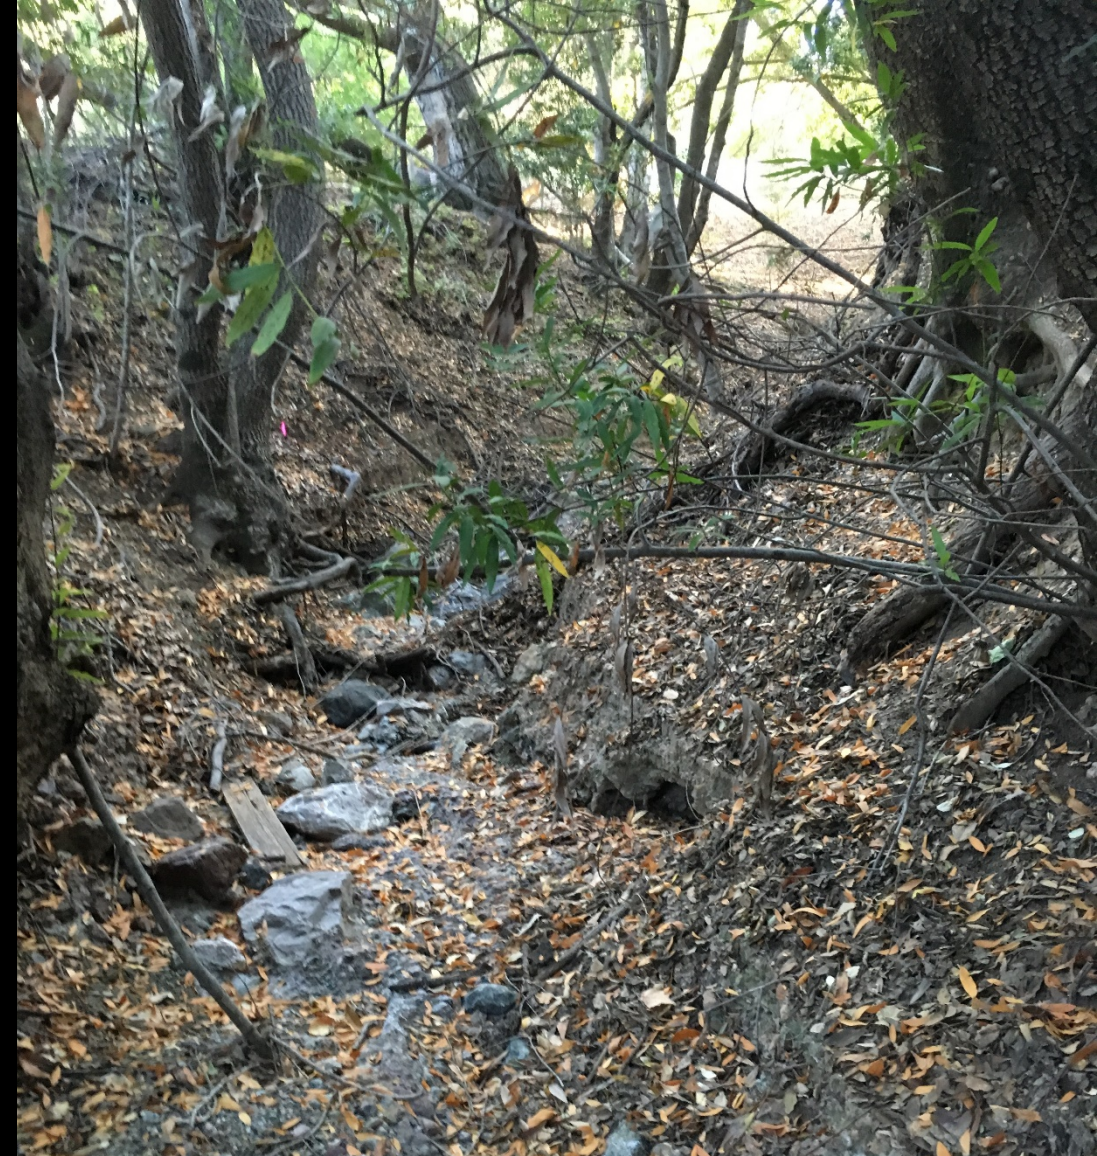
These last 3 photos were taken by Roux during one of their site visits. These images characterize the slopes of the reach (left) and the number of established trees imbedded in the slope, preventing erosion.

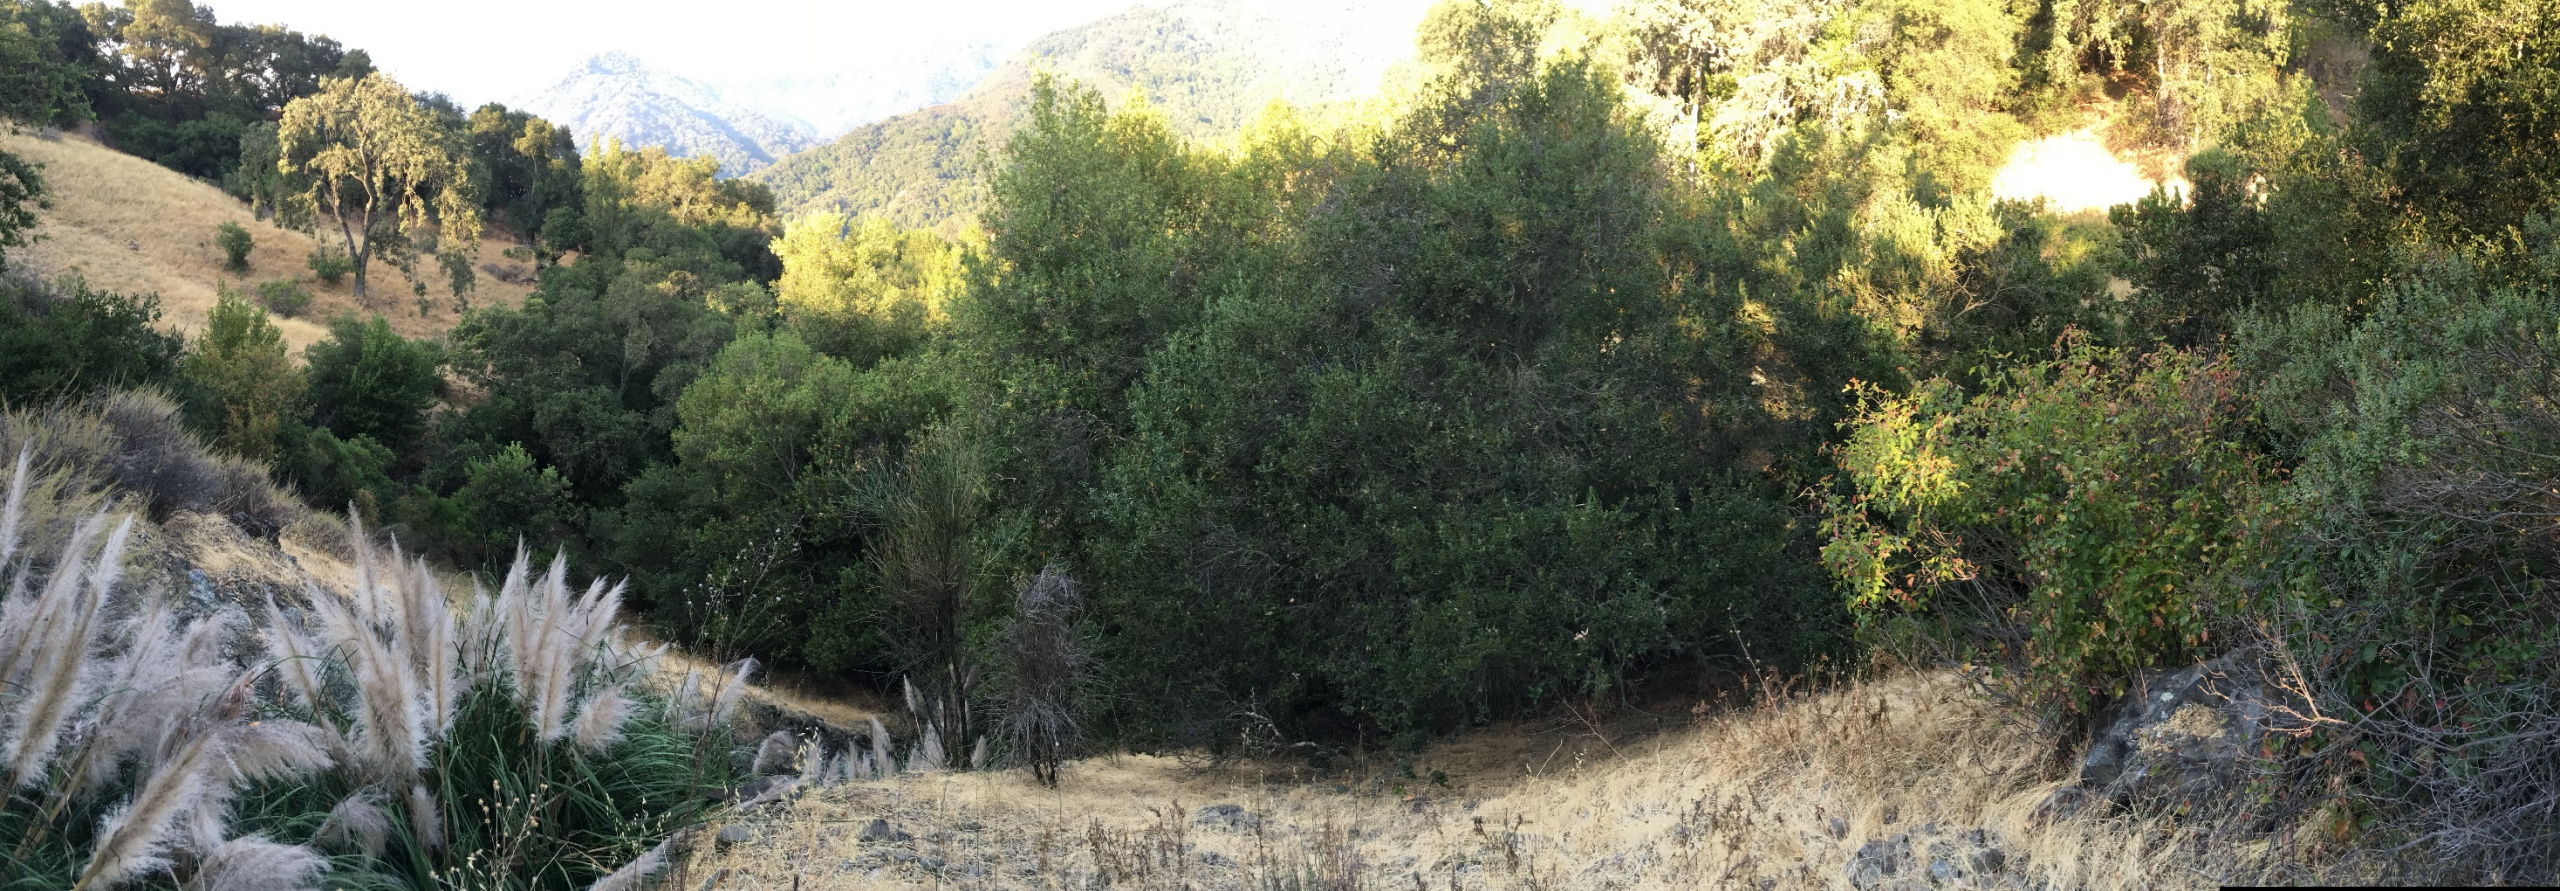
This photo, also by Roux, is taken at the top of the slope descending into Jacques Gulch. These steep slopes and large trees articulate well the challenges in accessing the site for remediation.
