Almaden Quicksilver County Park

- Hacienda Entrance to Quicksilver County Park – Clockwise from lower left: Service Vehicle Entry, construction trailer, Daily Instructions, Project Sign

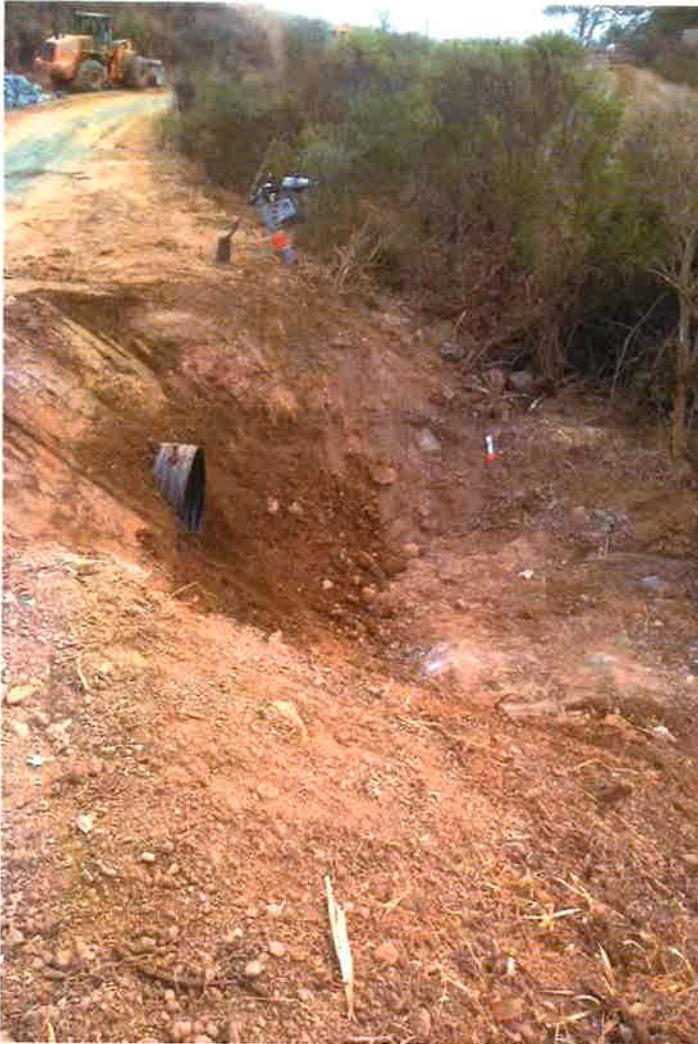
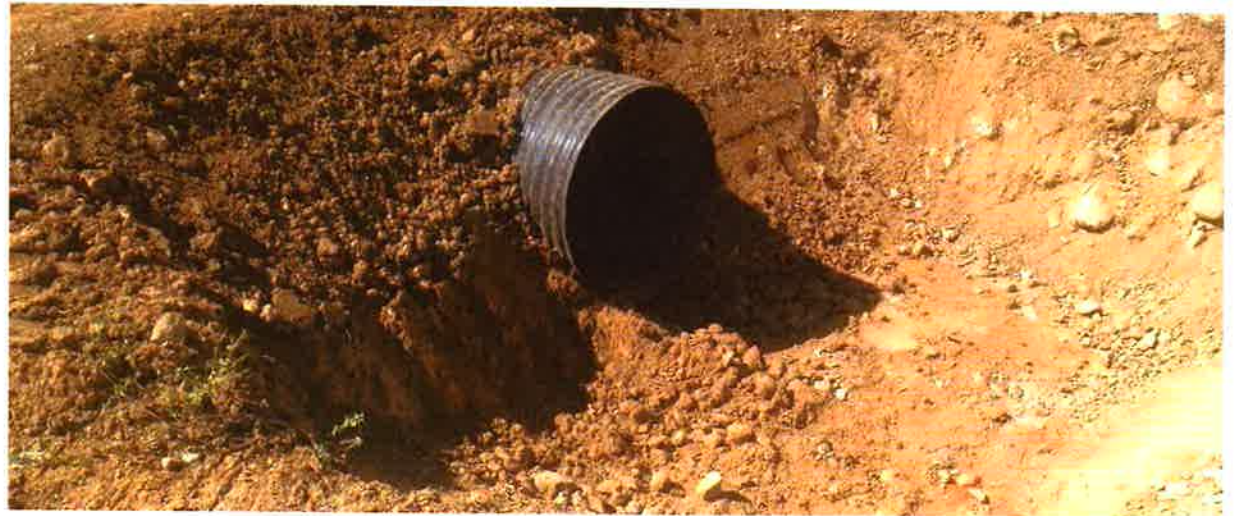
Castillero Trail at Culvert

- Existing Pampas Grass to be removed on each side of trail. Grass and other vegetation blocking the drainage flow to existing culvert

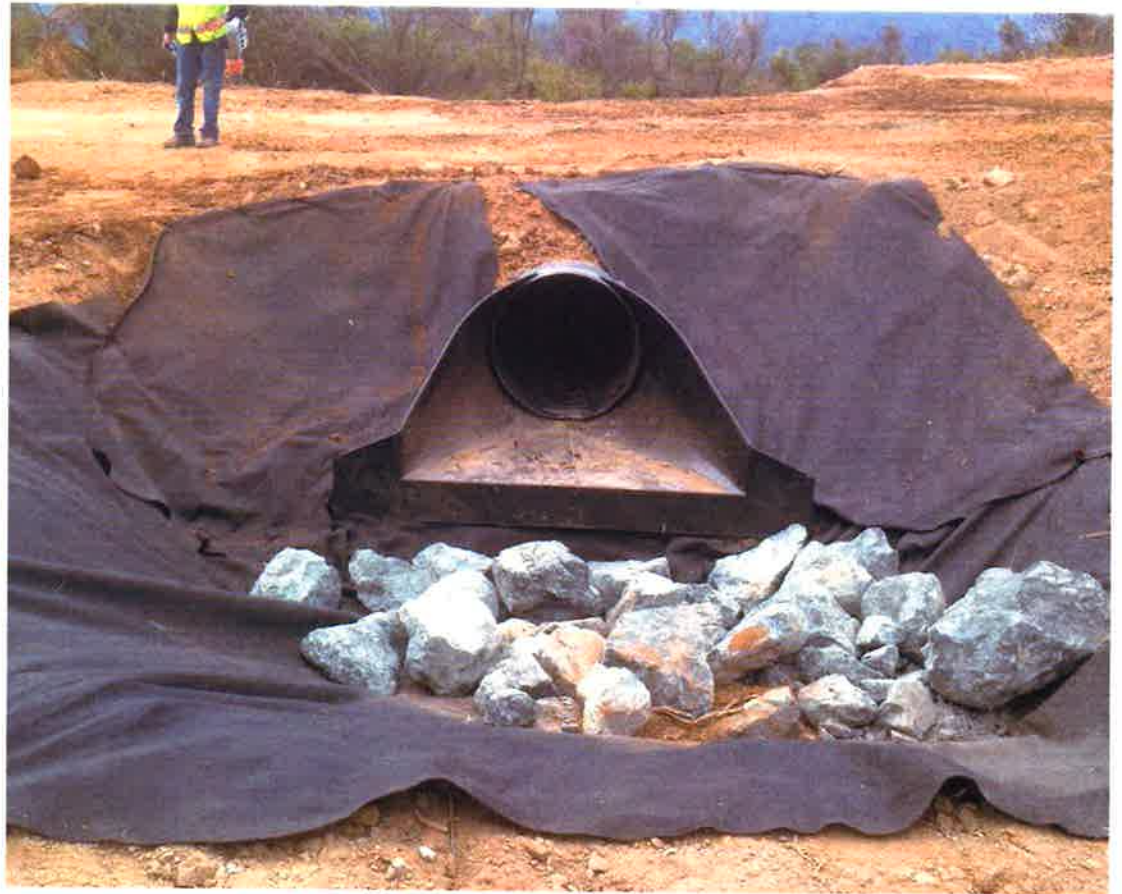
Castillero Trail 36" Culvert Construction

Installation of Geotextile Fabric
and Rock Slope Protection

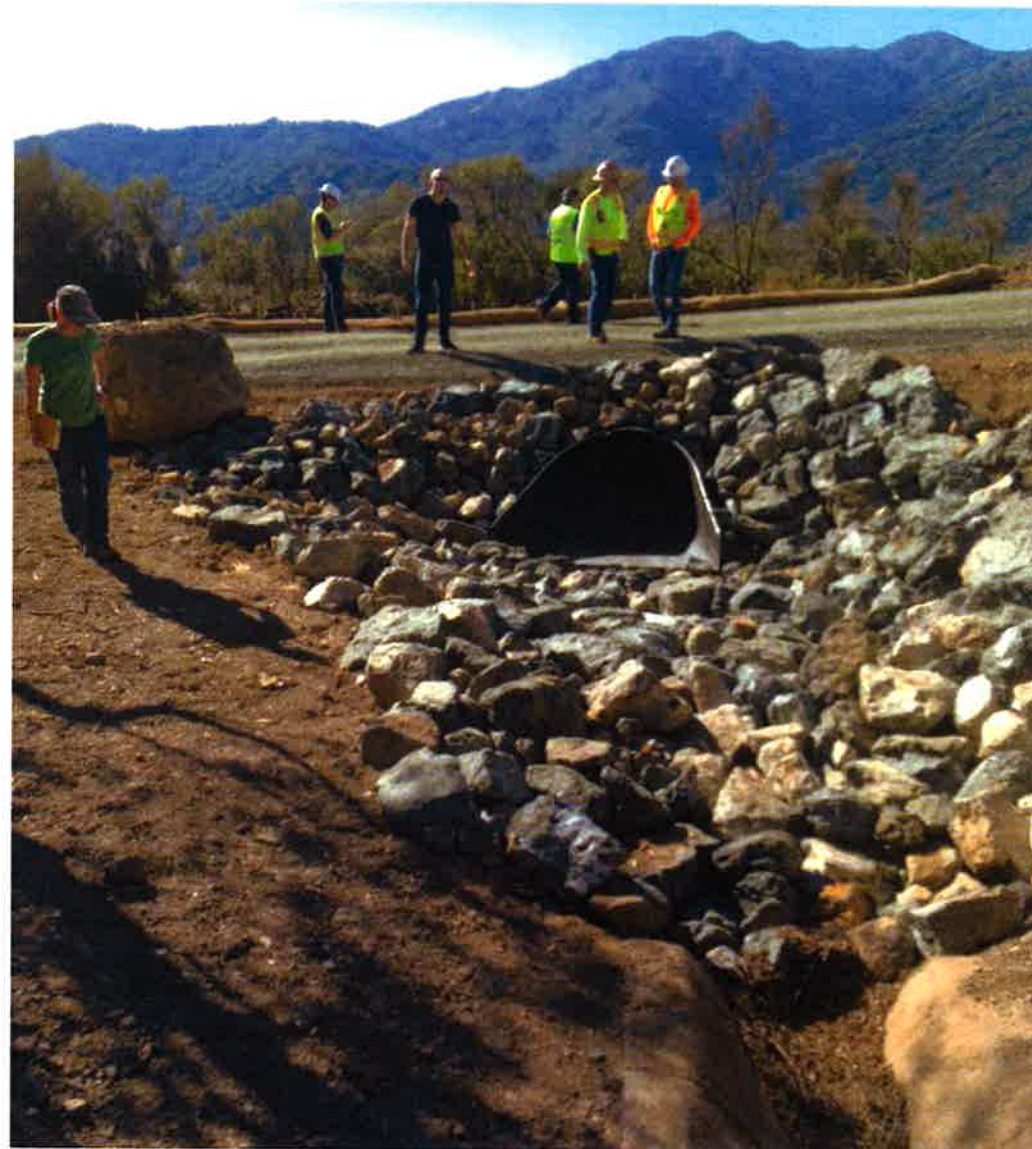
Castillero Trail 36" Culvert with Rip Rap

- Installation of culvert, rip rap and connection to concrete V ditch from SFOC

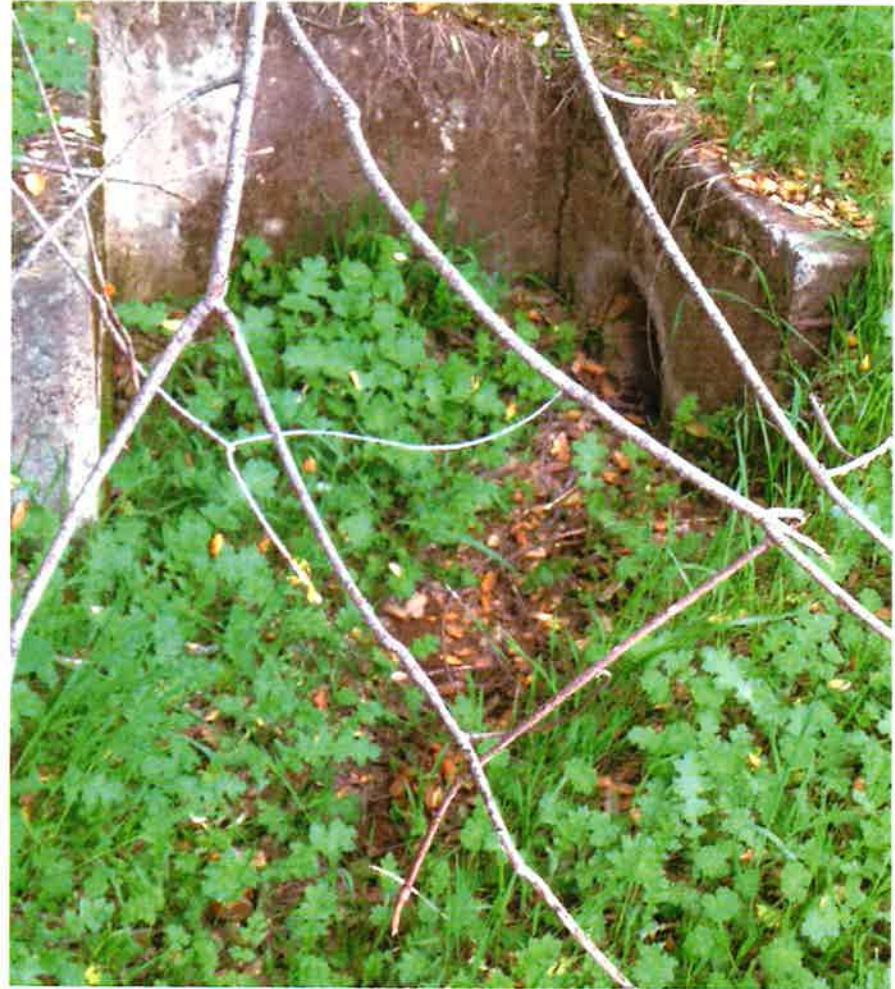
Castillero Trail

Existing Headwall for New 18"
Culvert with Earthen V-Ditch

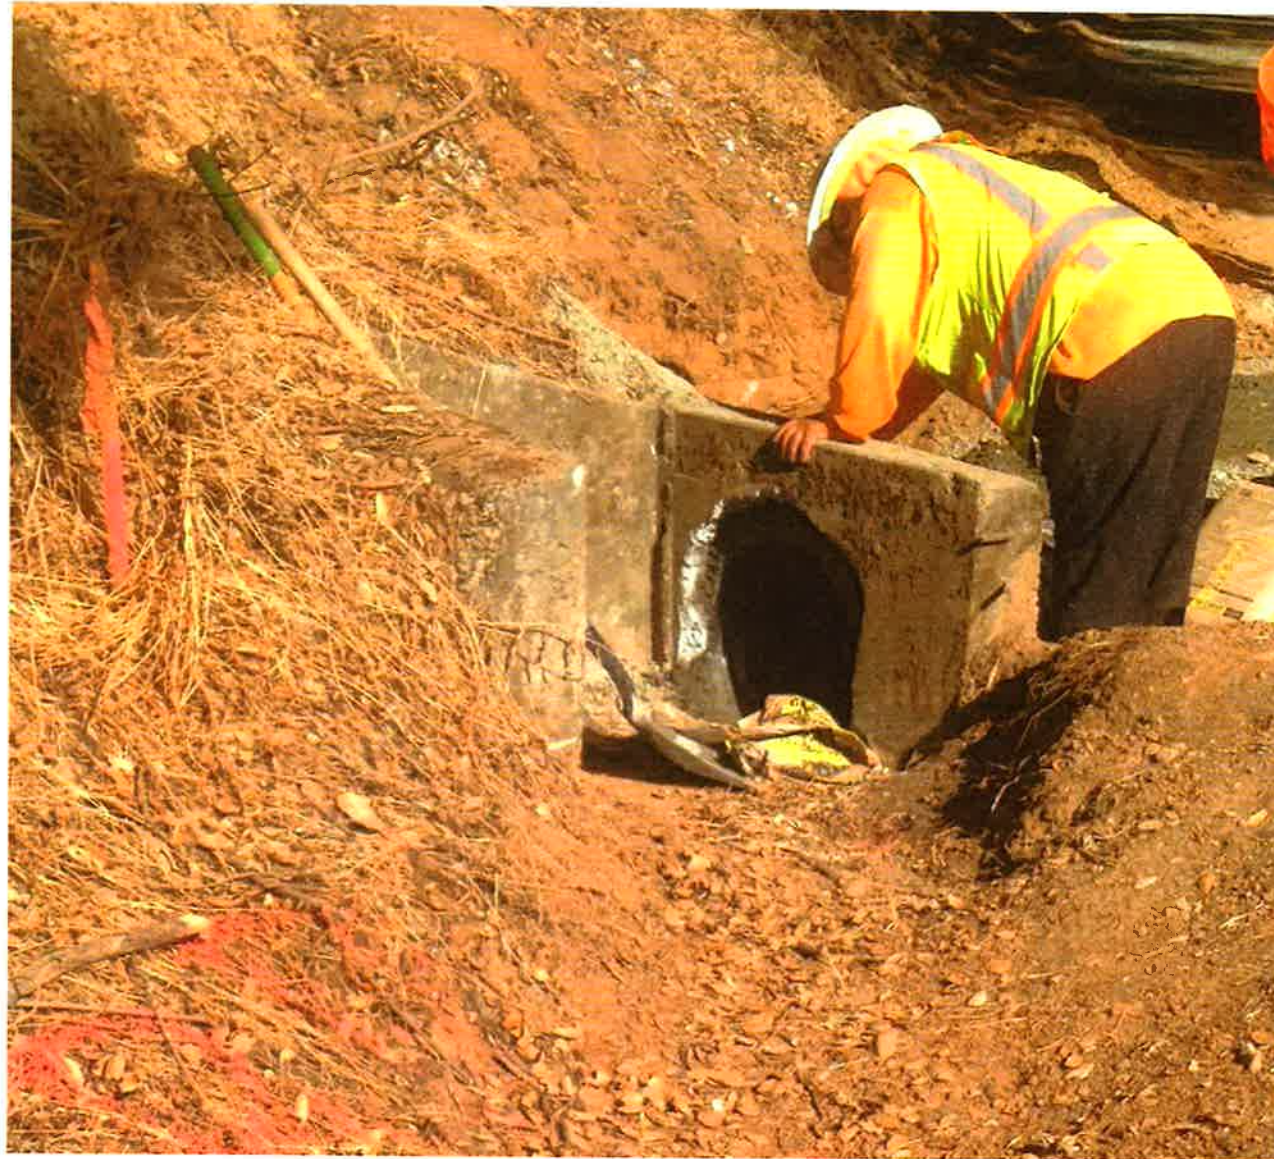
Castillero Trail

- Cleaning of Headwall, adding a 18" CMP culvert and Earthen Drainage Ditch

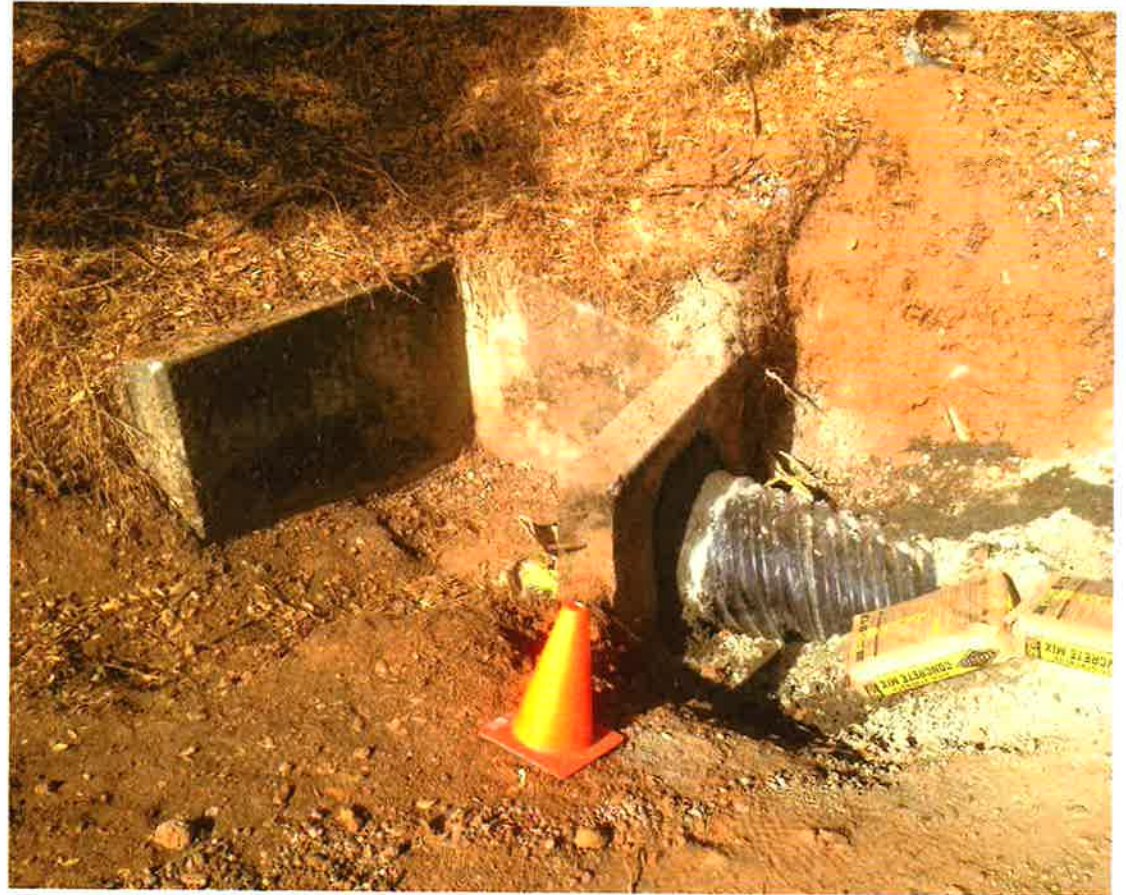
Castillero Trail

Existing Headwall and new 18"
Culvert

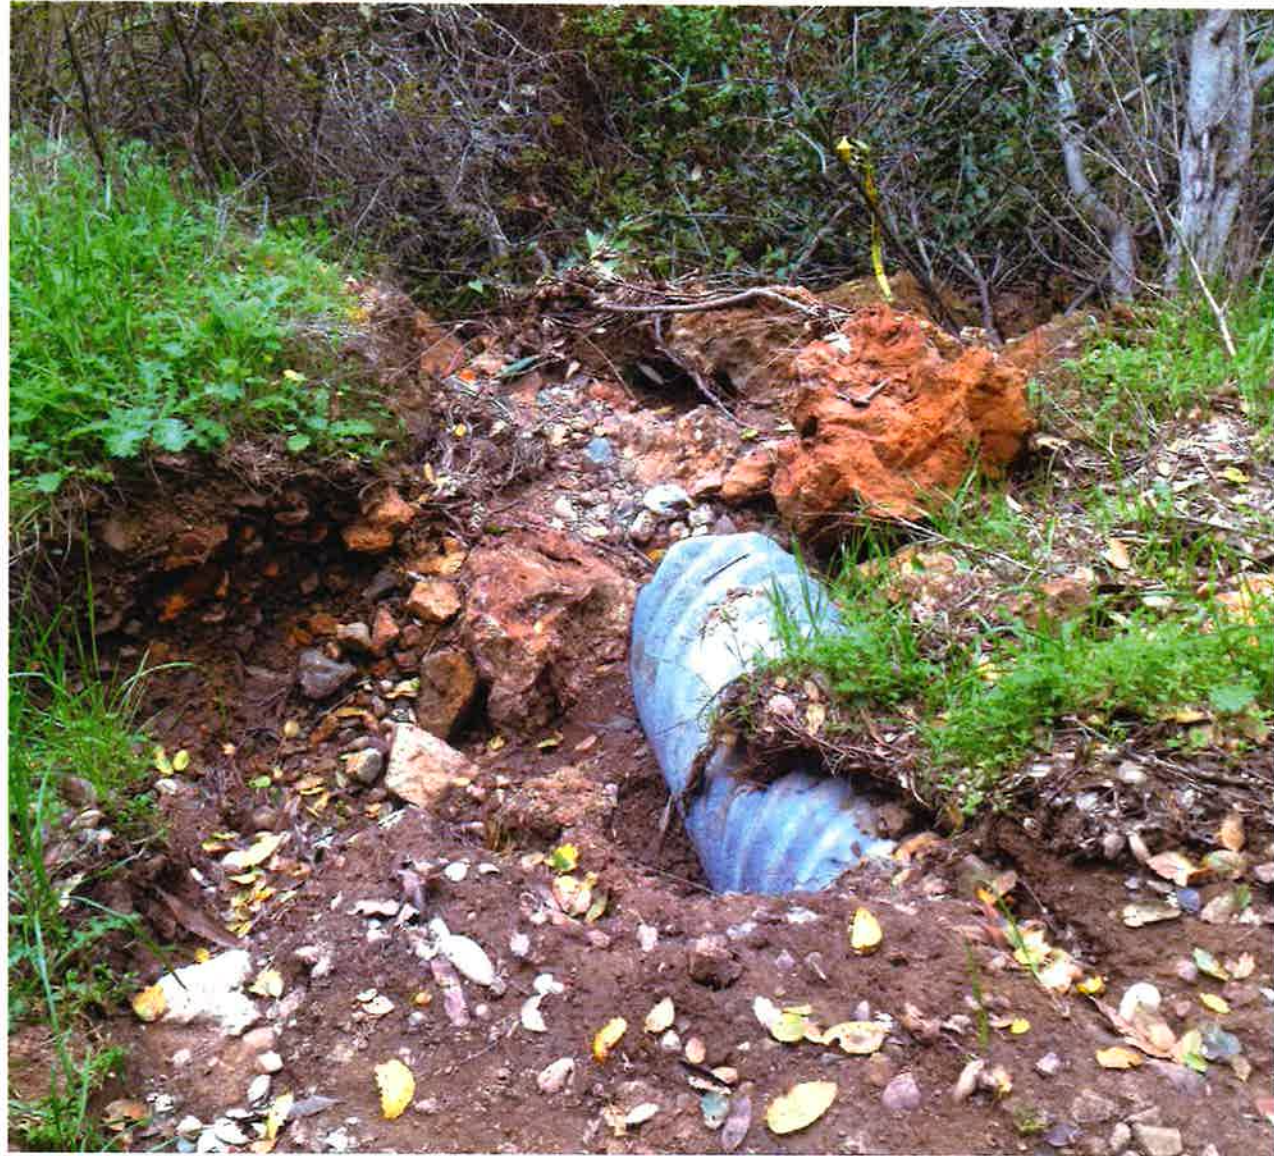
Randol Trail

Existing 18" drainage culvert
prior to calcine removal at
Station 12+00

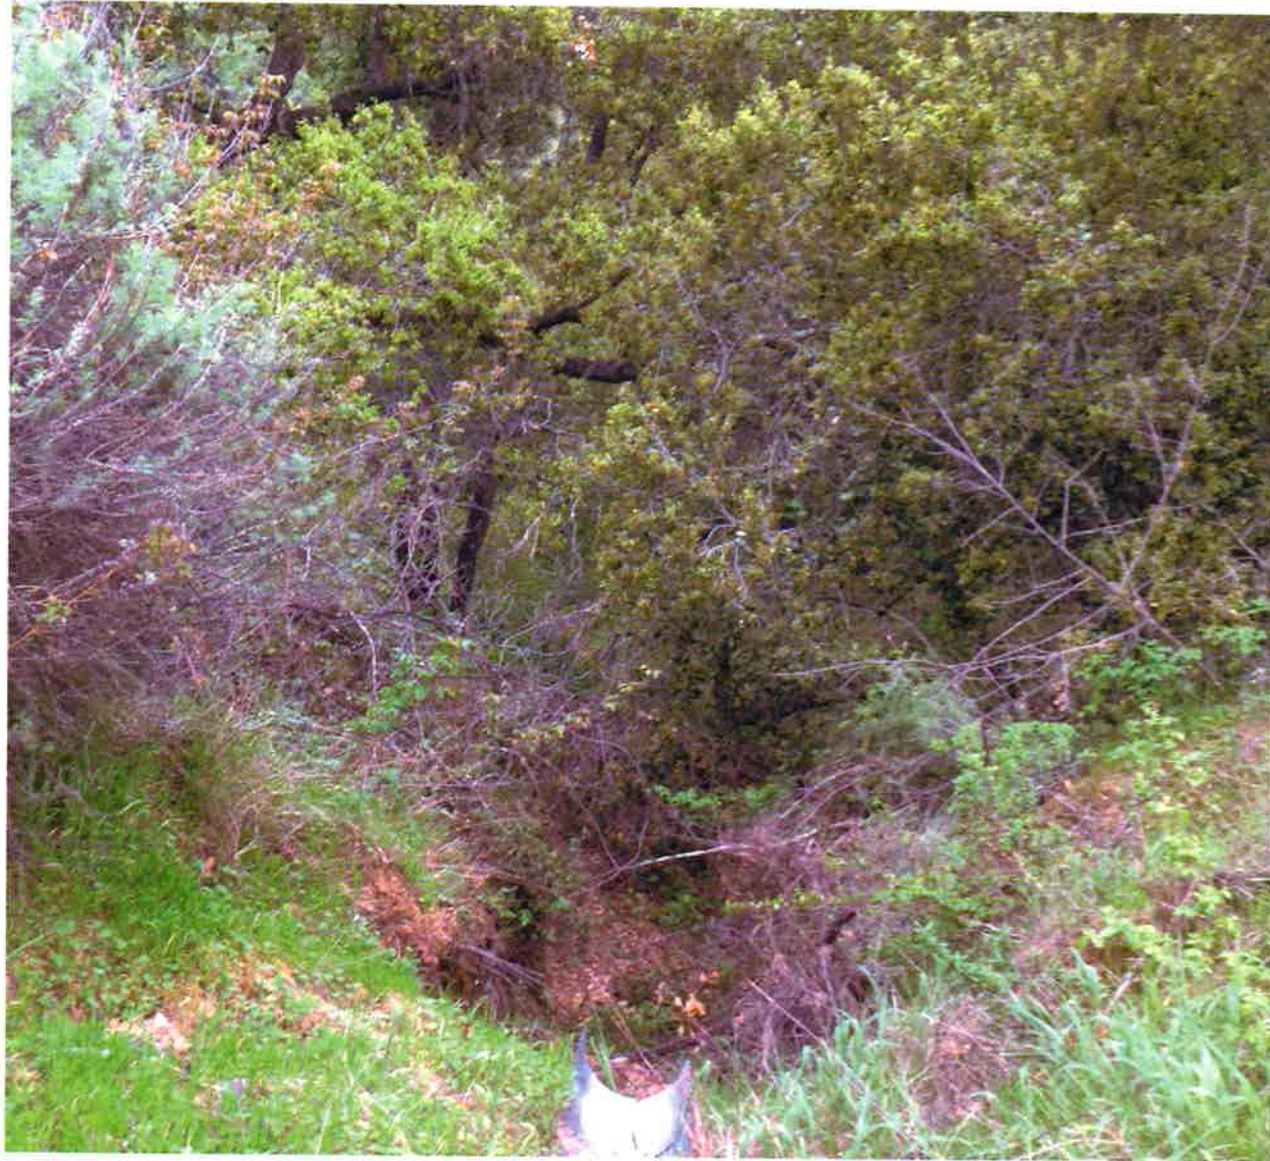
Randol Trail Culvert

Existing 18" Culvert
Downhill side at 19+25

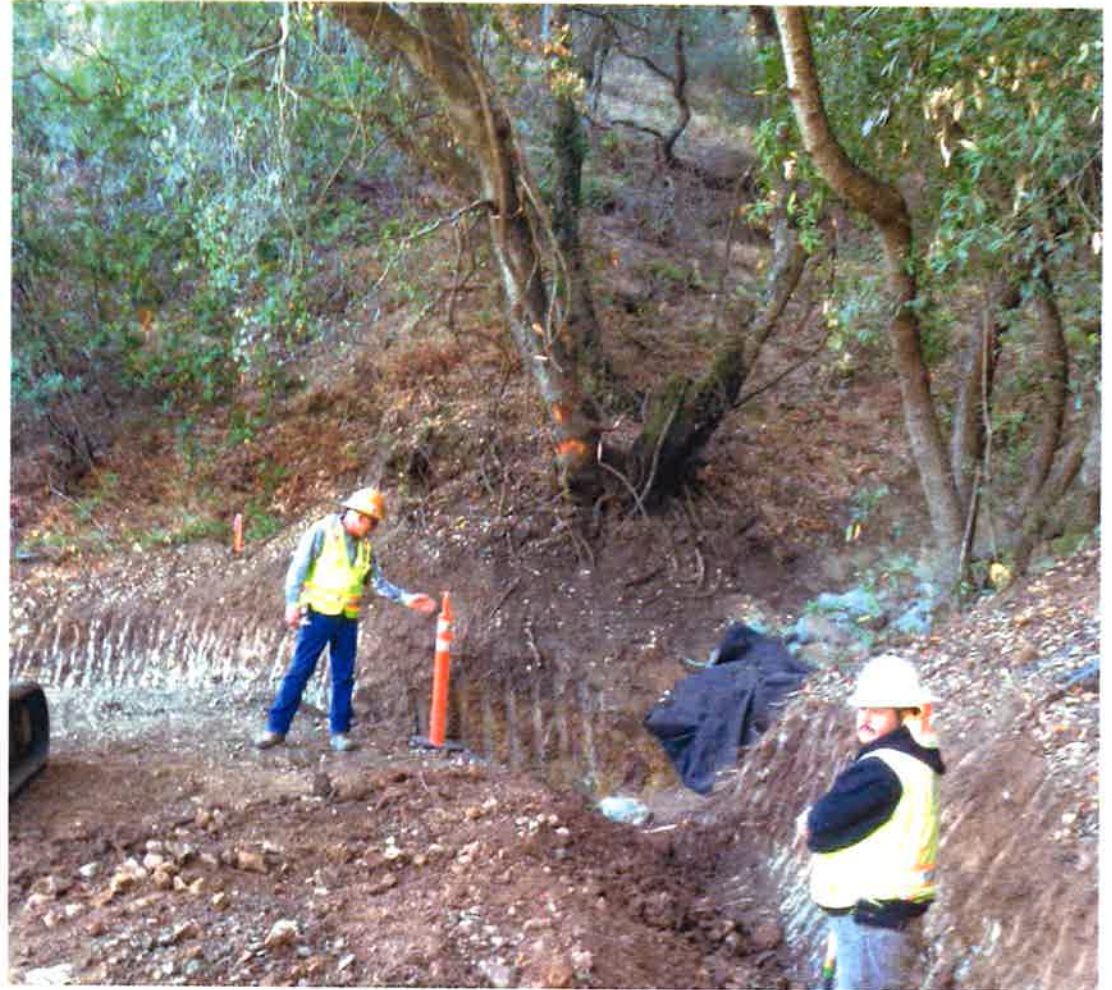
Randol Trail 36" Culvert

36" culvert under construction
with formation of Earthen
Drainage Ditch

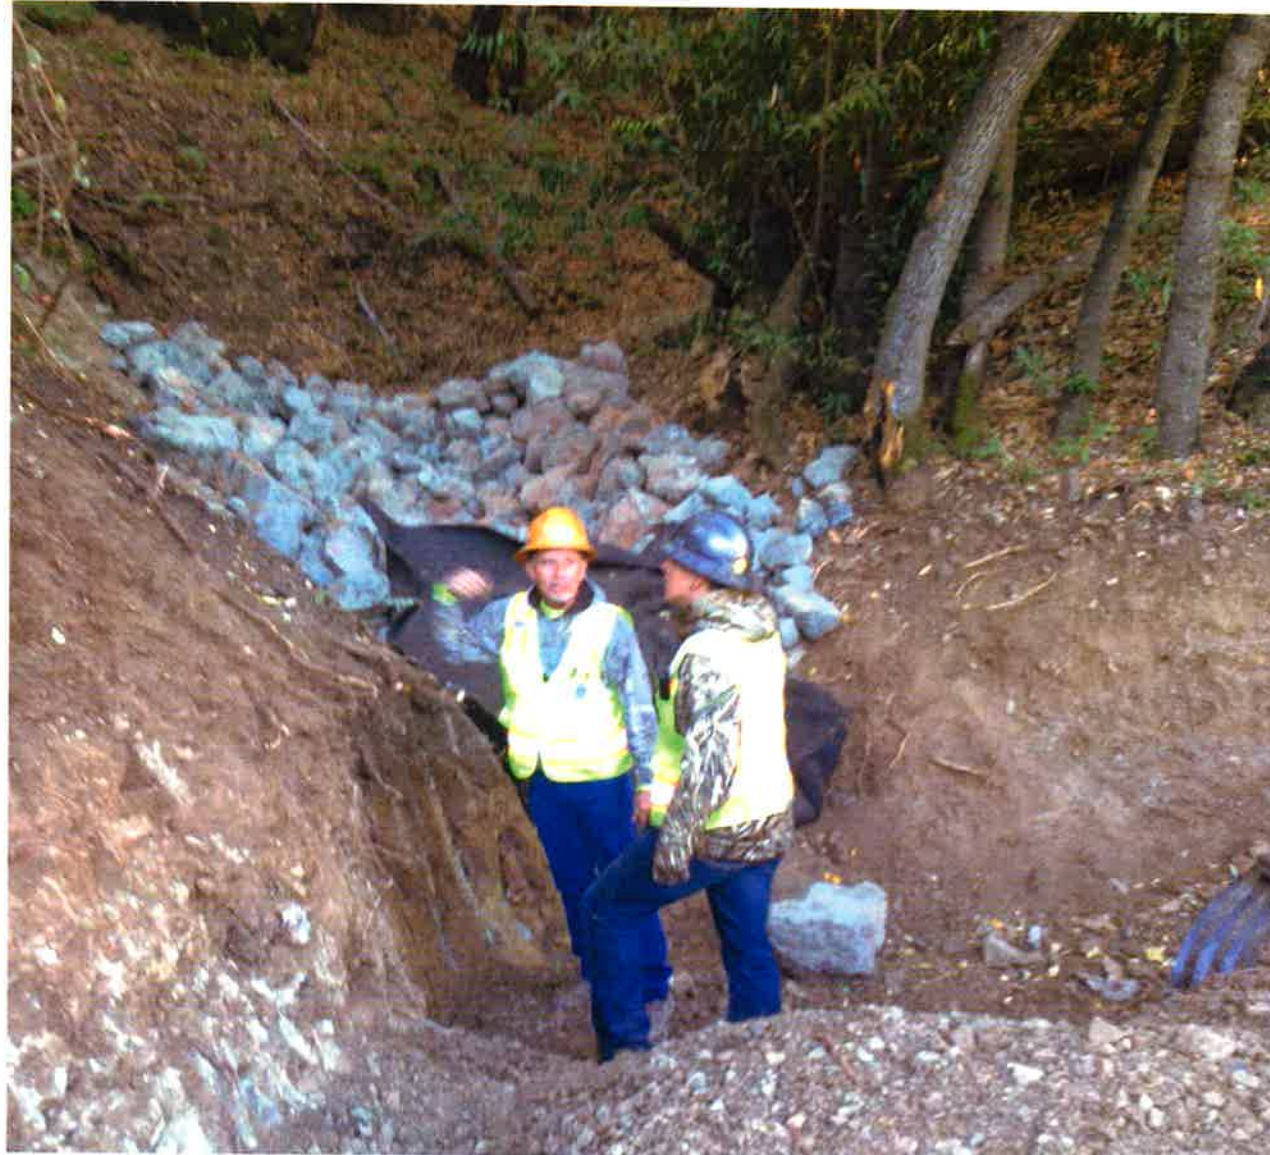
Randol Trail 36" Culvert

Uphill riprap and geotextile
fabric

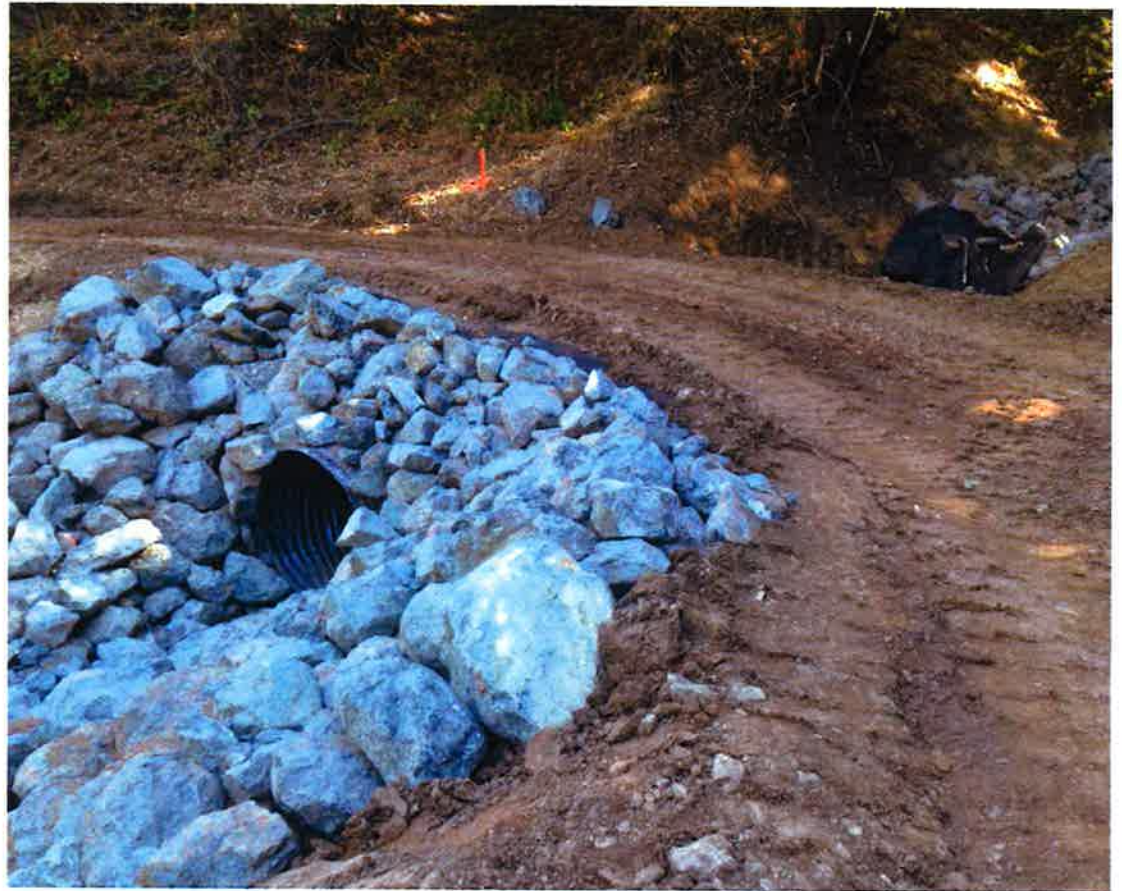
Randol Trail Construction of Culvert and Trail

Placement of 36" culvert and
riprap on uphill and downhill side
of trail

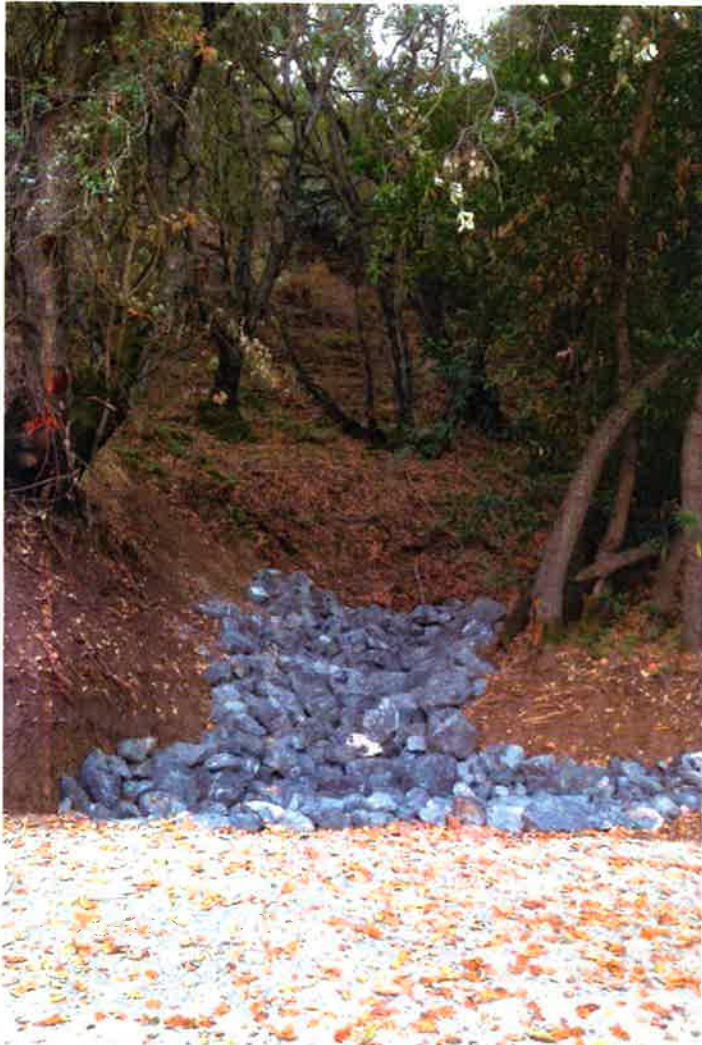
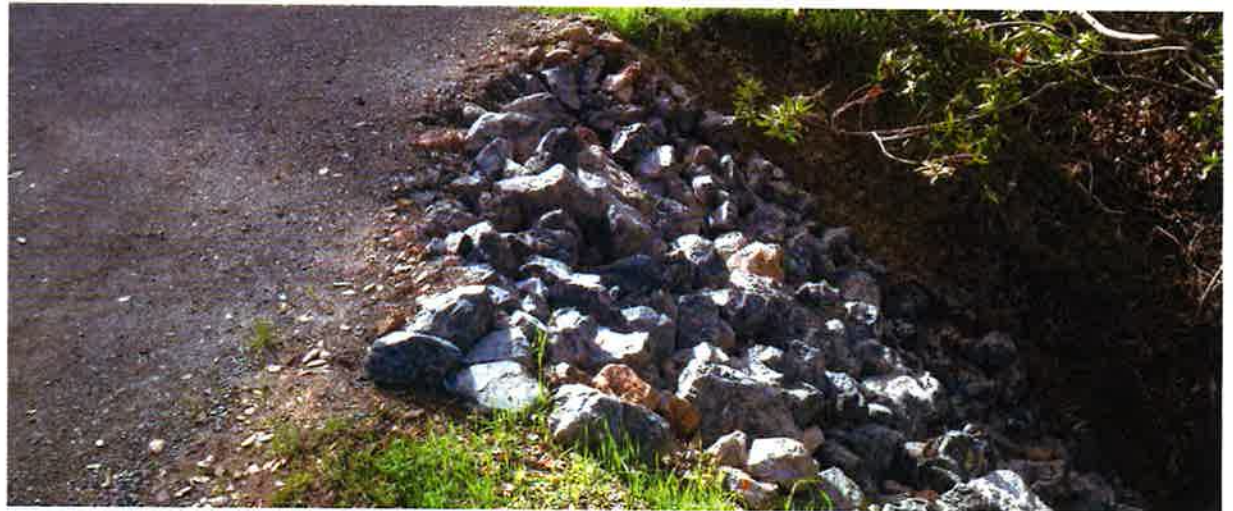
Randol Trail 36" Culvert

Detail of culvert with Apron

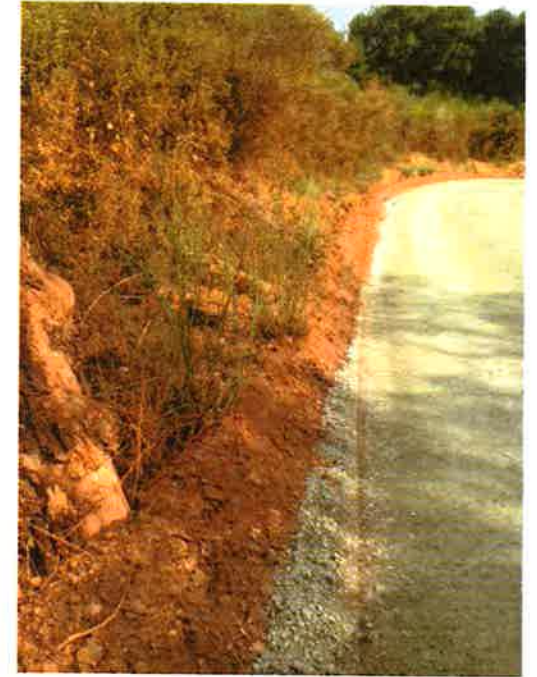
Randol Trail RipRap

Uphill & downhill RipRap from Trail

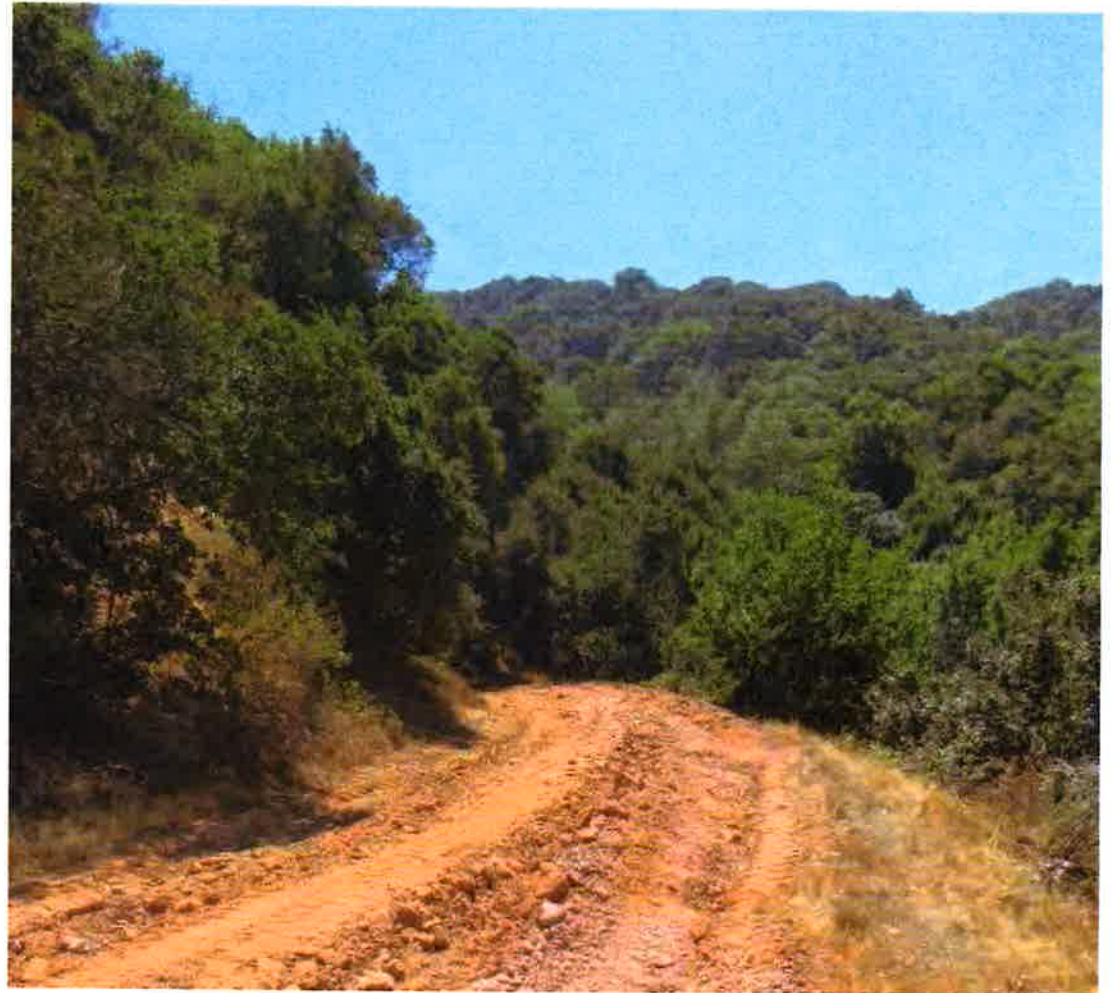
April Trail Excavation of Calcines

April Trail under excavation
revealed large boulders and rocks

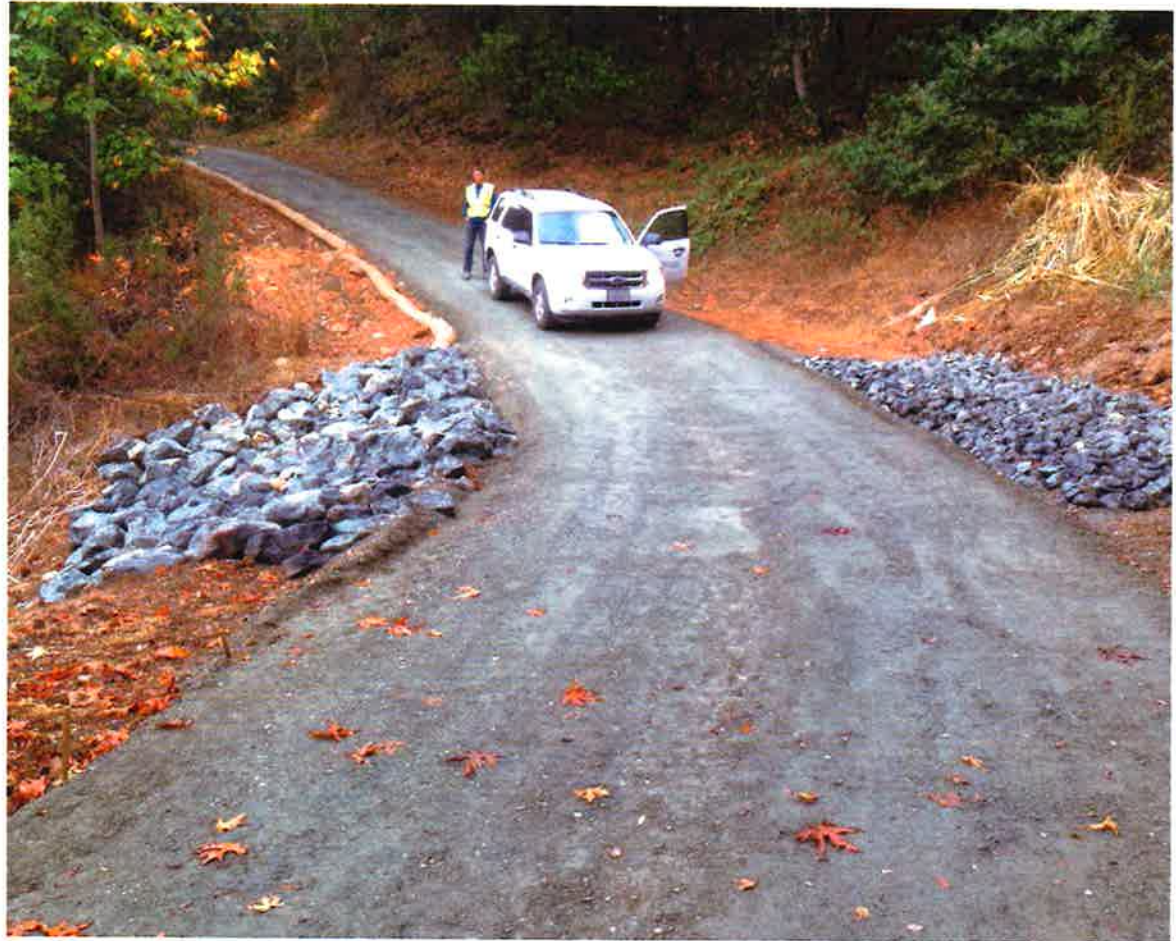
April Trail – Armored Rock Crossing 25' x 25'

- Installation included Geotextile fabric, rock slope protection and riprap; 1 ½" drainrock at 18" depth with 6" Class II Aggregate base on top compacted to 95% density

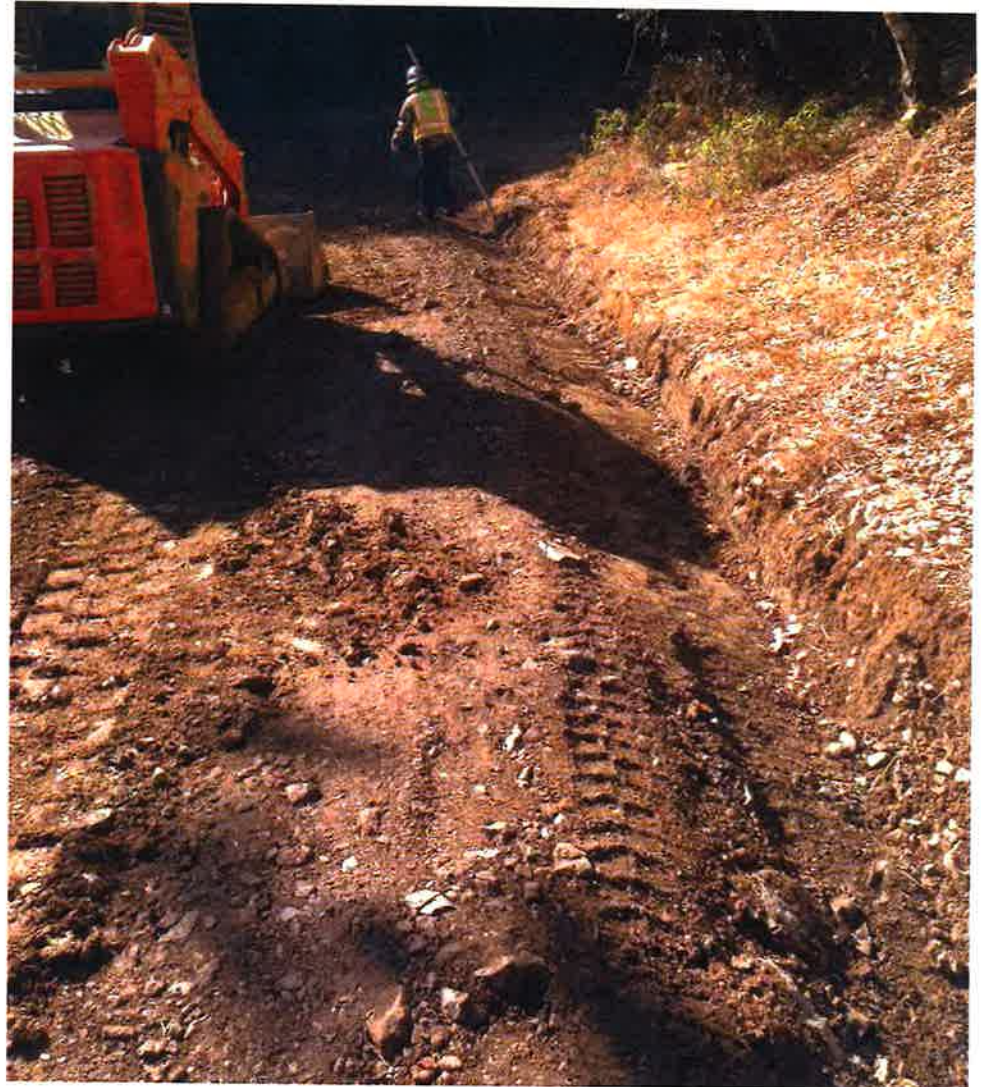
Upper Mine Hill & San Cristobal Mine Trail

- Upper Mine Hill Trail included an excess of calcines, deep, with large rocks and boulders beneath - making construction difficult.

Drainage to an existing culvert was required on both sides of the trail. Steep grade from San Cristobal Mine Trail to Mine Hill trail required outslope drainage on the downhill side and a constructed swale on the uphill side leading to the existing 18" culvert.

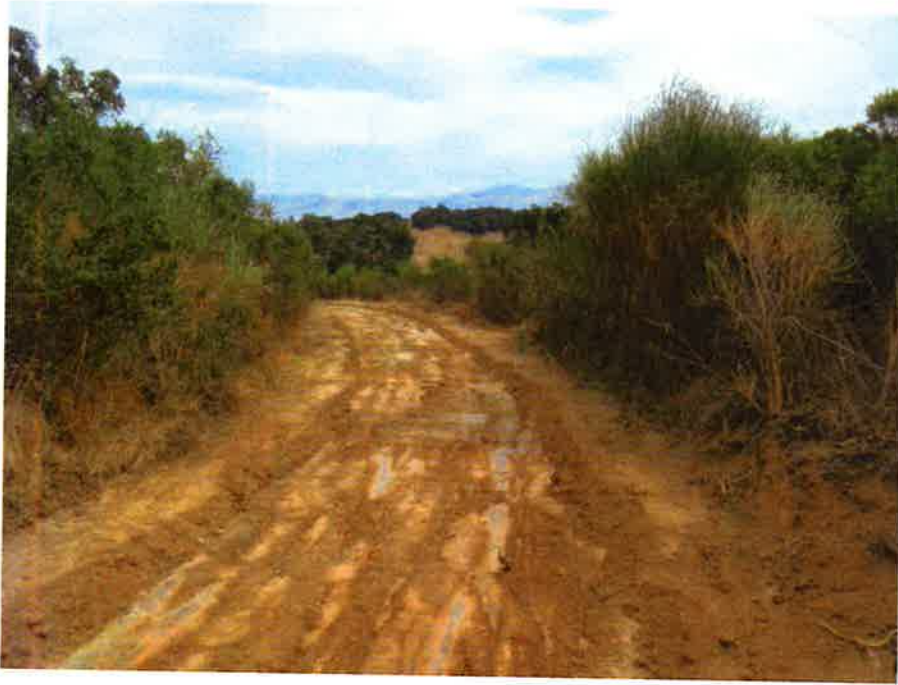
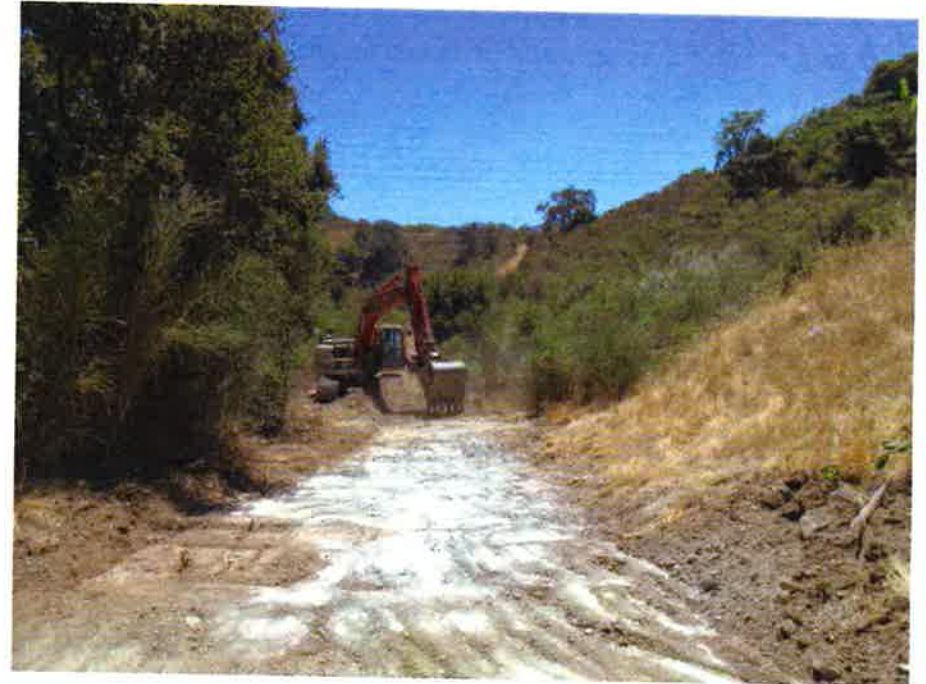
Yellow Kid and Hidalgo Cemetery Trail Excavation

- Clockwise from Top Left:
- 1. Pack Rat Nest
- 2. Excavation at top of Yellow Kid
- 3. Excavation of Hidalgo Cemetery

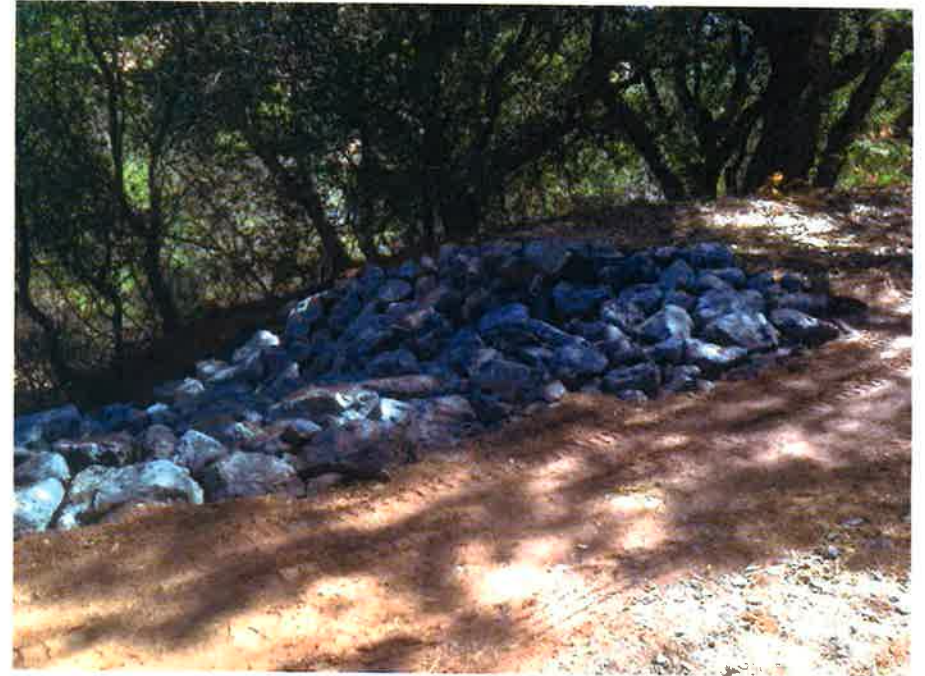
Yellow Kid Trail – Existing Culvert prior to rip rap installation; 20' x 20' x 5'
depth rip rap downslope of trail
