**TO:** Mark Frederick (Santa Clara County Parks)  
**FROM:** Angela Liang Cutting and Rachel Maxwell (Roux Associates, Inc.)  
**DATE:** February 22, 2017  
**RE:** Summary of Field Surveys for Conceptual 25% Design Plan for Jacques Gulch Remediation, Almaden Quicksilver County Park, San Jose, California

**Summary of Field Surveys for Conceptual  
25% Design Plan for Jacques Gulch Remediation**

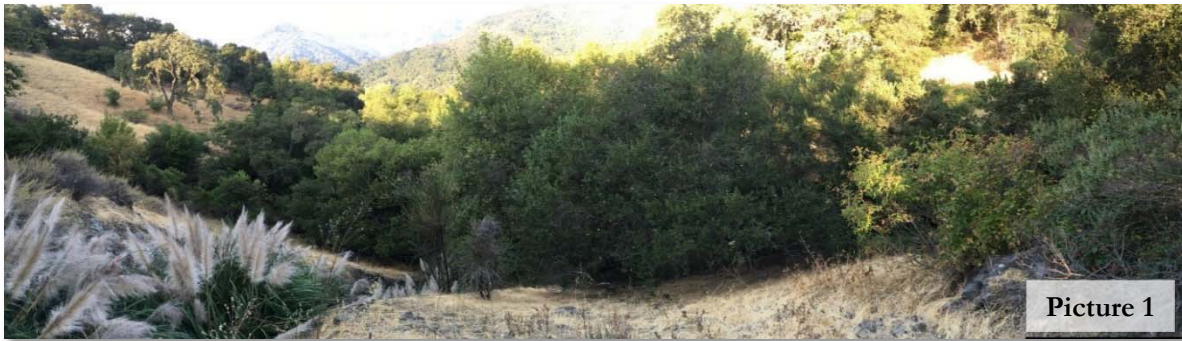
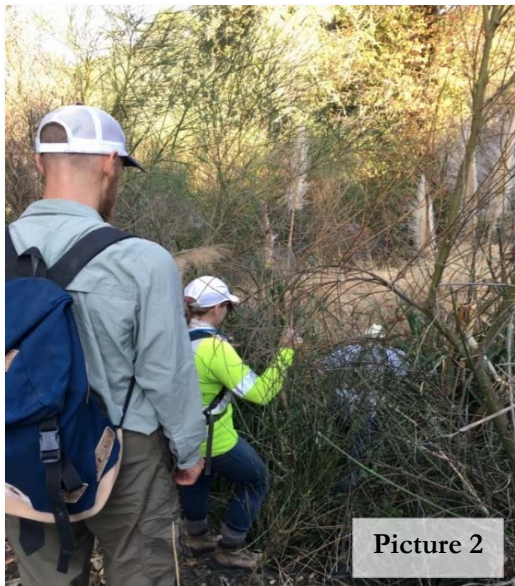
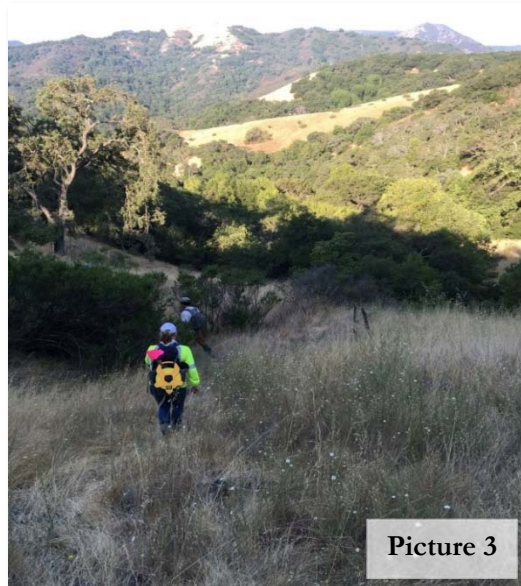
The access to the Project Area was challenging even exploring by foot. There were no visible trails/pathways through Upper Jacques Gulch. The thick vegetation made access by vehicles highly unlikely. Pictures 1-3 below illustrate the descent to the Project Area.

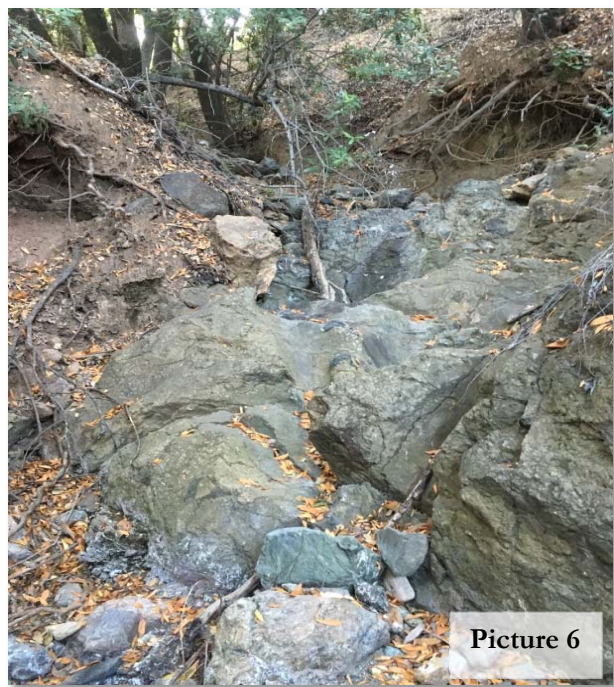
Once in the thickly forested portions of the Project Area, both bedrock and tree roots were observed along the streambed. Pictures 4-6 illustrate the extent of visible bedrock and vegetation.

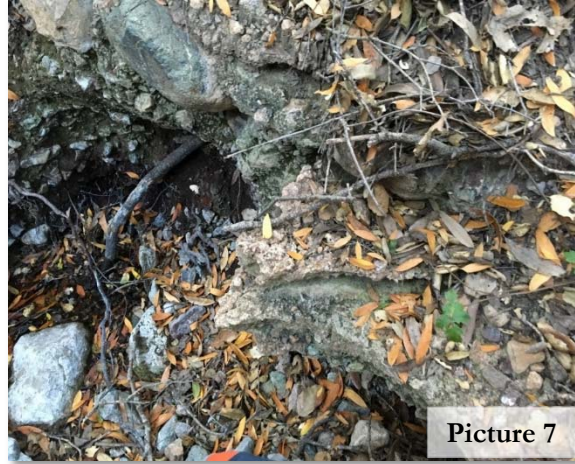
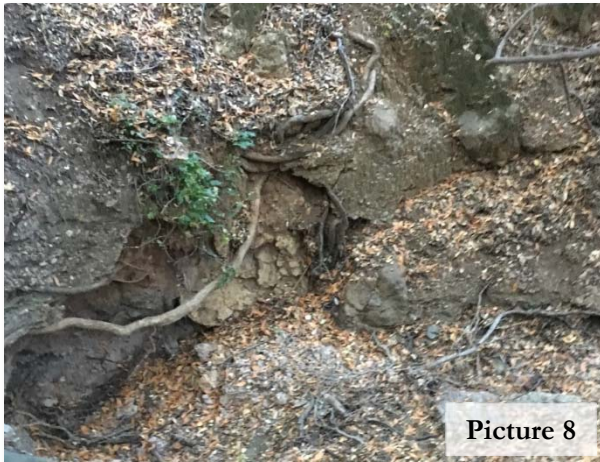
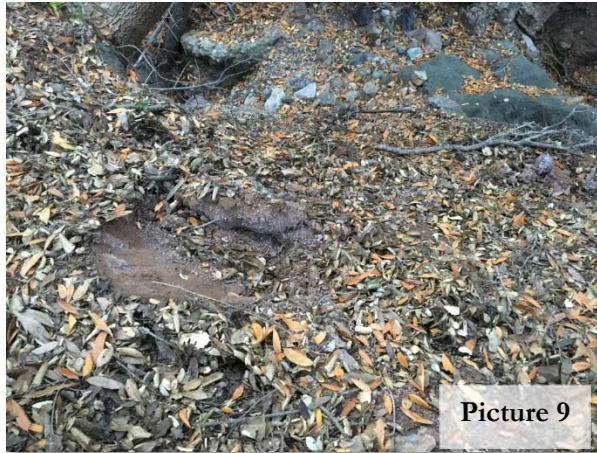
In addition to bedrock and tree roots, calcines were also observed (Picture 7).

These calcines were interbedded in both bedrock and tree roots and at various elevations along the exposed steep side slopes. Removal of these calcines will involve significant slope destabilization due to the removal of bedrock and trees and excavations into the steep slope slopes on either side of the gulch. Pictures 8 and 9 display the interbedded calcines along the Project Area.

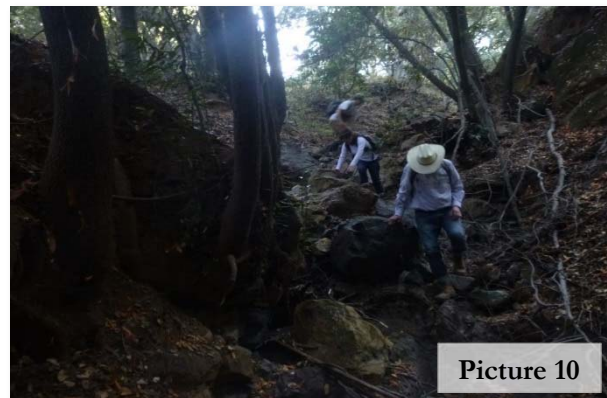
One of the reasons that Upper Jacques Gulch is difficult to navigate is due to the steep slope of the narrow drainage course and adjacent hillsides in the Project Area (Picture 10). An access route will have to be constructed so that heavy equipment (e.g., backhoes, excavators, bulldozers, dump trucks) could be utilized for calcine removal.

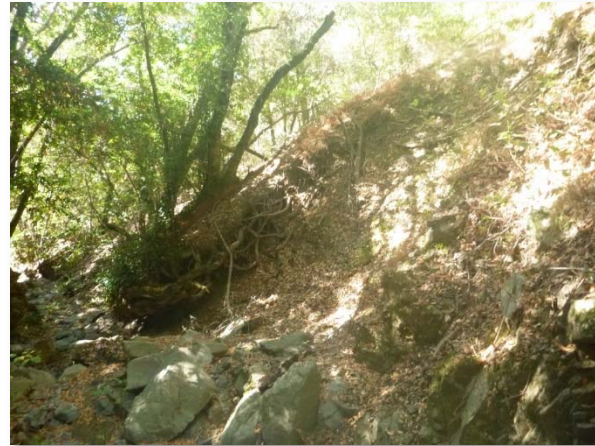
During these two site visits, MEI noted several relatively small erosional features and shallow landslides along the steep slope margins of the gulch. However, the majority of the slopes observed appear relatively stable. We believe a primary reason is the presence of trees and low lying brush whose well-established root systems add substantial stability to these slopes over time. Picture 11 shows the root system of a Bay Tree that provides significant support to the slope.

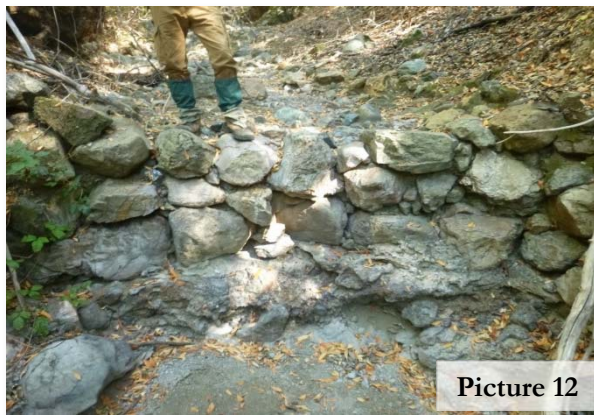
Other important reasons adding to the stability of these slopes are the presence of several man-made rock drop structures which reduces stream velocity and erosion, and presence of exposed highly resistant bedrock along portions of the channel. Picture 12 shows one of the man-made rock drop structures.

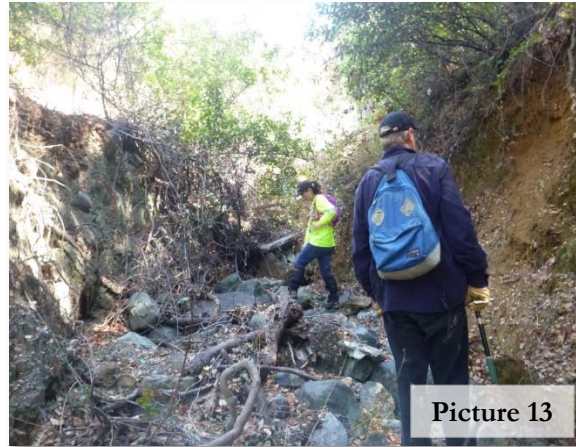
**Picture 13**

As previously discussed, calcine deposits were observed embedded in bedrock deposits and sporadically along portions of the side slopes. From a geologic viewpoint, the upper steep heavily vegetated section of the gulch appears to be within an eroded segment of the channel with the majority of the deposition occurring in the lower reaches of the gulch. However, within this steeper zone there appears to be some localized deposition along bends and at different elevations in the channel. Such natural geologic processes

make removal of calcine deposits complex and a significant challenge. Based on our field findings, we anticipate the need for near-continuous excavation along the base and side slopes of the gulch which will require significant removal of vegetation presently providing stability to these slopes. Such grading will have significant impacts on temporary and long-term slope stability which will need to be adequately addressed.

Picture 13 shows a portion of the gulch with tree roots and rocks along the bottom of the gulch.

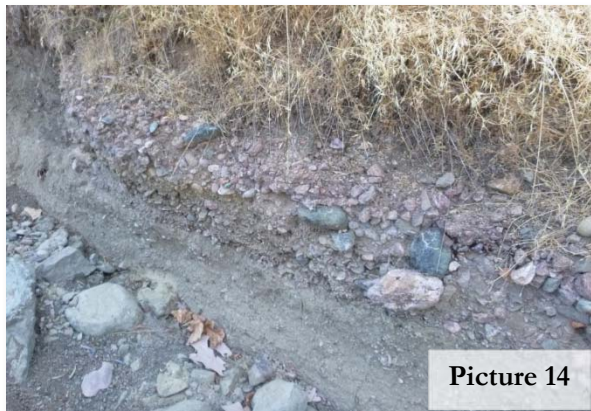
**Picture 14**

During the geologic and hydrologic field surveys, calcines were detected in the lower reaches of Jacques Gulch (Site B). Picture 14 shows imbedded calcines along the lower reaches of the previously remediated portion of Jacques Gulch.

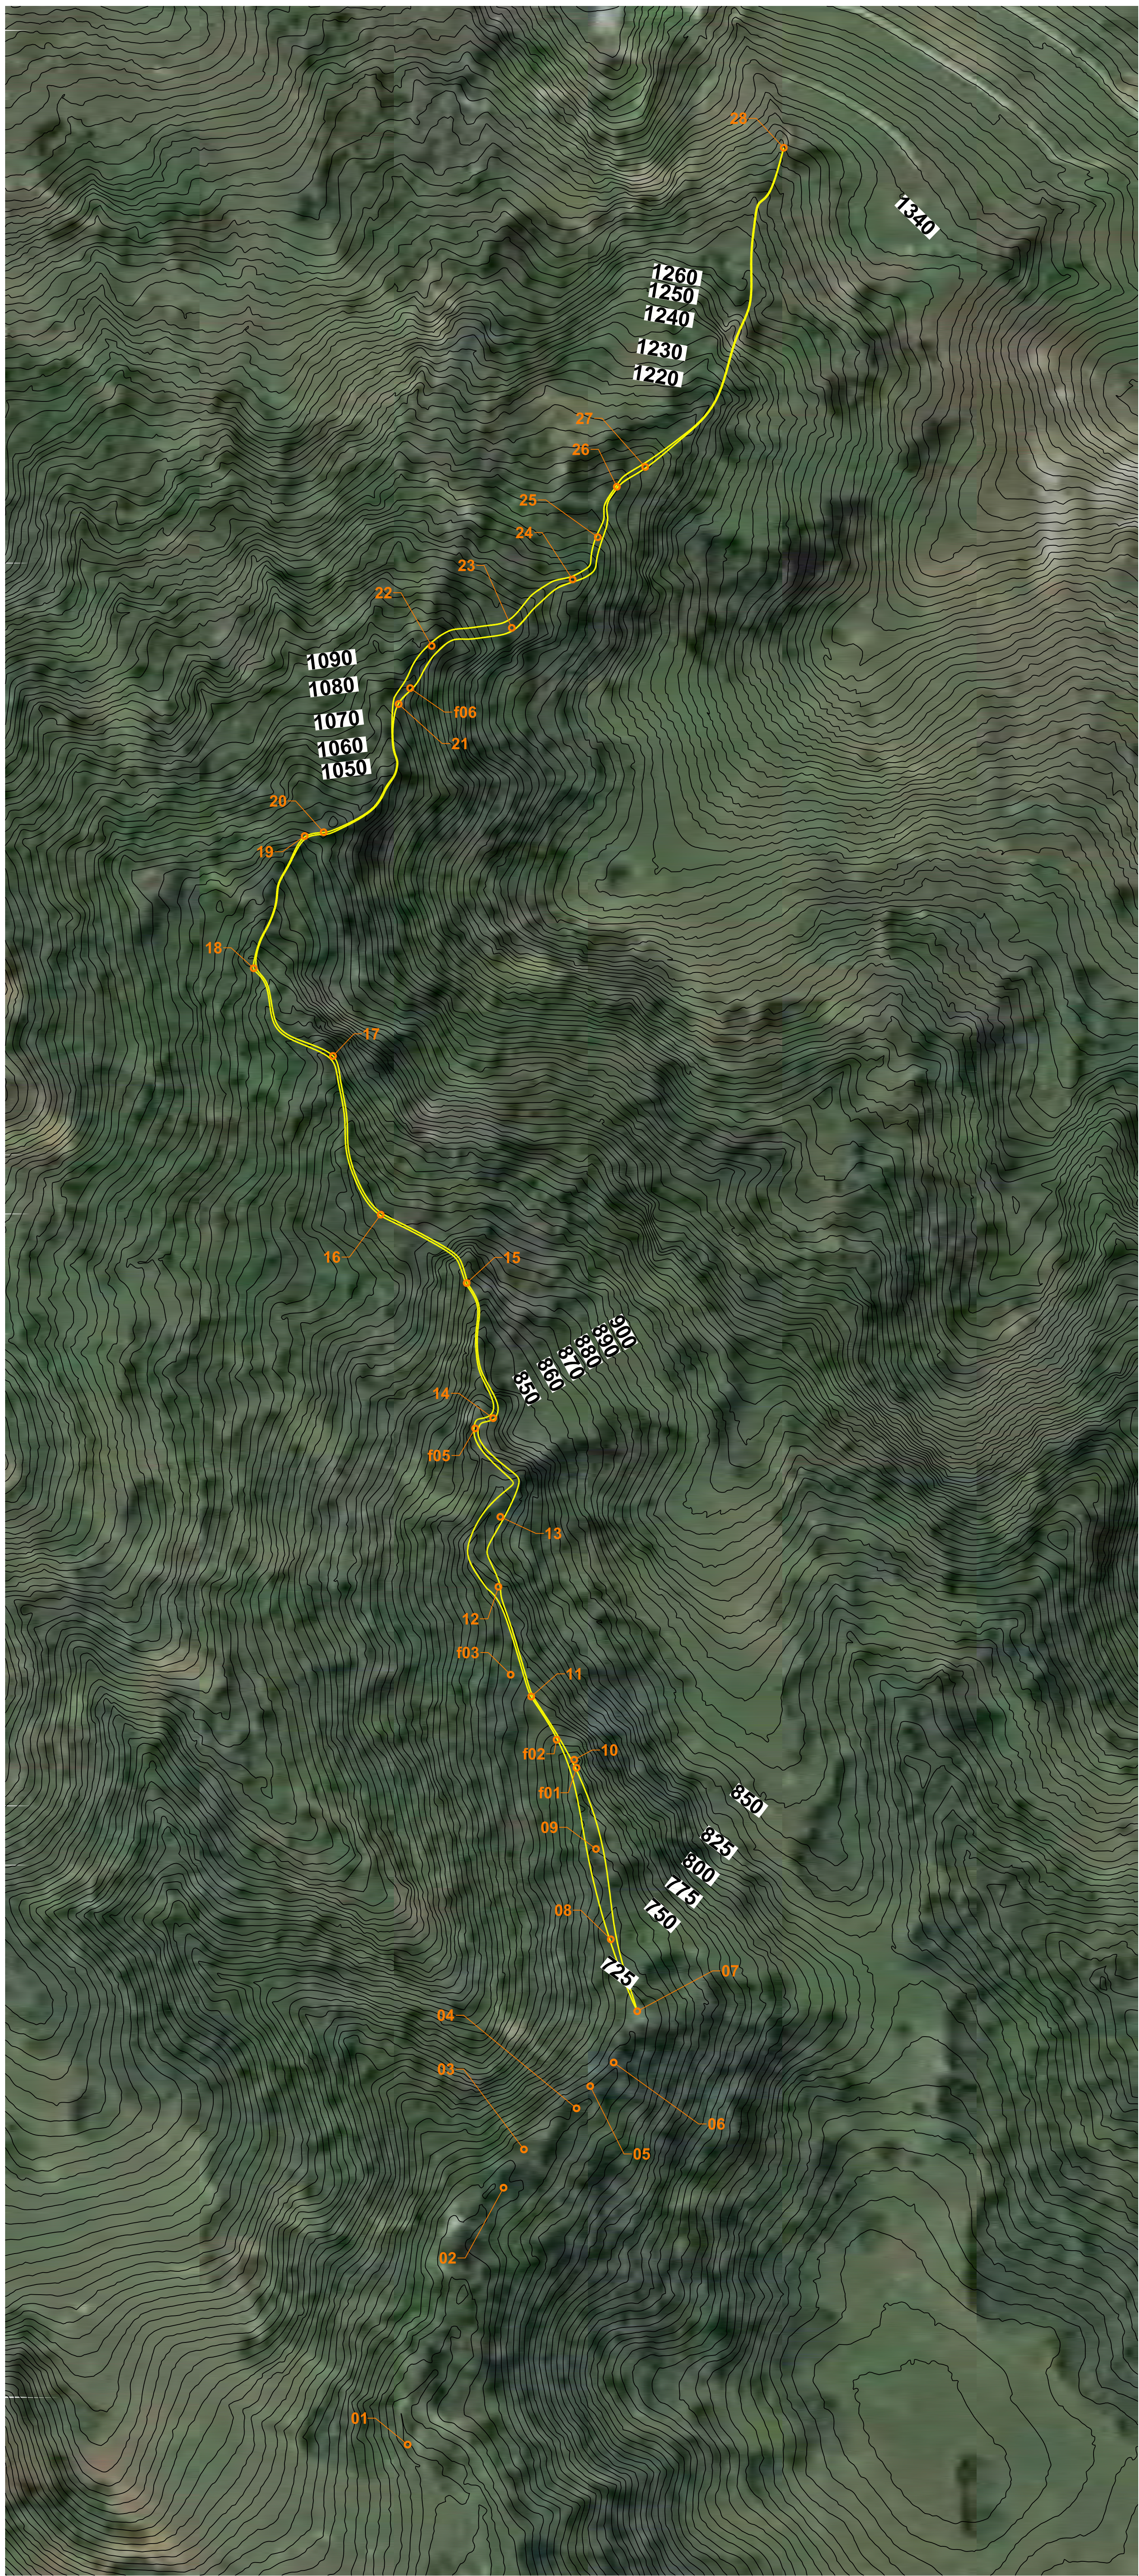
During the October 2016 field survey, Roux Associates measured a total of 86 soil measurements from 28 locations with an XRF and documented the GPS coordinates at each XRF location. At each of the 28 locations, the XRF measurements were started by taking a reading the middle of the gulch and then moving out laterally until a value below the equipment detection limit was obtained. Approximately, three to five XRF measurements were collected at each location. The locations of the XRF measurements are included in Figure 5. XRF is a non-destructive analytical technique used to identify the elemental composition of materials. An XRF unit can determine the chemistry of a sample by measuring the fluorescent (or secondary) X-ray emitted from a sample when it is excited by a primary X-ray source. Each of the elements present in a sample produces a set of characteristic fluorescent X-rays ("a fingerprint") that is unique for that specific element.
