# Hicks Flat Final Project Report

Prepared by Matt Baldzikowski, CPESC #828, Midpeninsula Regional Open Space District

December 2013

# Hicks Flat Remediation Project Field Implementation Report

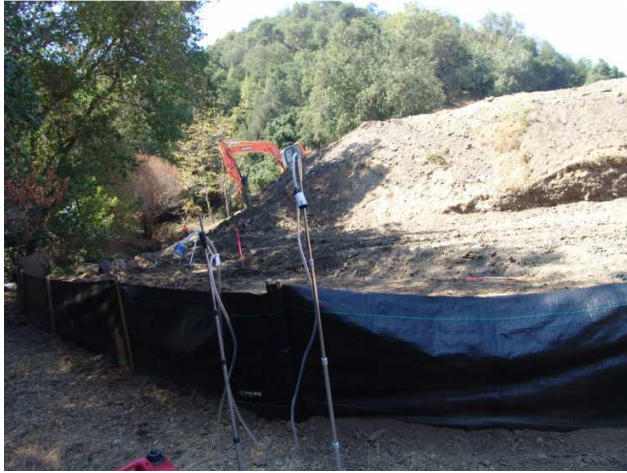
**Figure 5.** Perimeter air monitoring.

The monitoring effort and conclusions are presented in the final Air Monitoring Report (October 31, 2013, Attachment 2 to this report). The Air Monitoring Report concludes that dust suppression management practices were effective in controlling the pollutants of concern, and that there was a low exposure risk to workers, with exposures orders of magnitude below the Permissible Exposure Limit for airborne contaminants adopted by Cal/OSHA.

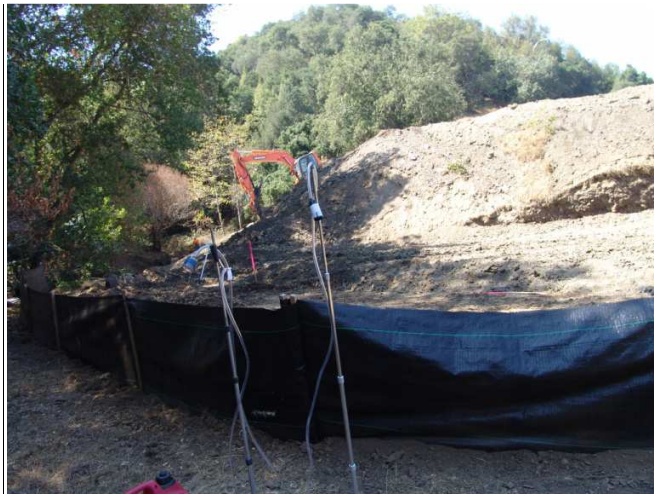
Air quality monitoring.

Substantial air quality monitoring was undertaken during the active grading portion of the project, consistent with the recommendations of the Health and Safety Plan prepared for the project. This monitoring documented that the intensive dust control measures undertaken during site disturbance activities were effective in controlling the pollutants of concern (mercury, and naturally occurring asbestos).

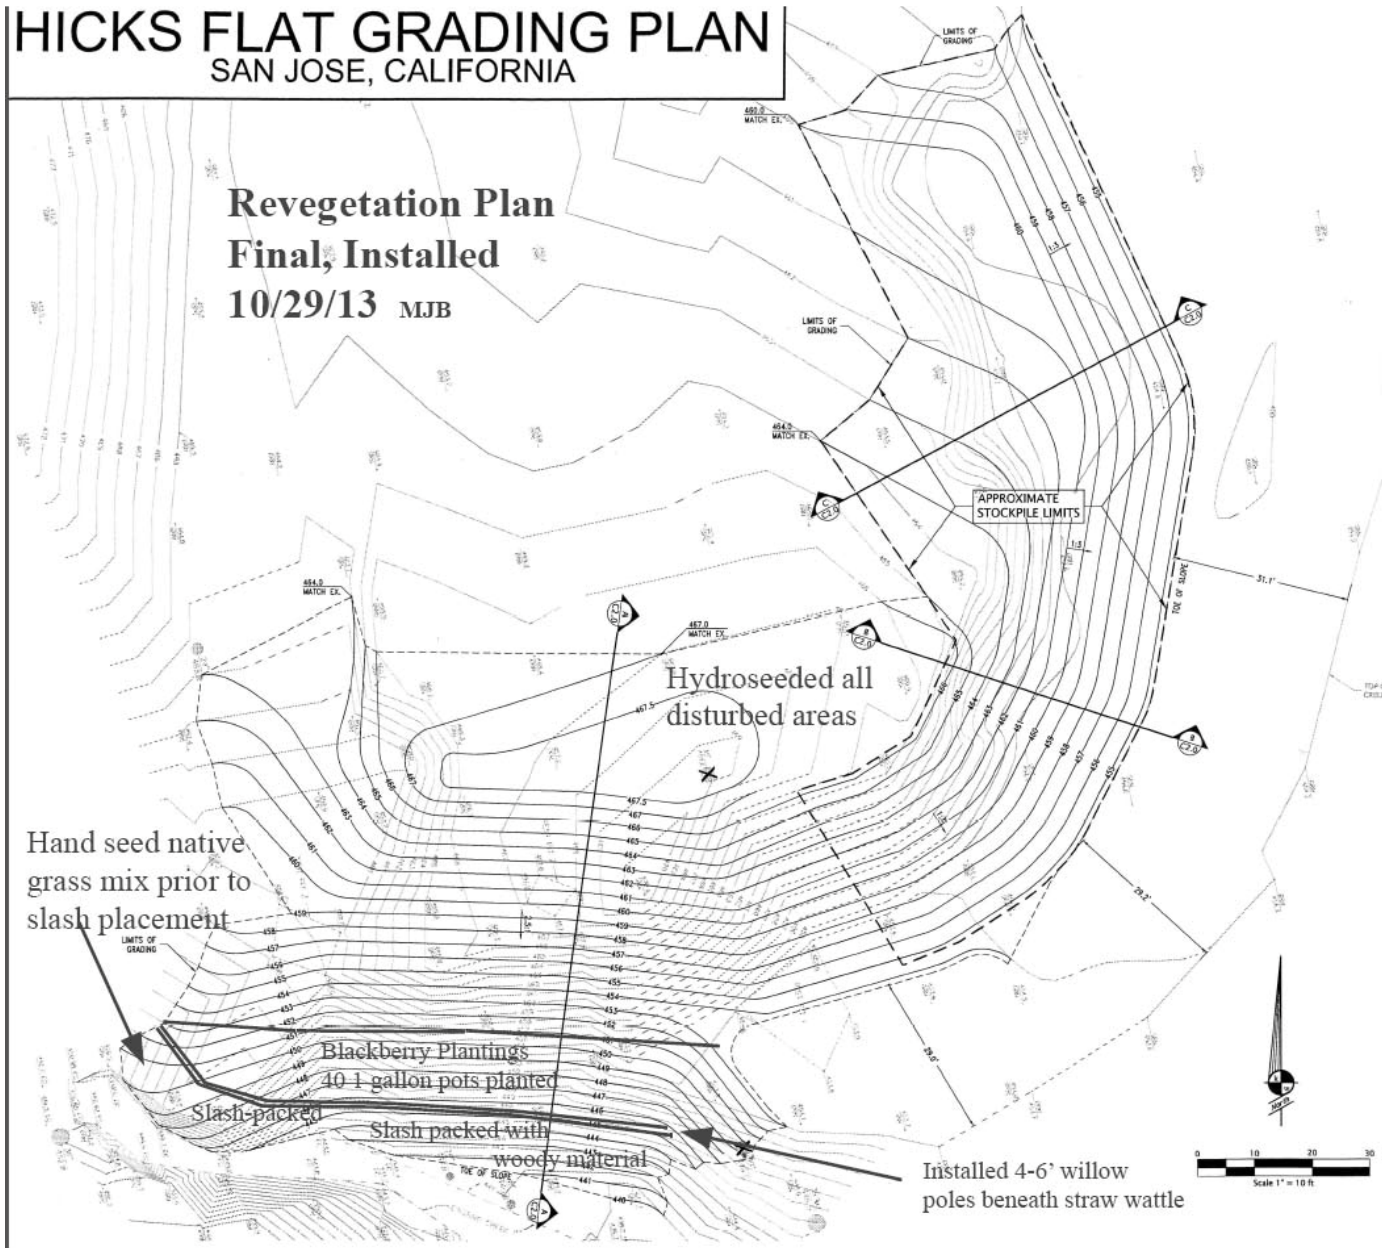
Figure 1. Record drawing: Revegetation Plan Final Installed

In summary, the project was successfully completed in substantial conformance with the approved plans and specs, and included the necessary oversight and monitoring to achieve the projects goal. Some biotechnical restoration measures were added, or modified to accommodate restoration opportunities (wood), and difficult site conditions (rock), as detailed above. These changes are reflected in the revised record drawing of the Revegetation Plan (see Figure 1, next page).

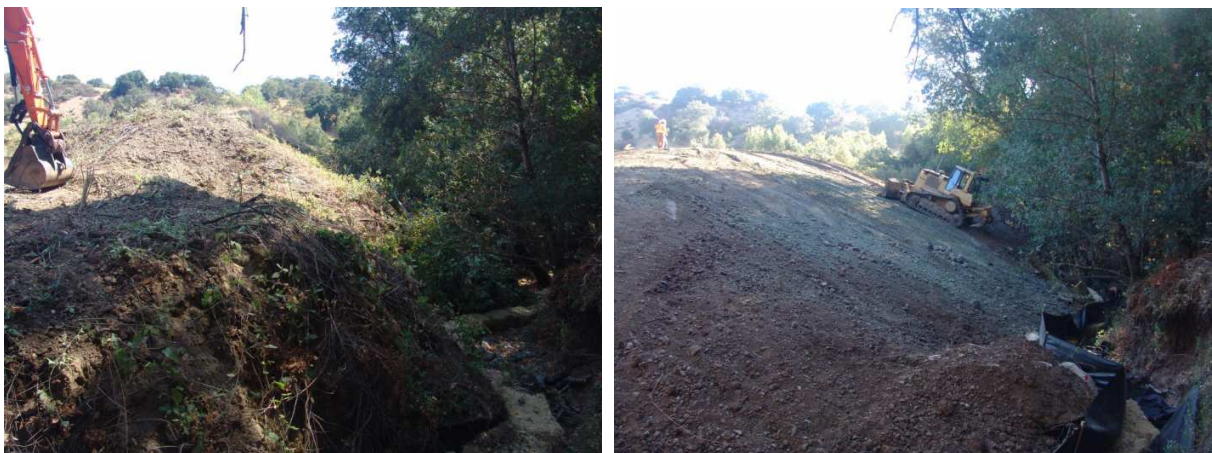
Slope flattening to achieve stable slope configuration.

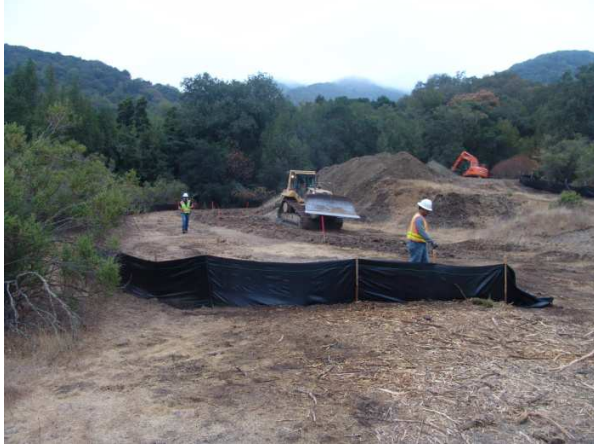
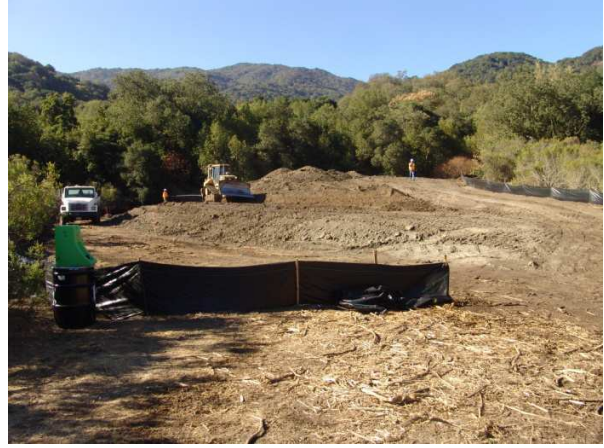
Stable waste (fill) disposal location.

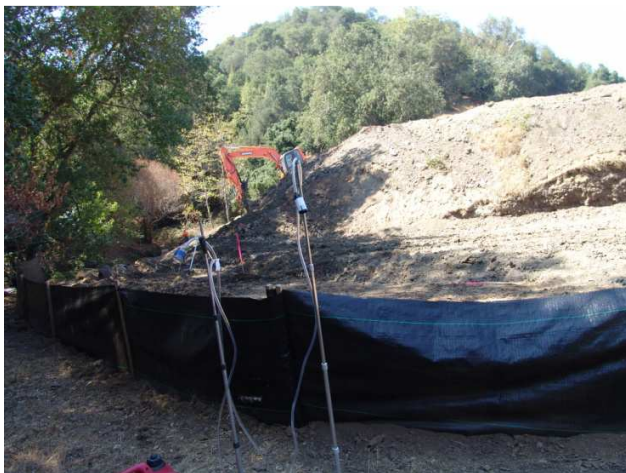
One of four perimeter air monitoring locations.

The monitoring effort and conclusions are presented in the final Air Monitoring Report (October 31, 2013, Attachment 2 to this report). The Air Monitoring Report concludes that dust suppression management practices were effective in controlling the pollutants of concern, and that there was a low exposure risk to workers, with exposures orders of magnitude below the Permissible Exposure Limit for airborne contaminants adopted by Cal/OSHA.

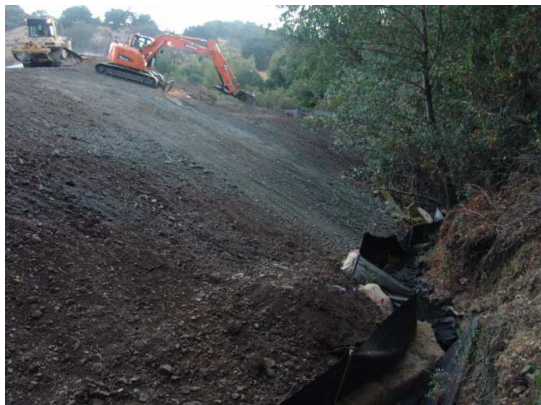
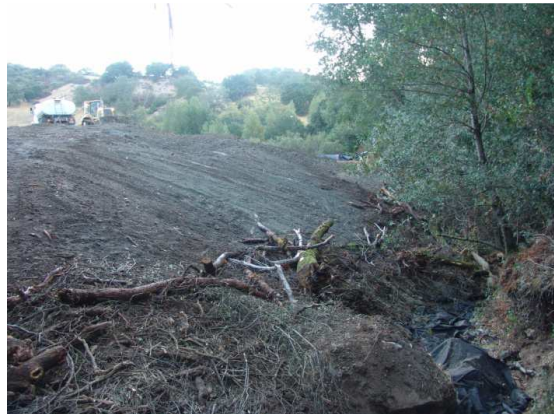
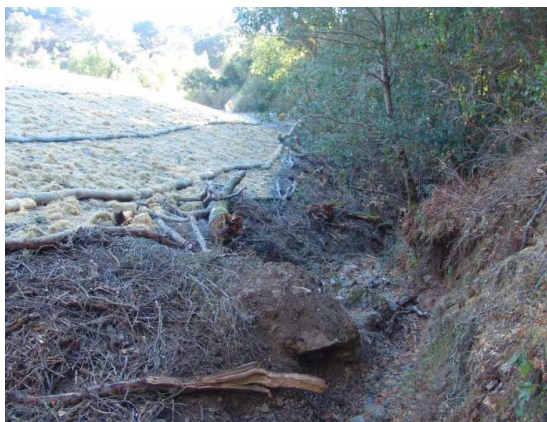
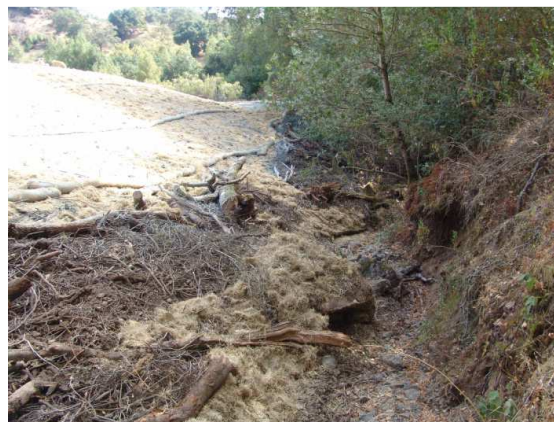
Erosion and sediment control measures were installed during project implementation and at the completion of the grading for final project surface stabilization, as recommended on the Erosion Control Plan sheet, and Revegetation Plan developed for the project. These included the installation of silt fencing, straw bales, straw wattles, extensive creek protection measures (described in Field Implementation Report), straw mulch, hydroseeding, and site plantings of native blackberry, and willow cuttings. Additionally, the near creek environment was treated with native woody material for additional erosion control and creek restoration/ wildlife habitat benefits (photo's below).

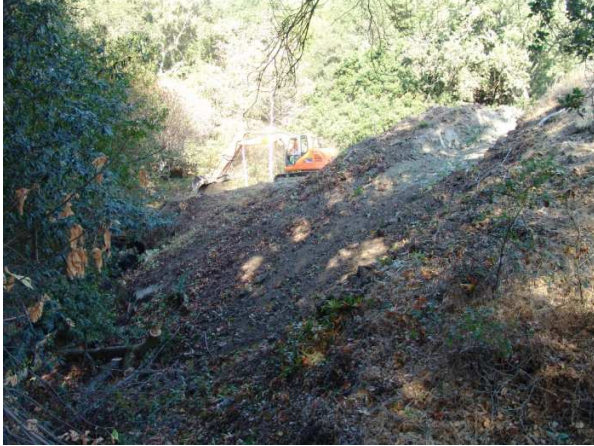
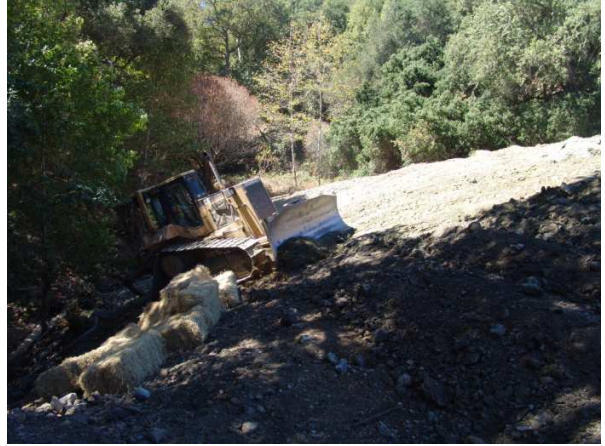
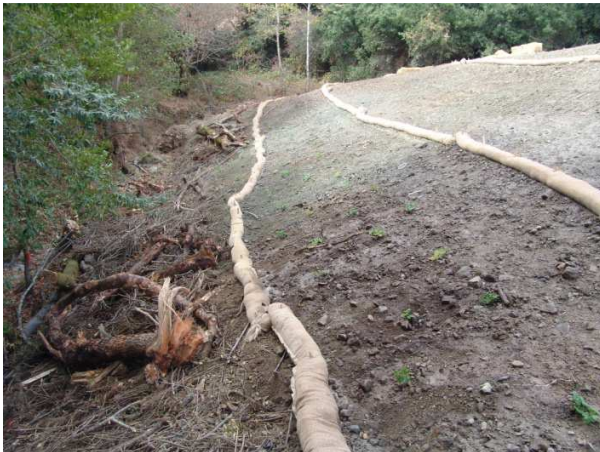
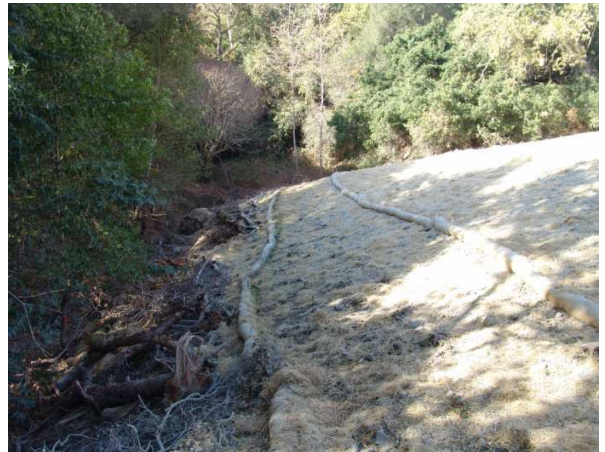
Photo point 5 sequence. Slope flattening, creek-side restoration, final erosion control implementation.

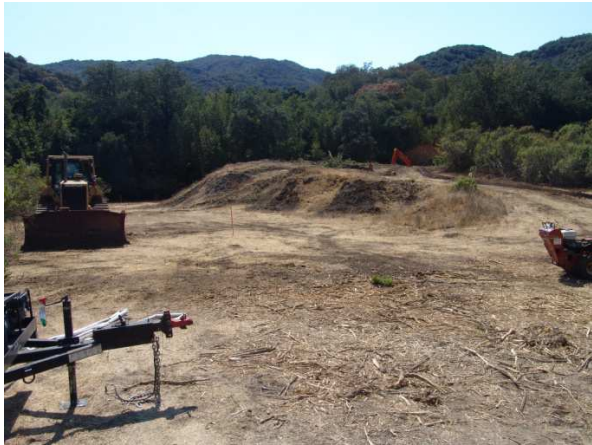
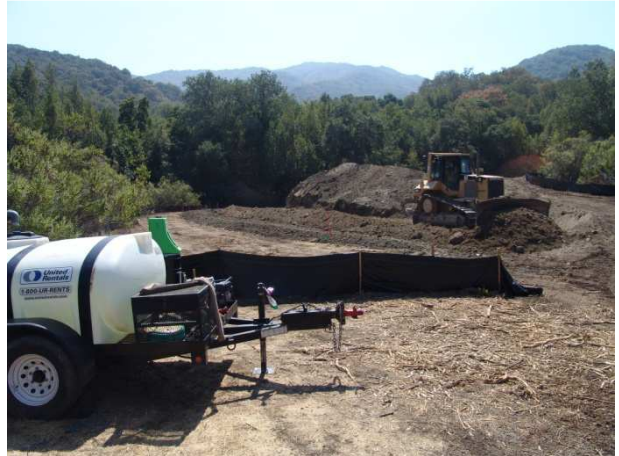
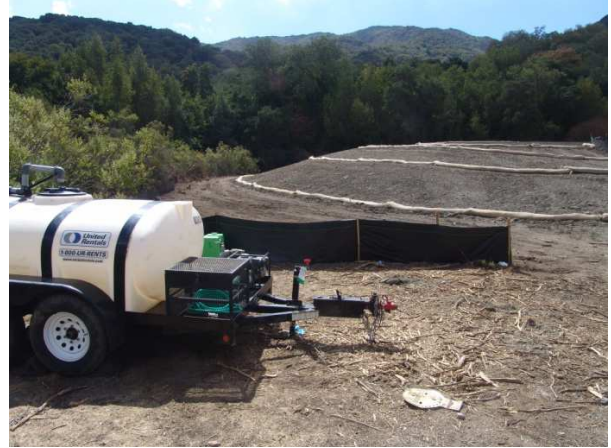
Photo point 3 sequence. Waste disposal (fill) placement through grading completion.

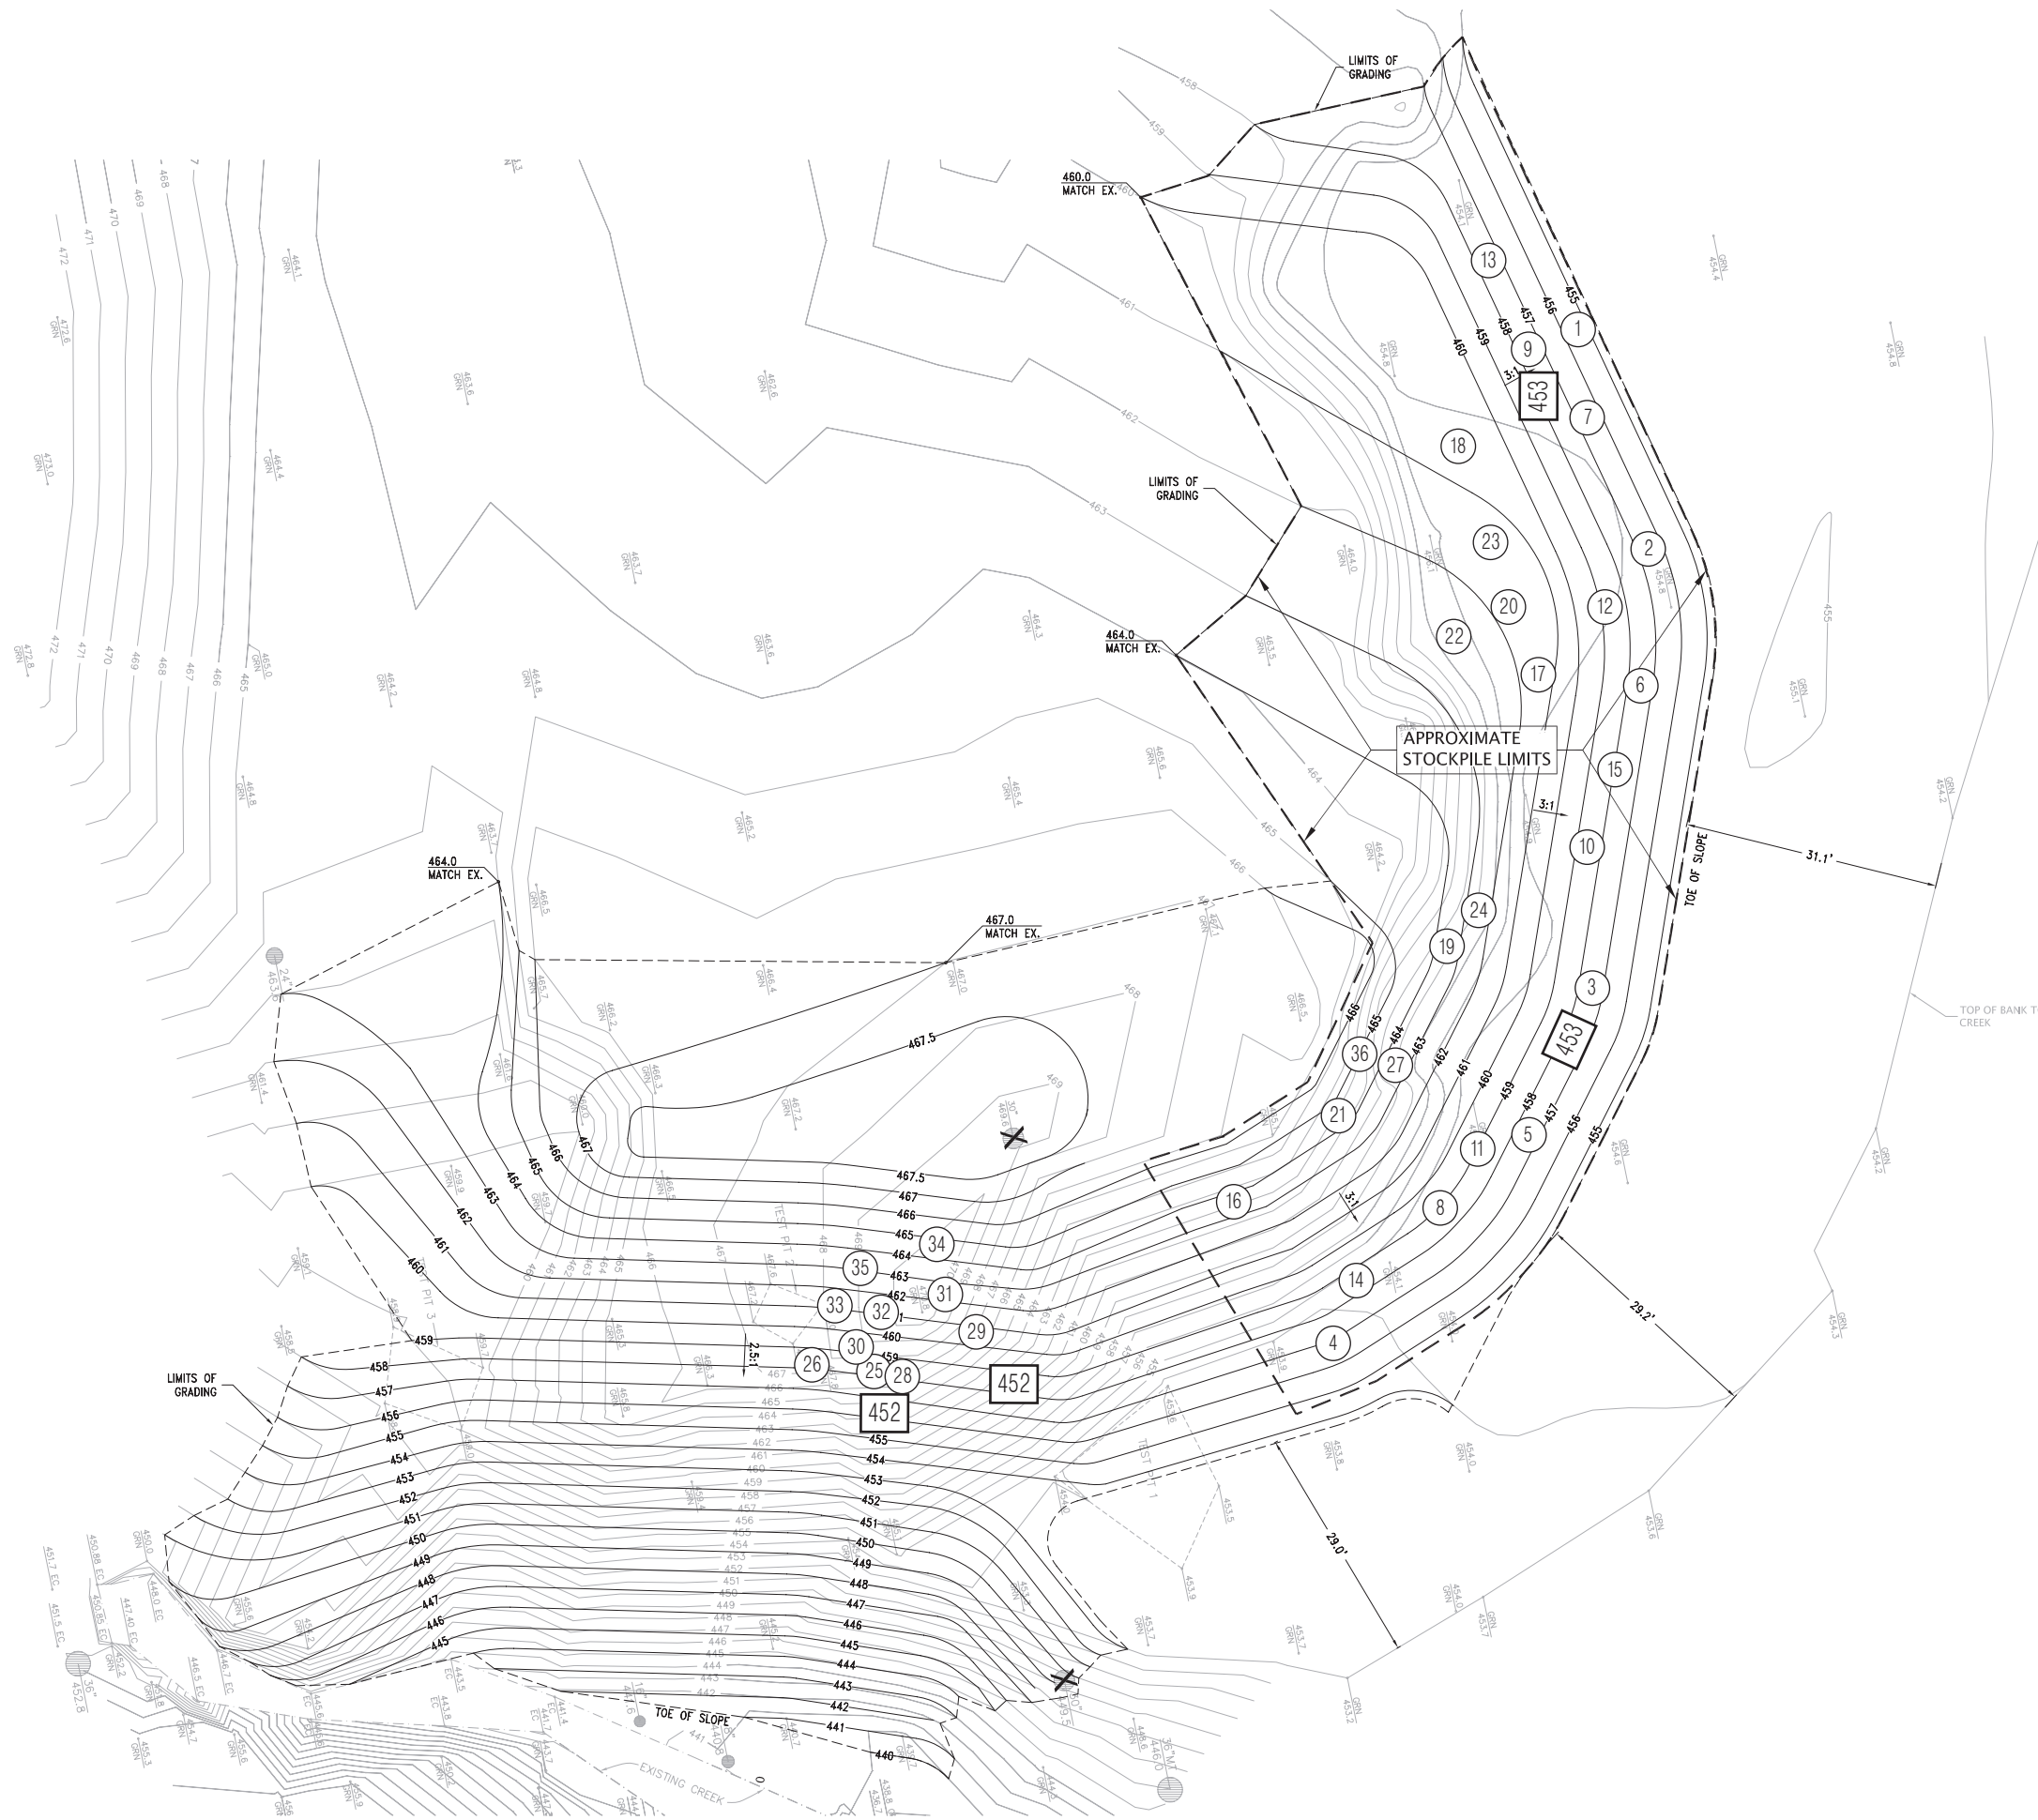
In general, the in-place density test results indicate that fill soils were compacted to at least 85% relative compaction above optimum moisture content in the 3:1 fill slope areas and at least 87% relative compaction above optimum moisture content in the stability fill, at the locations tested. The approximate locations of the in-place density and moisture content tests are shown on the *Field Density Test Location Map* (Figure 1, attached). We note that our referenced correspondence recommended that structural fill i.e. fills within the stability fill be compacted to 90% relative compaction. Some of our in-place density tests within the stability fill indicated relative compaction slightly below 90%; however, based on the as-graded configuration of the stability fill, the inclination of the finished slope face at the stability fill, and our laboratory shear strength testing, it is our opinion the as-graded slope configuration in this area possesses a factor of safety of 1.5 or greater against deep-seated slope instability.
