Operations and Maintenance of Horizontal Levees – Lessons from the Oro Loma Pilot Project

April 2025

San Francisco Estuary Partnership

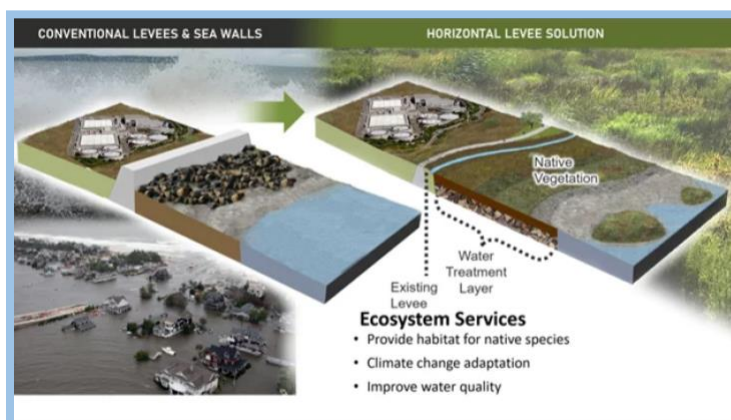
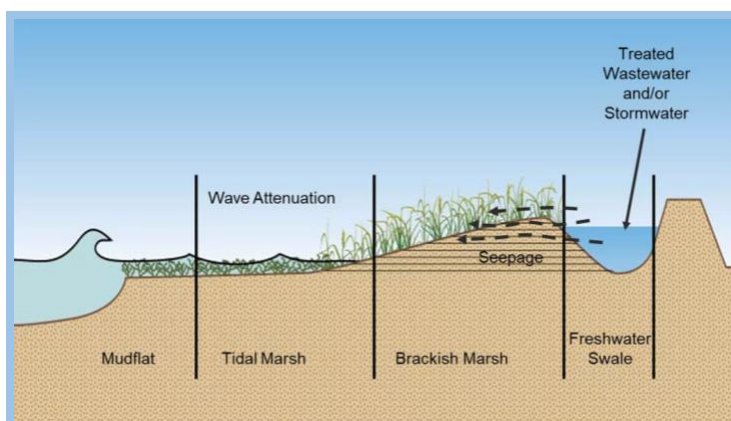
Diagram Credit: Angelo Stiegler

The Oro Loma horizontal levee pilot has a 30:1 slope in most areas and a 15:1 slope in a few experimental areas. It is divided into 12 different experimental areas referred to as “cells”, which contain different substrates and vegetation/habitat types to test the efficiency of each for water quality improvement. Wastewater from Oro Loma Sanitary District and reverse osmosis concentrate from Valley Water are pumped and trucked, respectively, to the horizontal levee to

flow through the cells. The substrate of the horizontal levee cells consists of layers of clay, porous gravel, bay mud, woodchips, sand and soil.

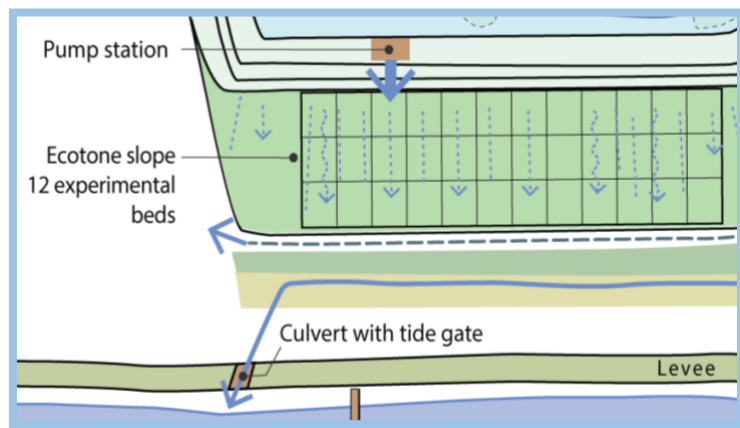
Source: ESA

The experimental cells at the Oro Loma Horizontal Levee Pilot Project are divided into 12 beds and test for different combinations of soil types, plant species, and source water types.
